BALTIMORE CITY MS4 ANNUAL REPORT

Reporting Period: July 1, 2018 to June 30, 2019

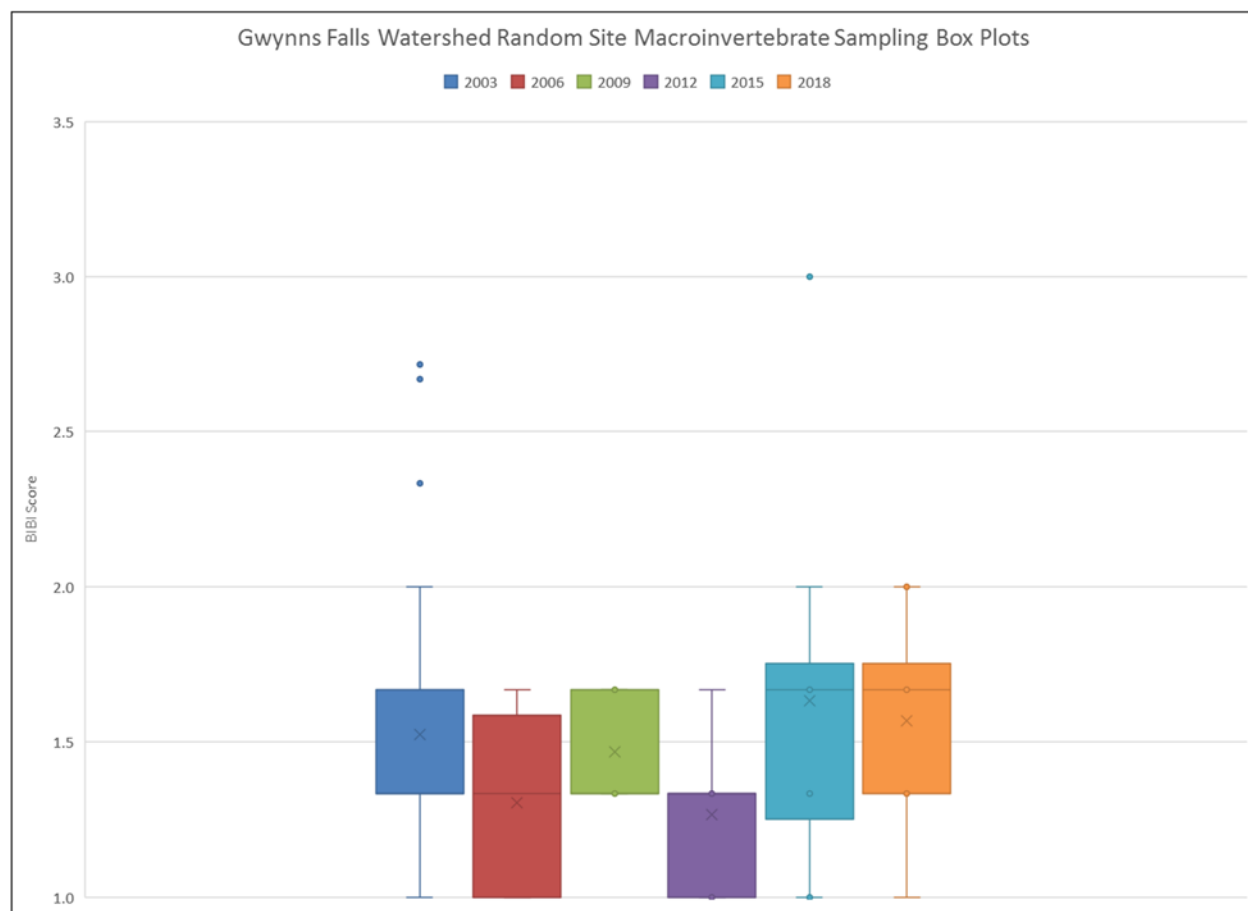
Figure 3-2: BIBI Scores for Macroinvertebrate Samples Random Sampling in the Gwynns Falls Watershed

DPW sampled 10 random stations in the Gwynns Falls watershed in 2018. The BIBI scores for these 10 samples ranged from 1.0 through 2.0: eight samples between 1.0 and 1.7, which are rated as “very poor”; and two samples equal 2.0, which is rated as “poor”. Random sampling was performed in the Gwynns Falls watershed in 2003, 2006, 2009, 2012, 2015 and 2018. Figure 3-2 graphically shows the distribution of the BIBI scores for each of those 6 years. The distribution for the 2018 set of samples is very similar to that for 2015, except that, for the 2015 set, there was one sample that rated 3.0 (which rates as “fair”).

The BIBI, embeddedness, epifaunal and habitat scores for all fixed station and random station samples from 2018 are listed in the *Biological Monitoring* table of the *MDE NPDES MS4 Geodatabase* (Appendix C of this report).
