BALTIMORE CITY MS4 ANNUAL REPORT

Reporting Period: July 1, 2021 to June 30, 2022

BALTIMORE CITY
DEPARTMENT OF
PUBLIC WORKS

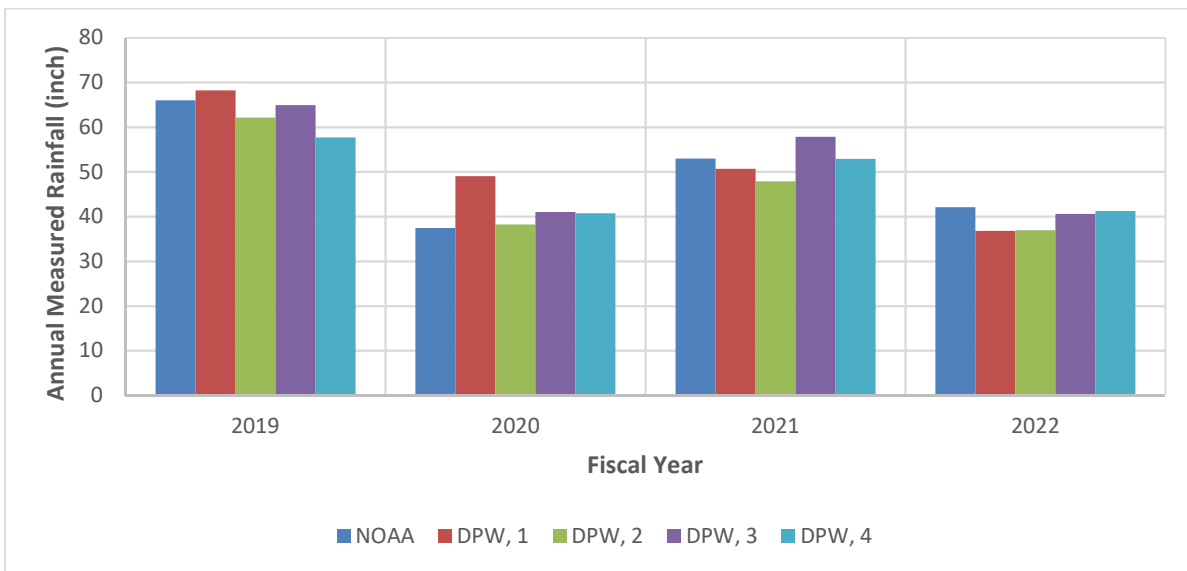
Figure 3-2: Summary of Annual Rainfall Variability

Table 3-2: Summary of Variability in Rainfall Data for Baltimore in FY 2022

Location	NOAA	DPW 1	DPW 2	DPW 3	DPW 4
Total Rainfall, in	42	36.8	36.9	40.6	41.2
Days > 0.1 in	62	68	69	66	62
Days > 1.0 in	12	10	9	12	12
Max. Daily Rainfall	4.1	2.0	3.0	2.9	3.7

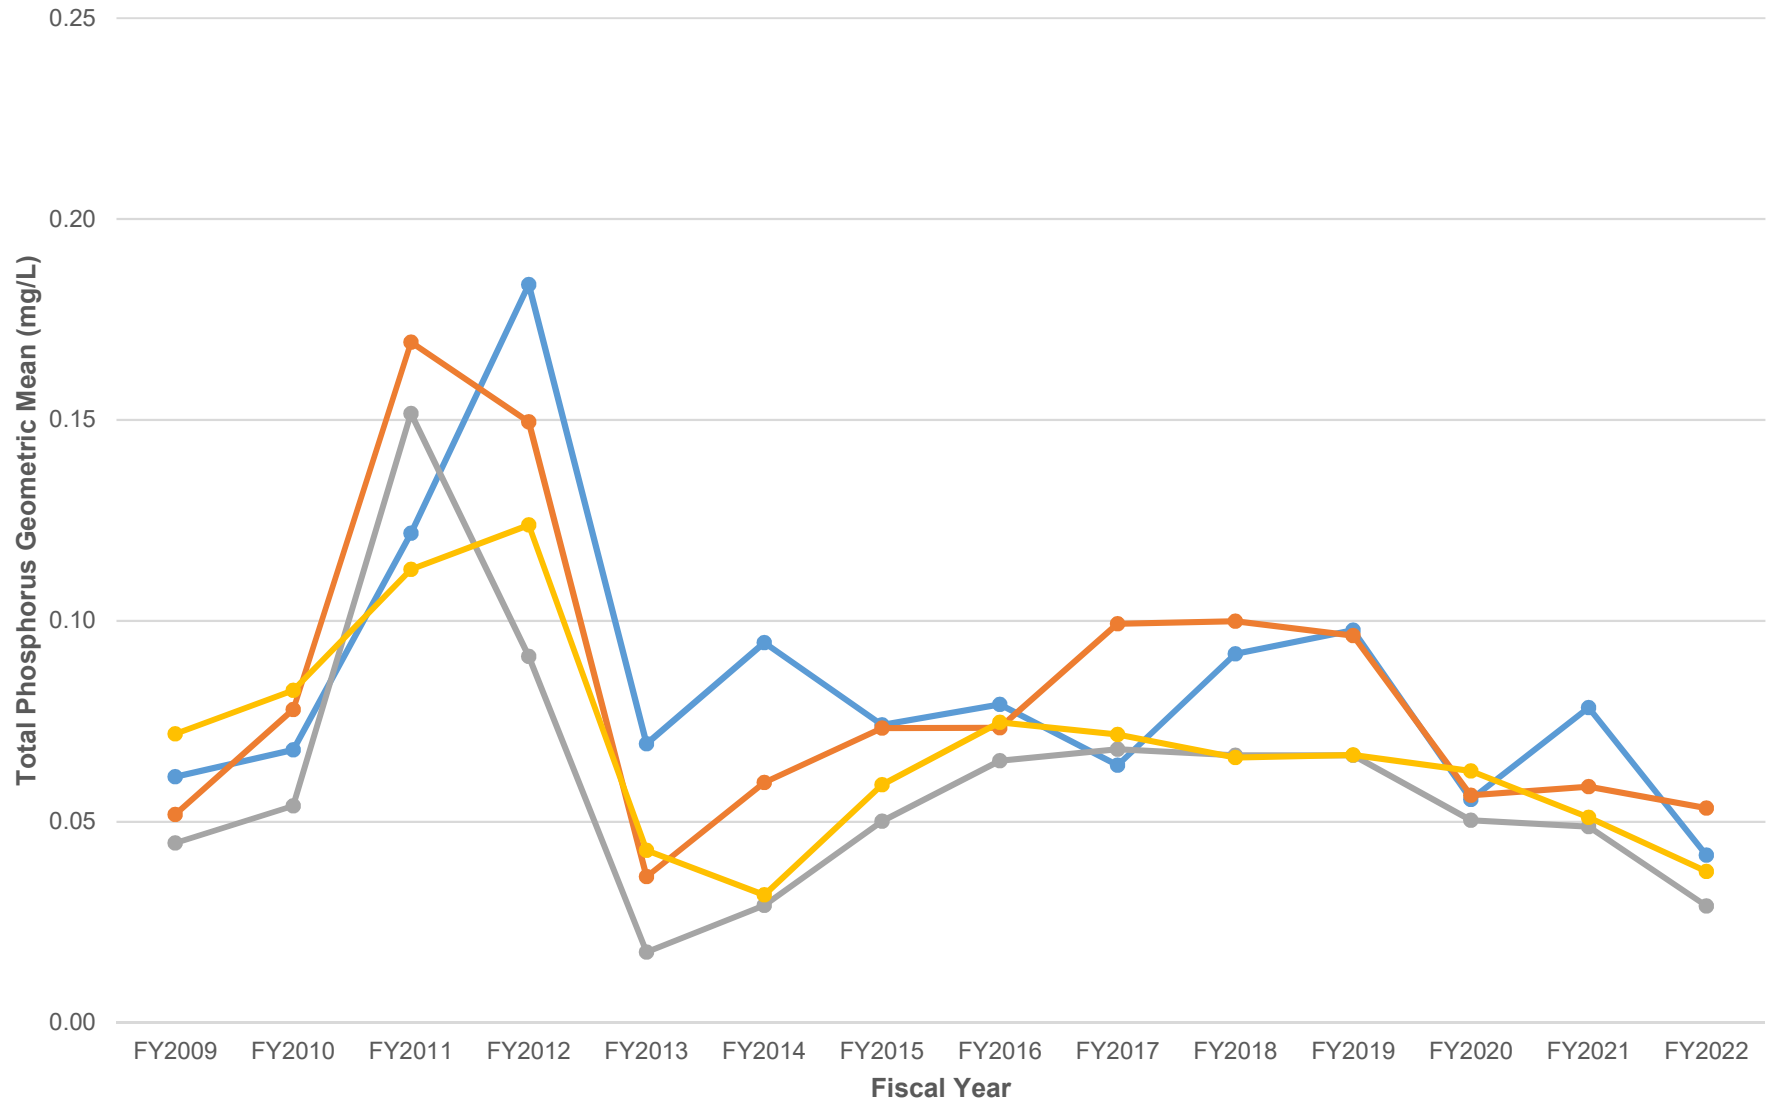
Total Phosphorus Geometric Means by Fiscal Year Back River Watershed, Moores Run Subwatershed

MARY AVE. HAMILTON AVE. RADECKE AVE. BIDDLE ST. & 62ND ST.

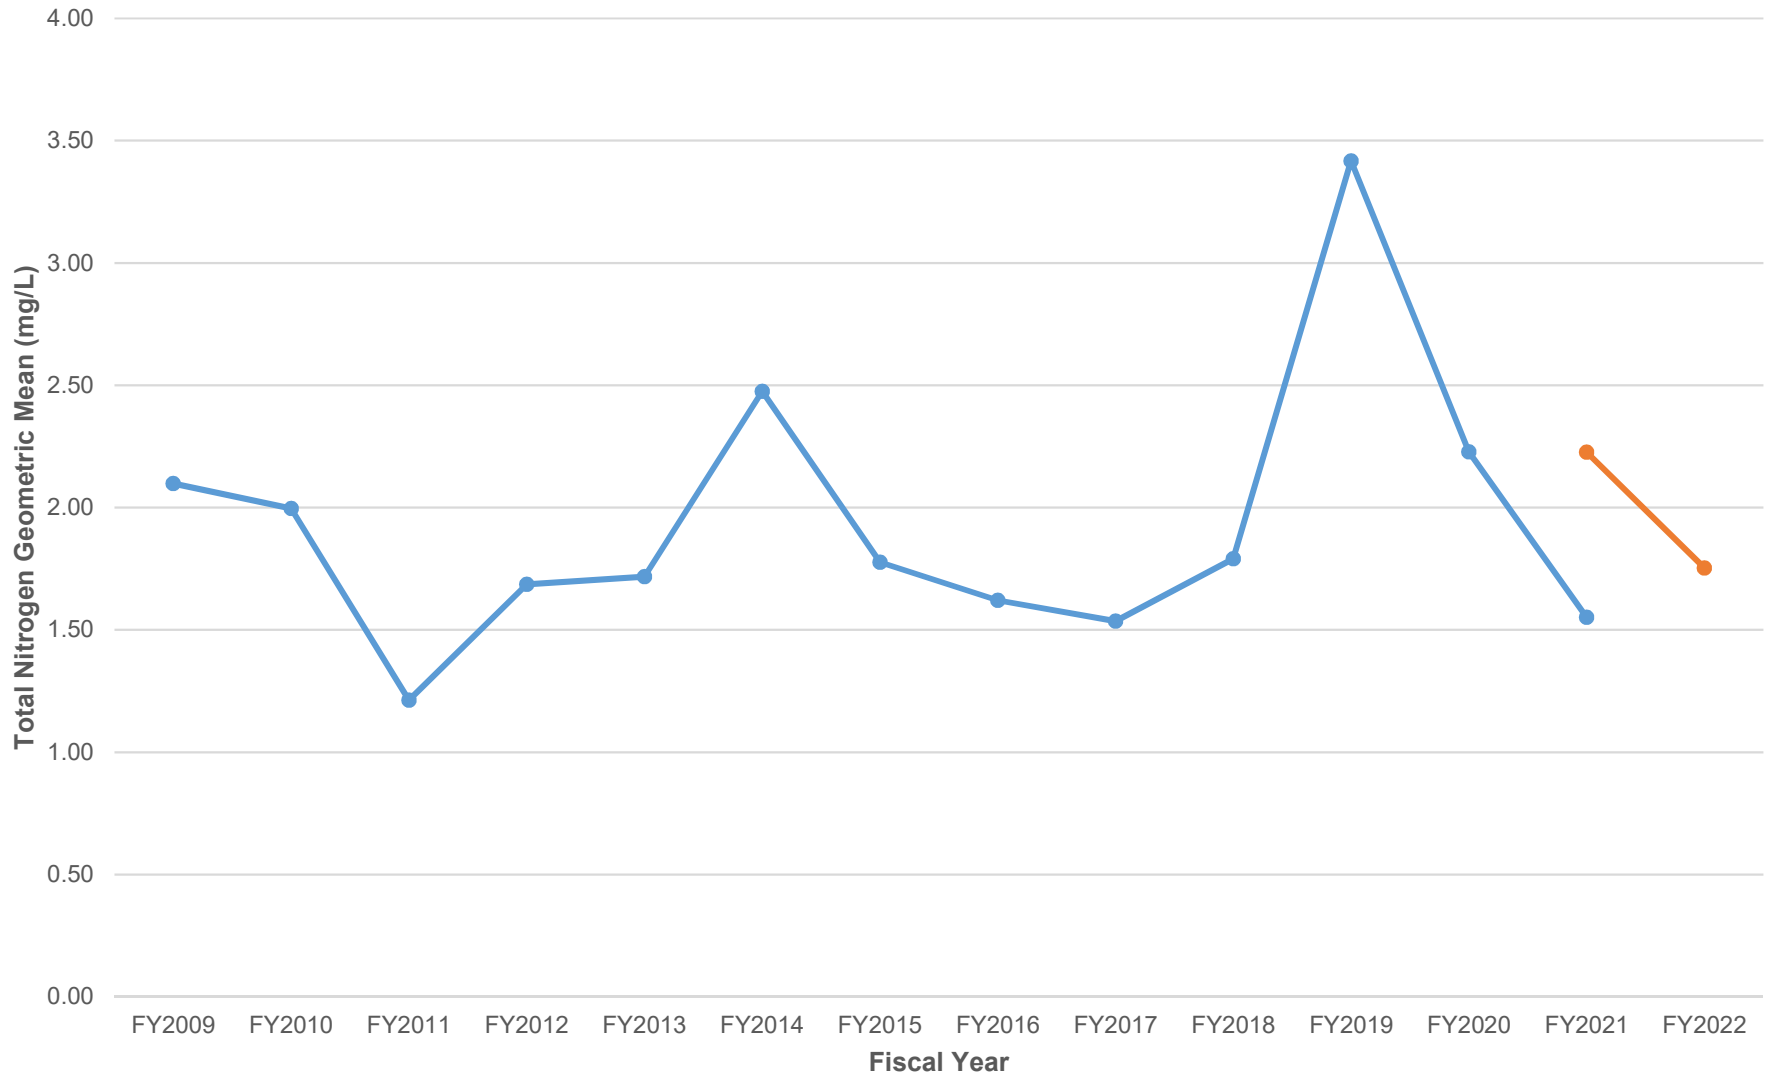
Total Nitrogen Geometric Means by Fiscal Year Patapsco River Watershed

Sampling suspended at REEDBIRD AVE. in October 2020 due to construction at site.
