# **BALTIMORE CITY MS4 ANNUAL REPORT**

**Reporting Period: July 1, 2020 to June 30, 2021**

This report includes the progress of compliance for the period of Fiscal Year (FY) 2021, in association with Baltimore City's National Pollutant Discharge Elimination System (NPDES) Municipal Separate Storm Sewer System (MS4) Discharge Permit (Permit Number: 11-DP-3315, MD0068292). The permit associated with the time period of this report was issued on December 27, 2013. Although that permit expired on December 27, 2018, it was administratively continued and the City remained responsible for compliance of those permit conditions. Annual report periods follow the City's fiscal calendar: July 1 to June 30. This Annual report has been formatted to match the reporting requirements as listed in Part V of the MS4 permit.

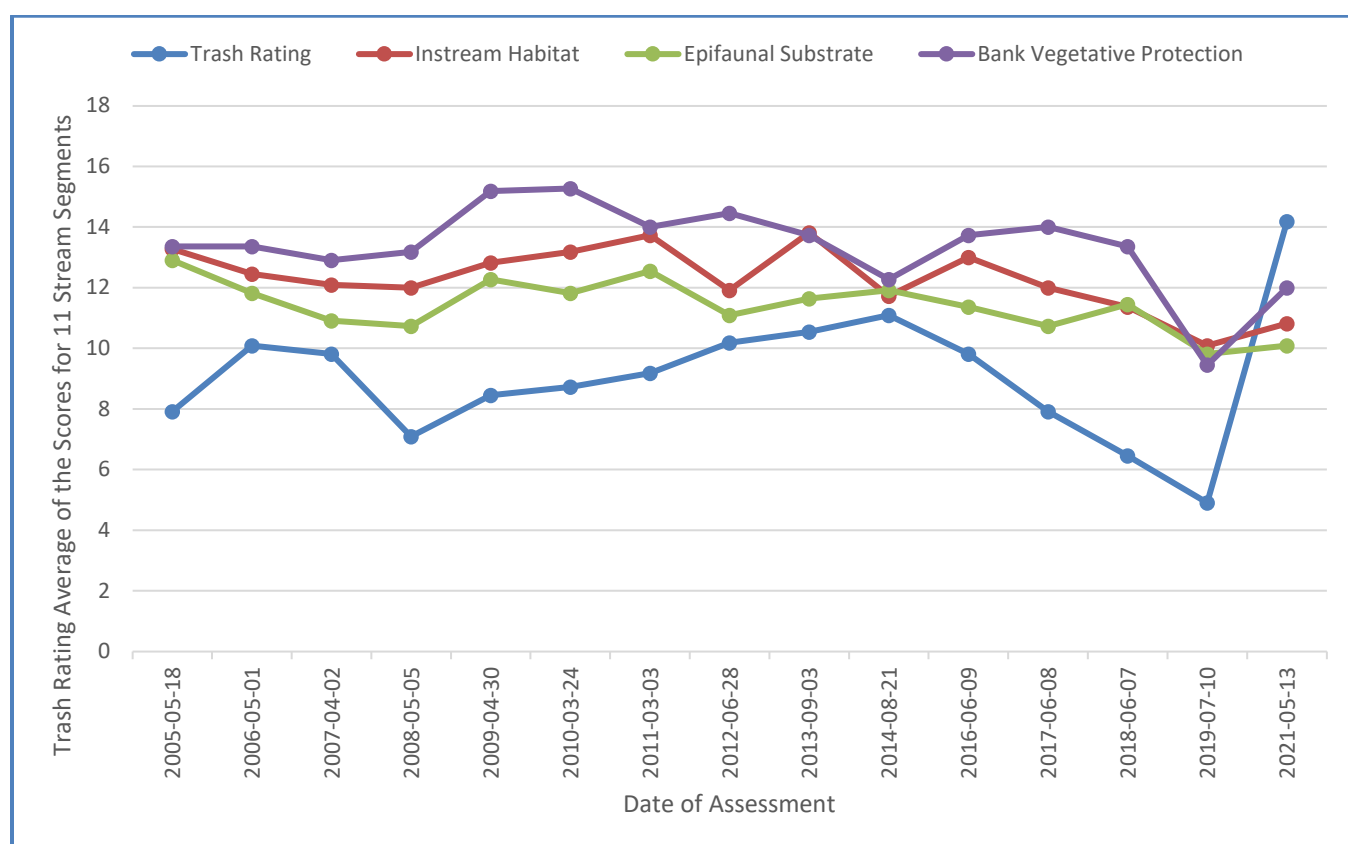
**Figure 3-3: Moores Run Habitat Assessment Scores**

DPW performed a habitat assessment survey of the upper Moores Run watershed on May 13, 2021. The results, along with fourteen other assessments (May 18, 2005 through July 10, 2019), are included in Appendix H of this report. The 2019 assessment had the lowest average scores for these parameters: instream habitat, epifaunal substrate, trash rating and bank vegetative protection. However, the average score for each of those parameters rebounded for the 2021 assessment. As shown in Figure 3-3, the 2021 assessment attained the highest average score for the trash rating.

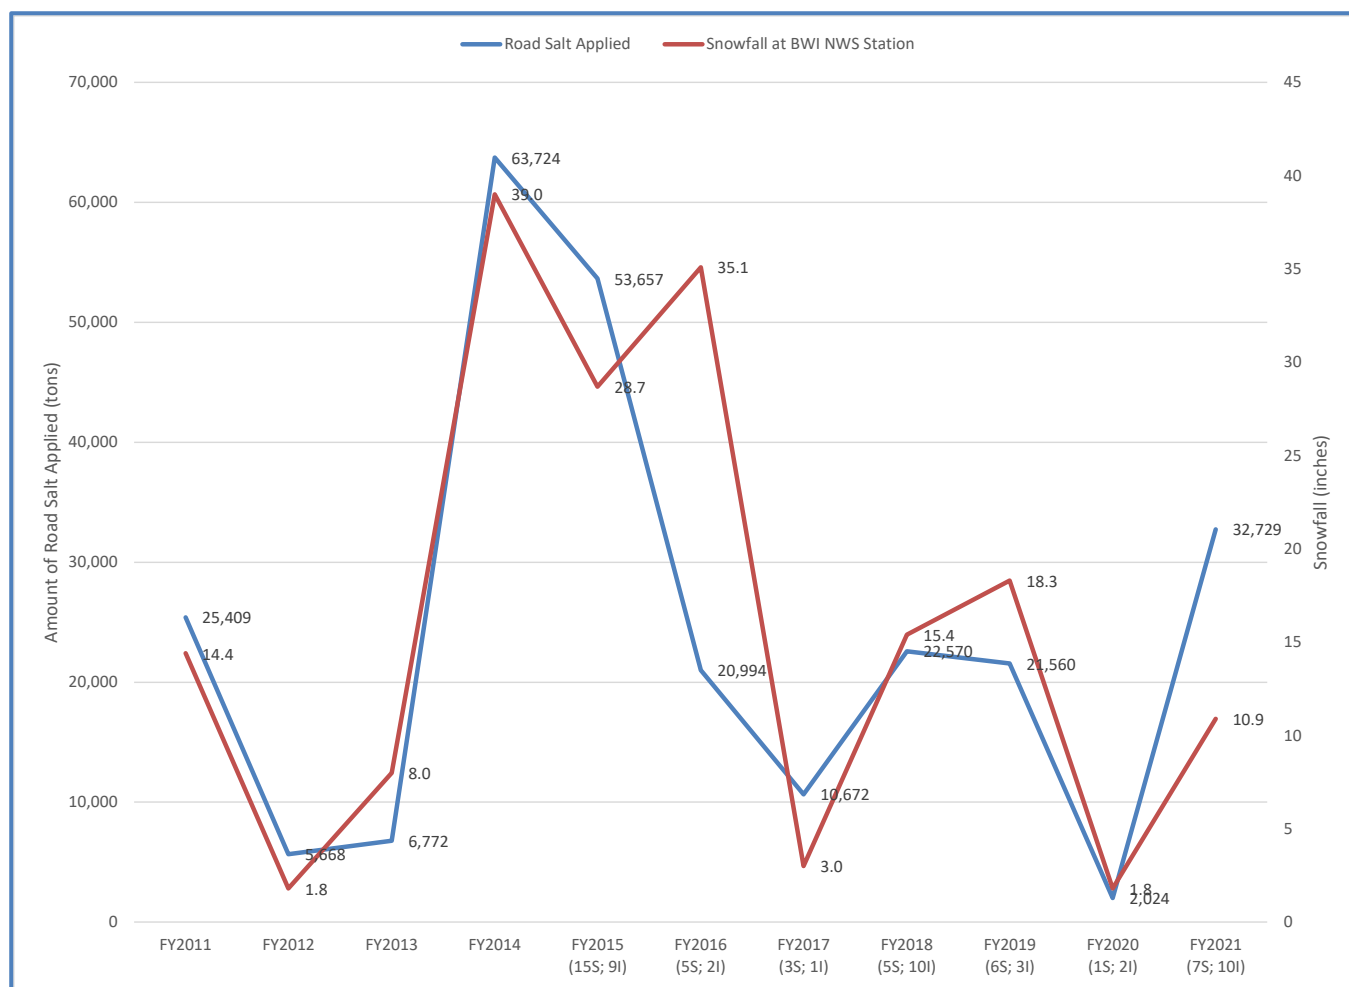
**Figure 5-1: Road Salt Applied by City of Baltimore and Snowfall at BWI by Fiscal Year**

Figure 5-1 depicts the amount of road salt and the amount of snowfall recorded at the National Weather Service station at BWI Airport for each fiscal year, from FY 2011 through FY 2021. Note that 30 inches out of the 35.1 inches of snow fell in one event in FY 2016, specifically on January 21-22, 2016. That is why that pair of numbers (20,994 tons of road salt applied and 35.1 inches of snowfall) are not well related with the other pairs of numbers.

**Note:** For FY 2015 through FY 2021, S = number of snow events; I = number of Ice events

There were seven (7) storms and ten (10) dates of icy conditions for which DOT applied road salt (sodium chloride) during FY 2021. In addition, DOT applied a brine solution to roads just prior to those storms for six out of seven of the storms. In total, DOT applied 32,610 tons of road salt, and used an additional 119 tons of road salt to make the brine solution; for a grand total of 32,729 tons of road salt for FY 2021. This is a substantial increase of 1,517% from the 2,024 tons that were applied during FY 2020. The snowfall total recorded at BWI for FY 2021 was 10.9 inches- compared to 1.8 inches for FY 2020.

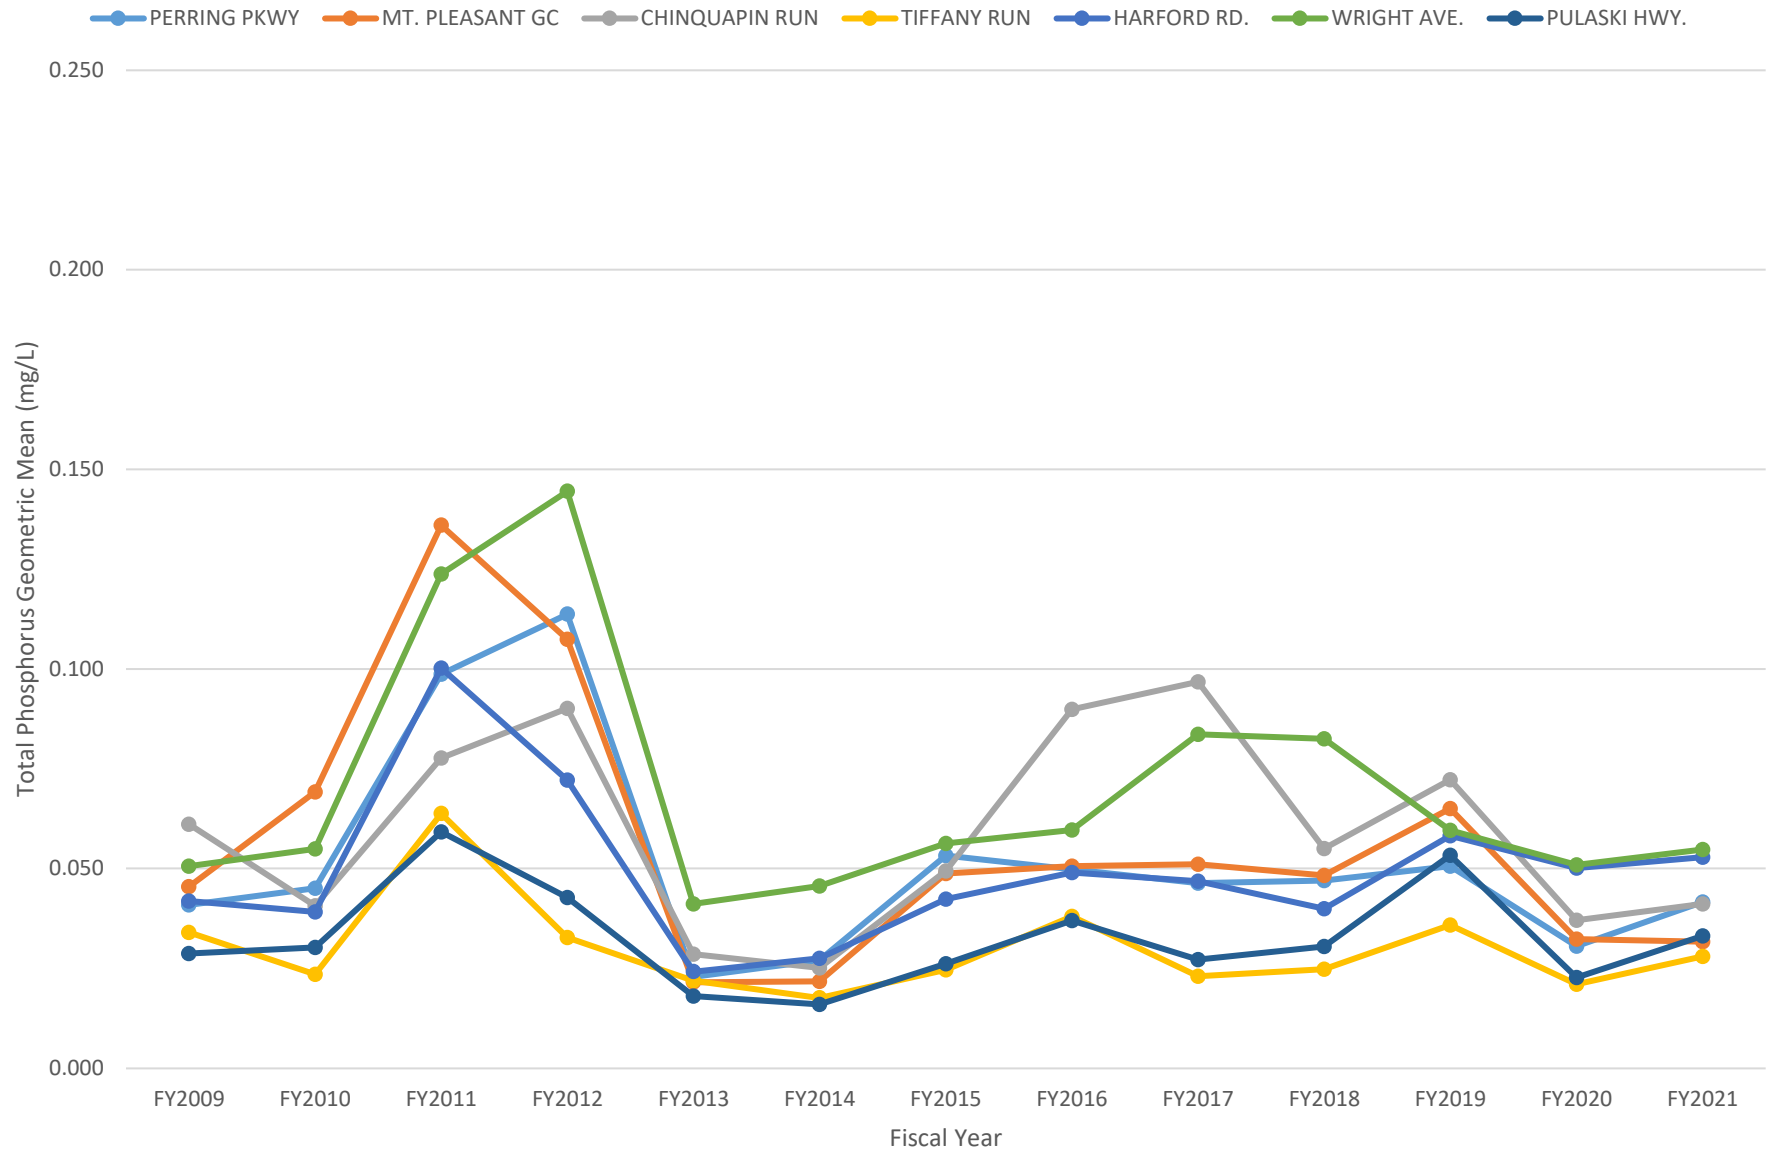
# Total Phosphorus Geometric Means by Fiscal Year Back River Watershed, Herring Run Subwatershed

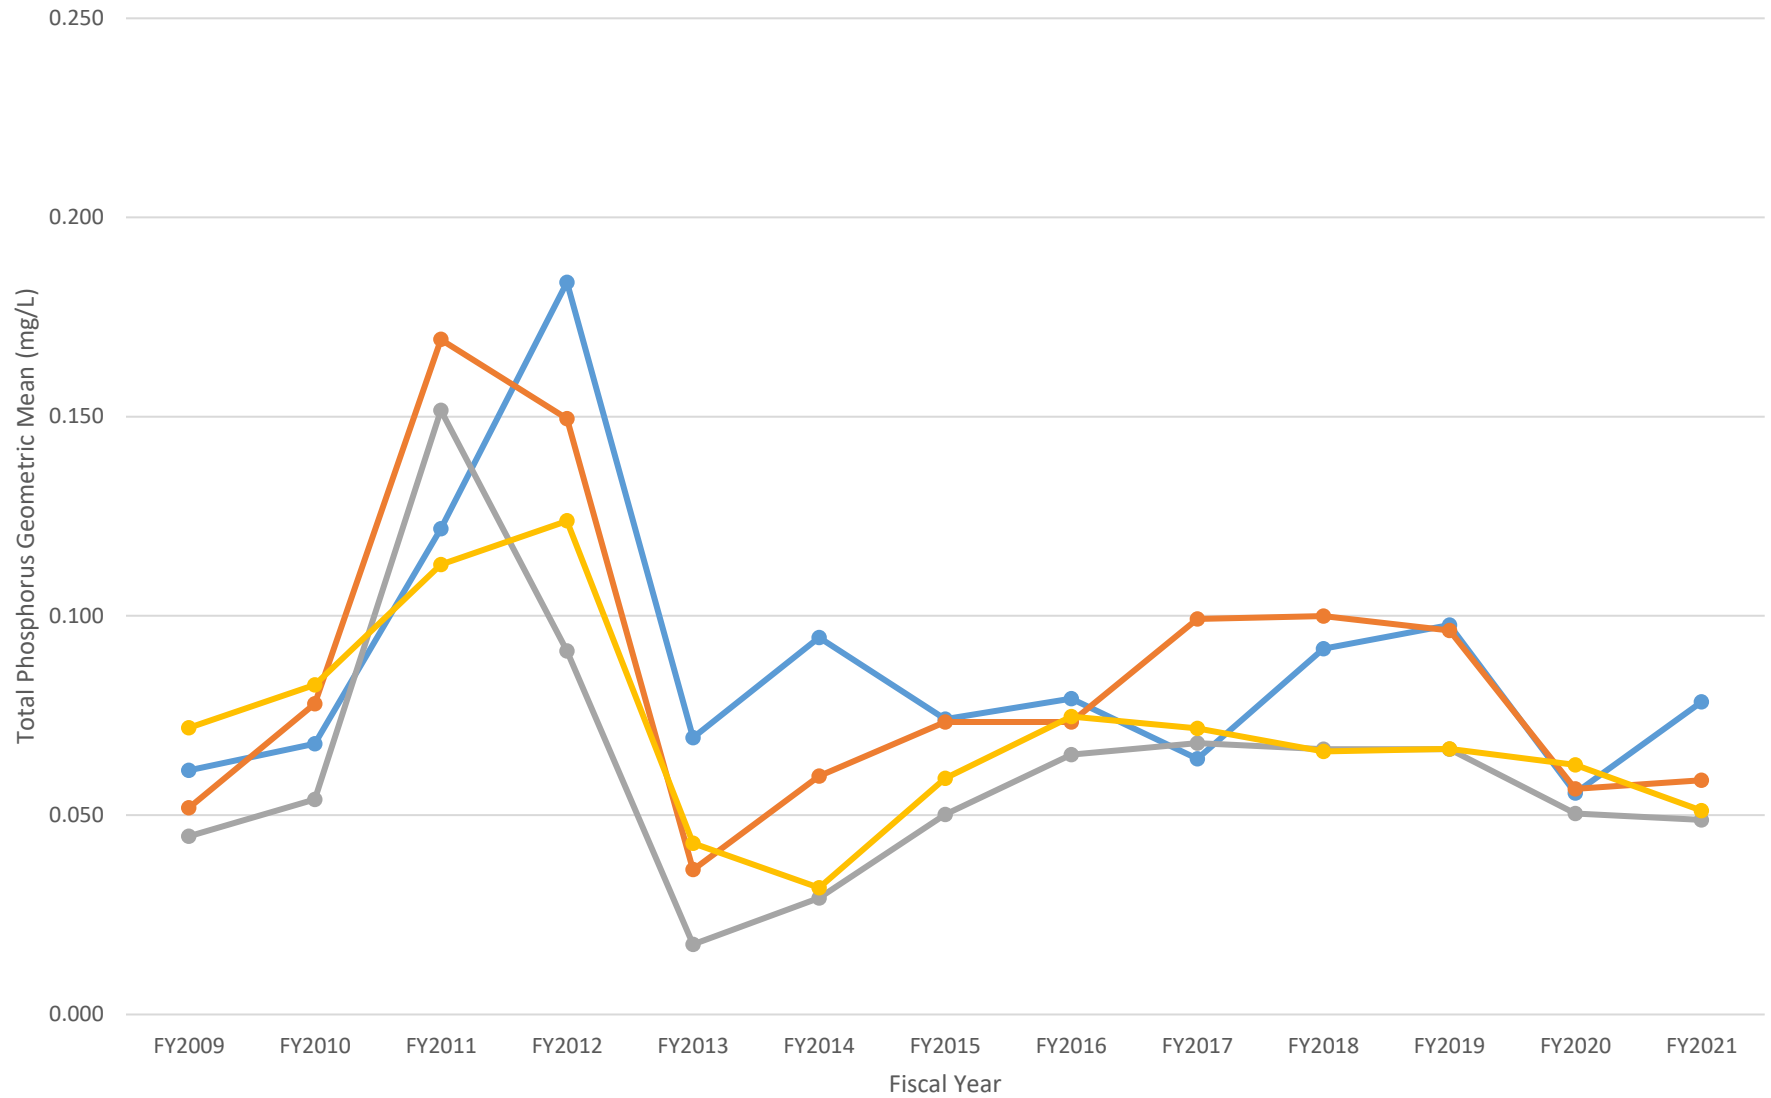
# Total Phosphorus Geometric Means by Fiscal Year Back River Watershed, Moores Run Subwatershed

MARY AVE. HAMILTON AVE. RADECKE AVE. BIDDLE ST. & 62ND ST.

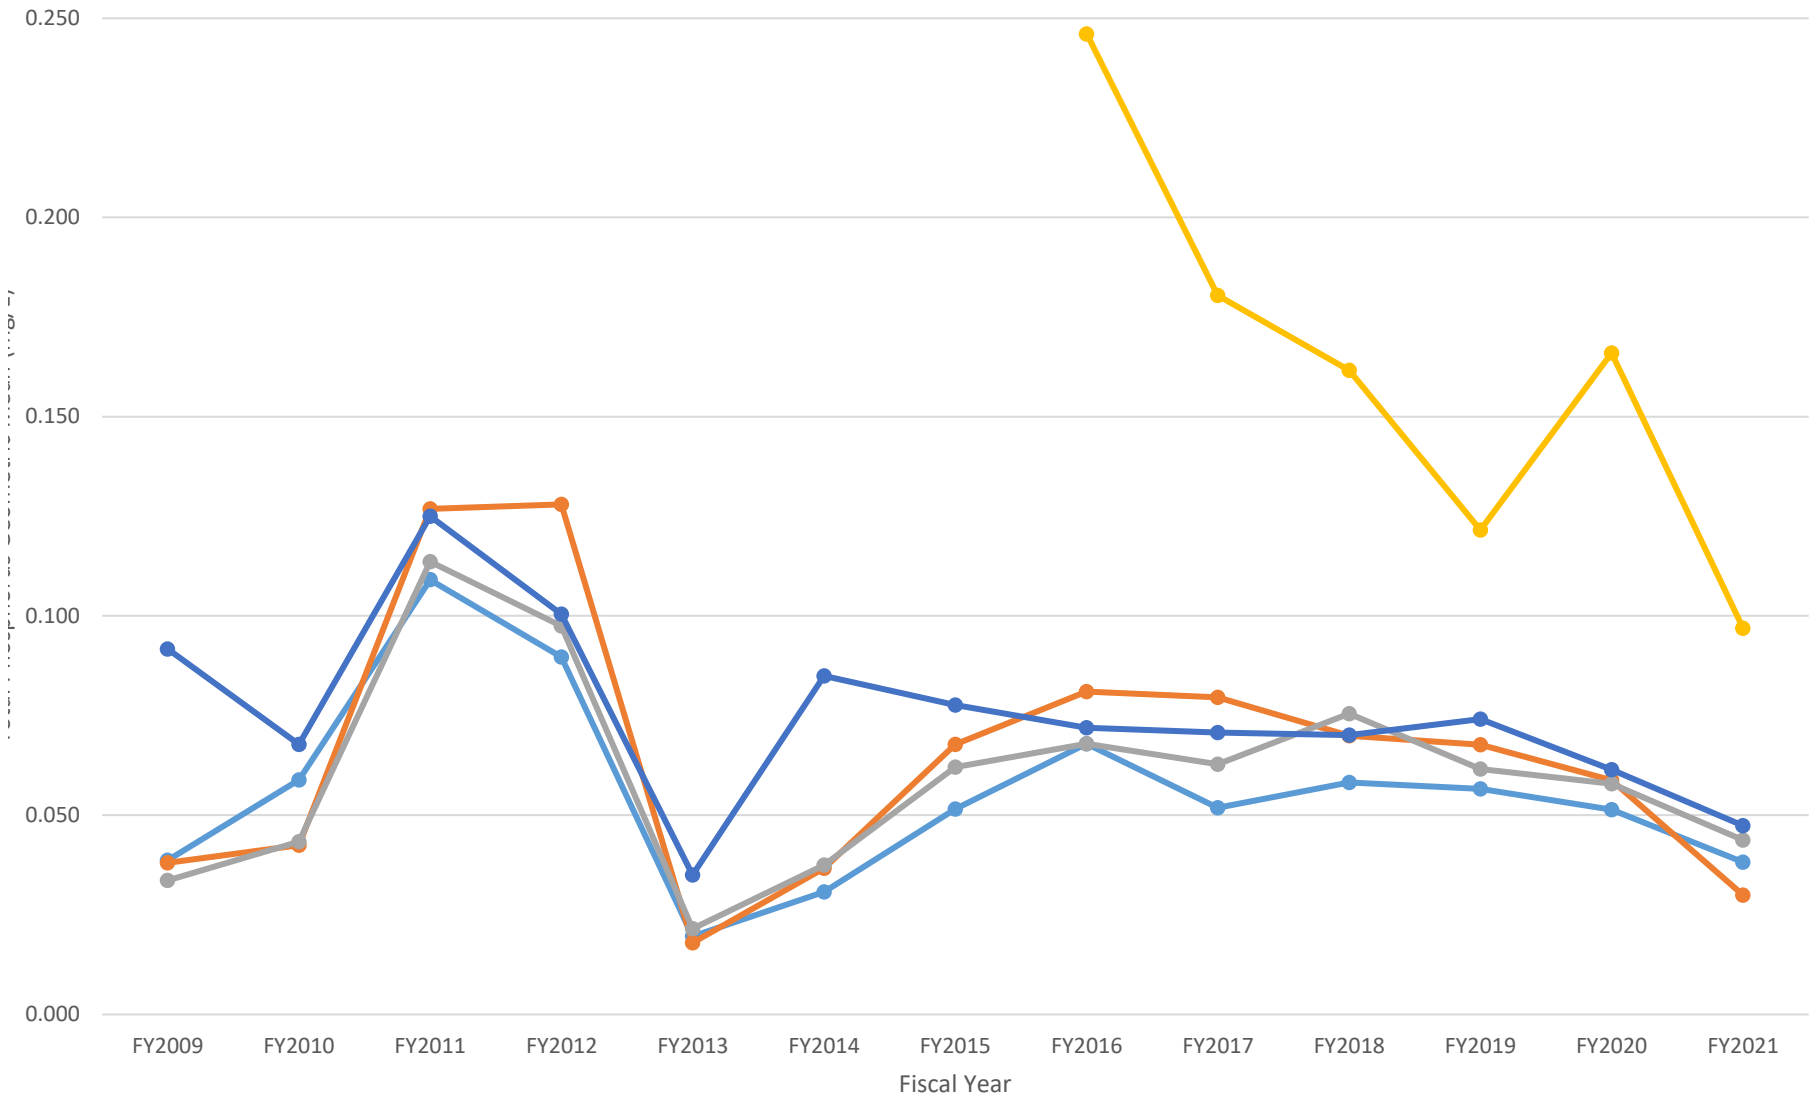
# Total Phosphorus Geometric Means by Fiscal Year

## Jones Falls Watershed

SMITH AVE. WESTERN RUN STONY RUN JF 11.5 LOMBARD ST.

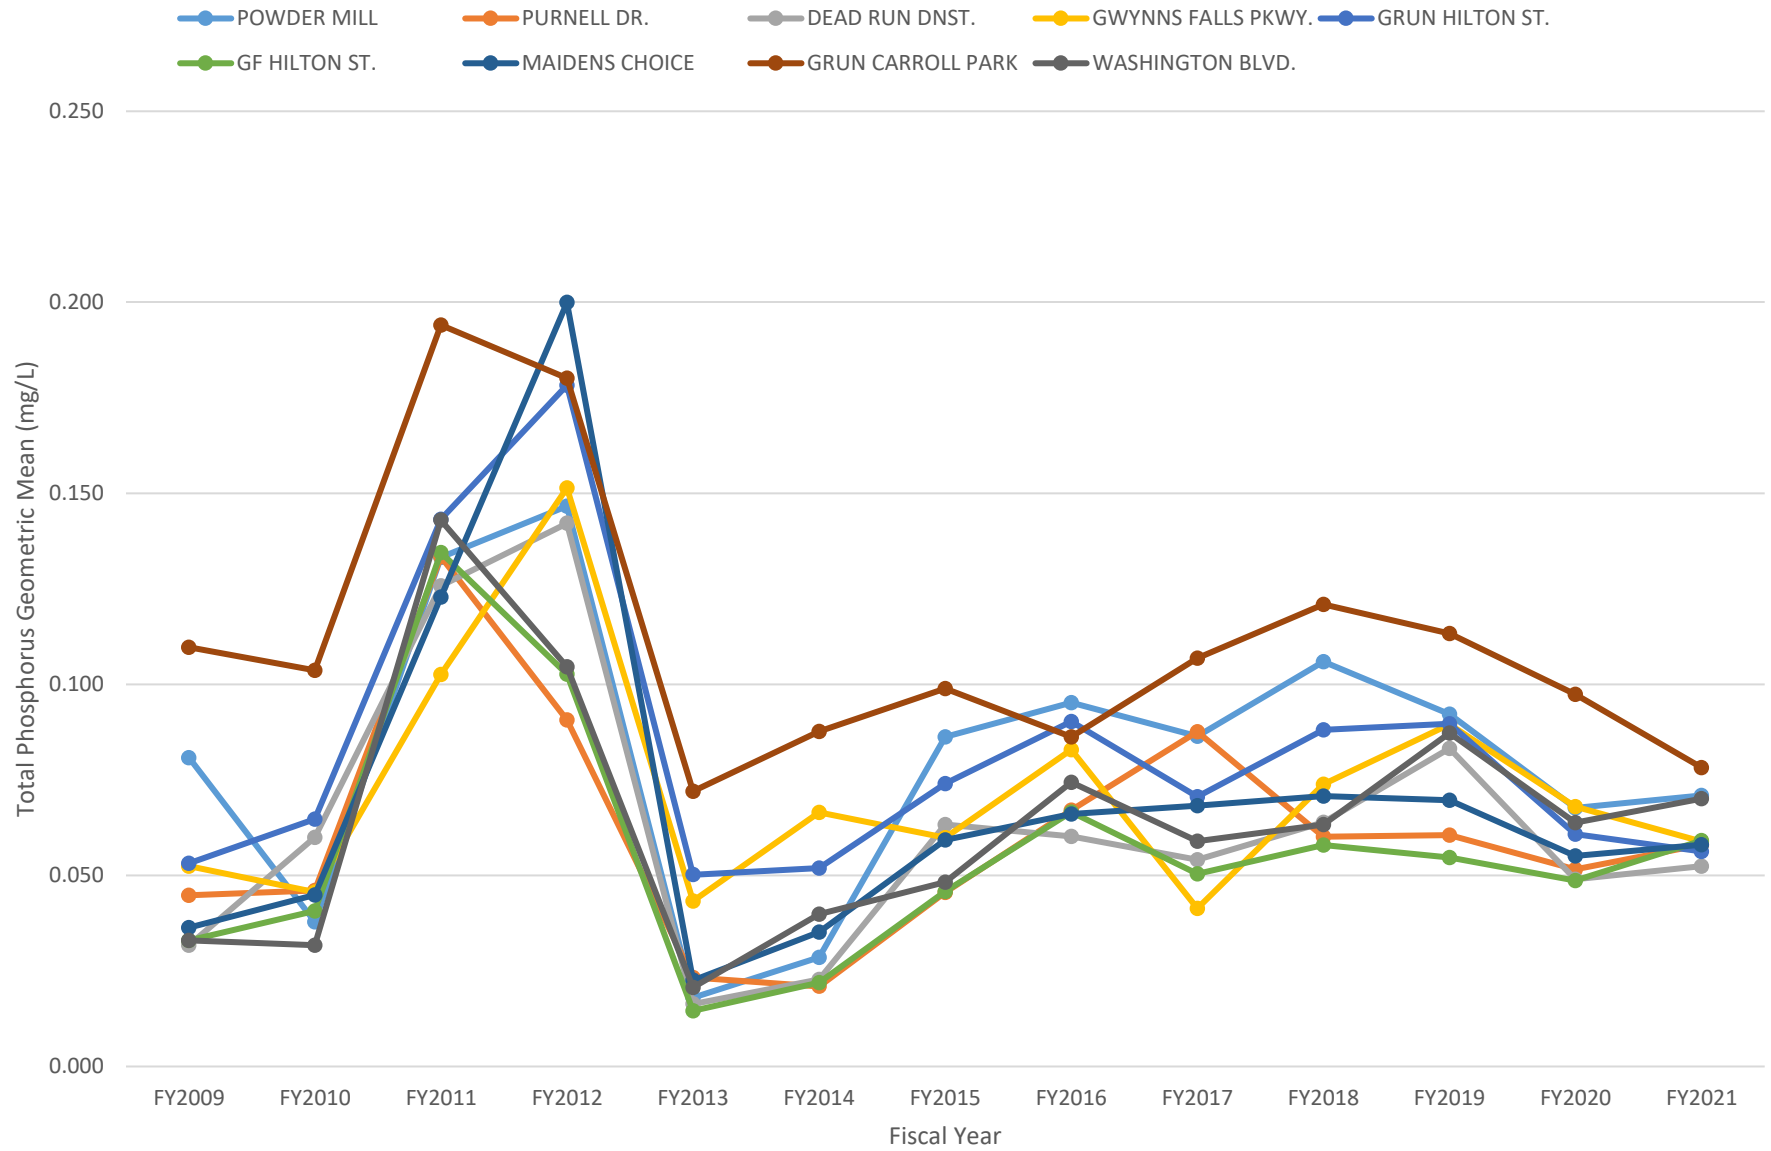
# Total Phosphorus Geometric Means by Fiscal Year Gwynns Falls Watershed

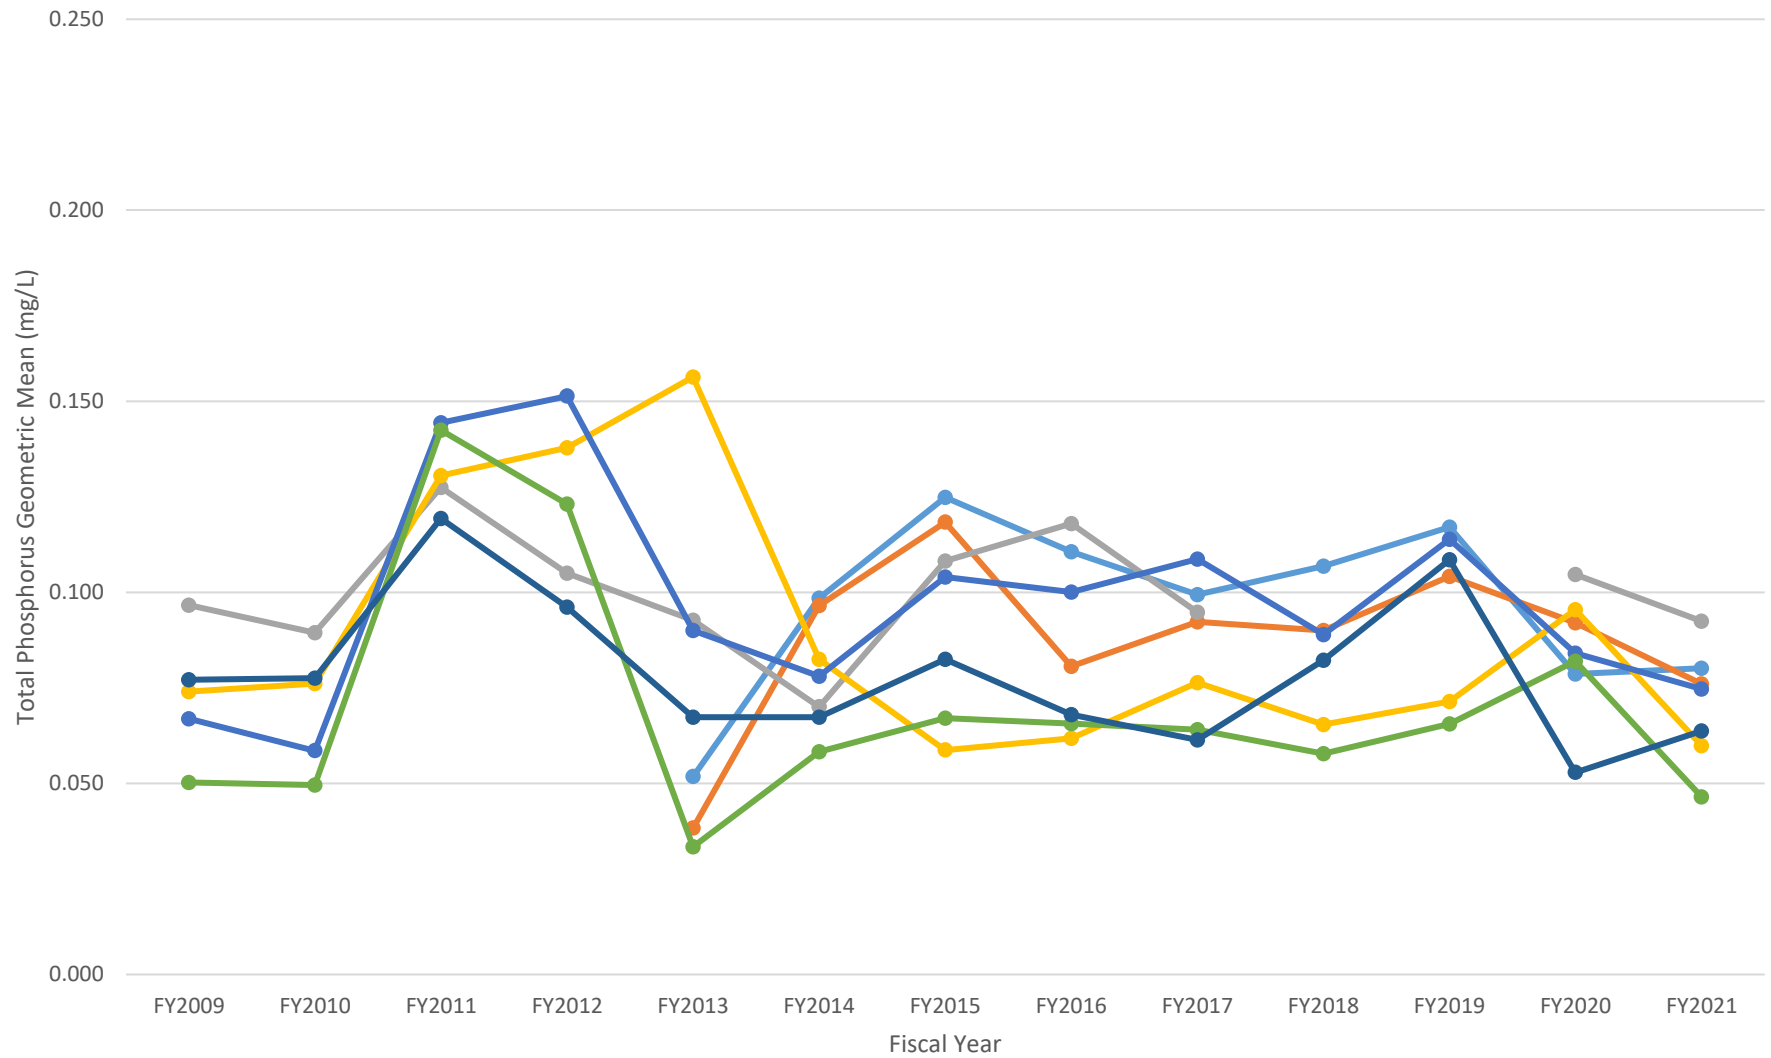
# Total Phosphorus Geometric Means by Fiscal Year

## Direct Harbor Watershed

LINWOOD & ELLIOTT LAKEWOOD & HUDSON CENTRAL & LANCASTER LIGHT ST.  
WARNER & ALLUVION WATERVIEW AVE. JANEY RUN

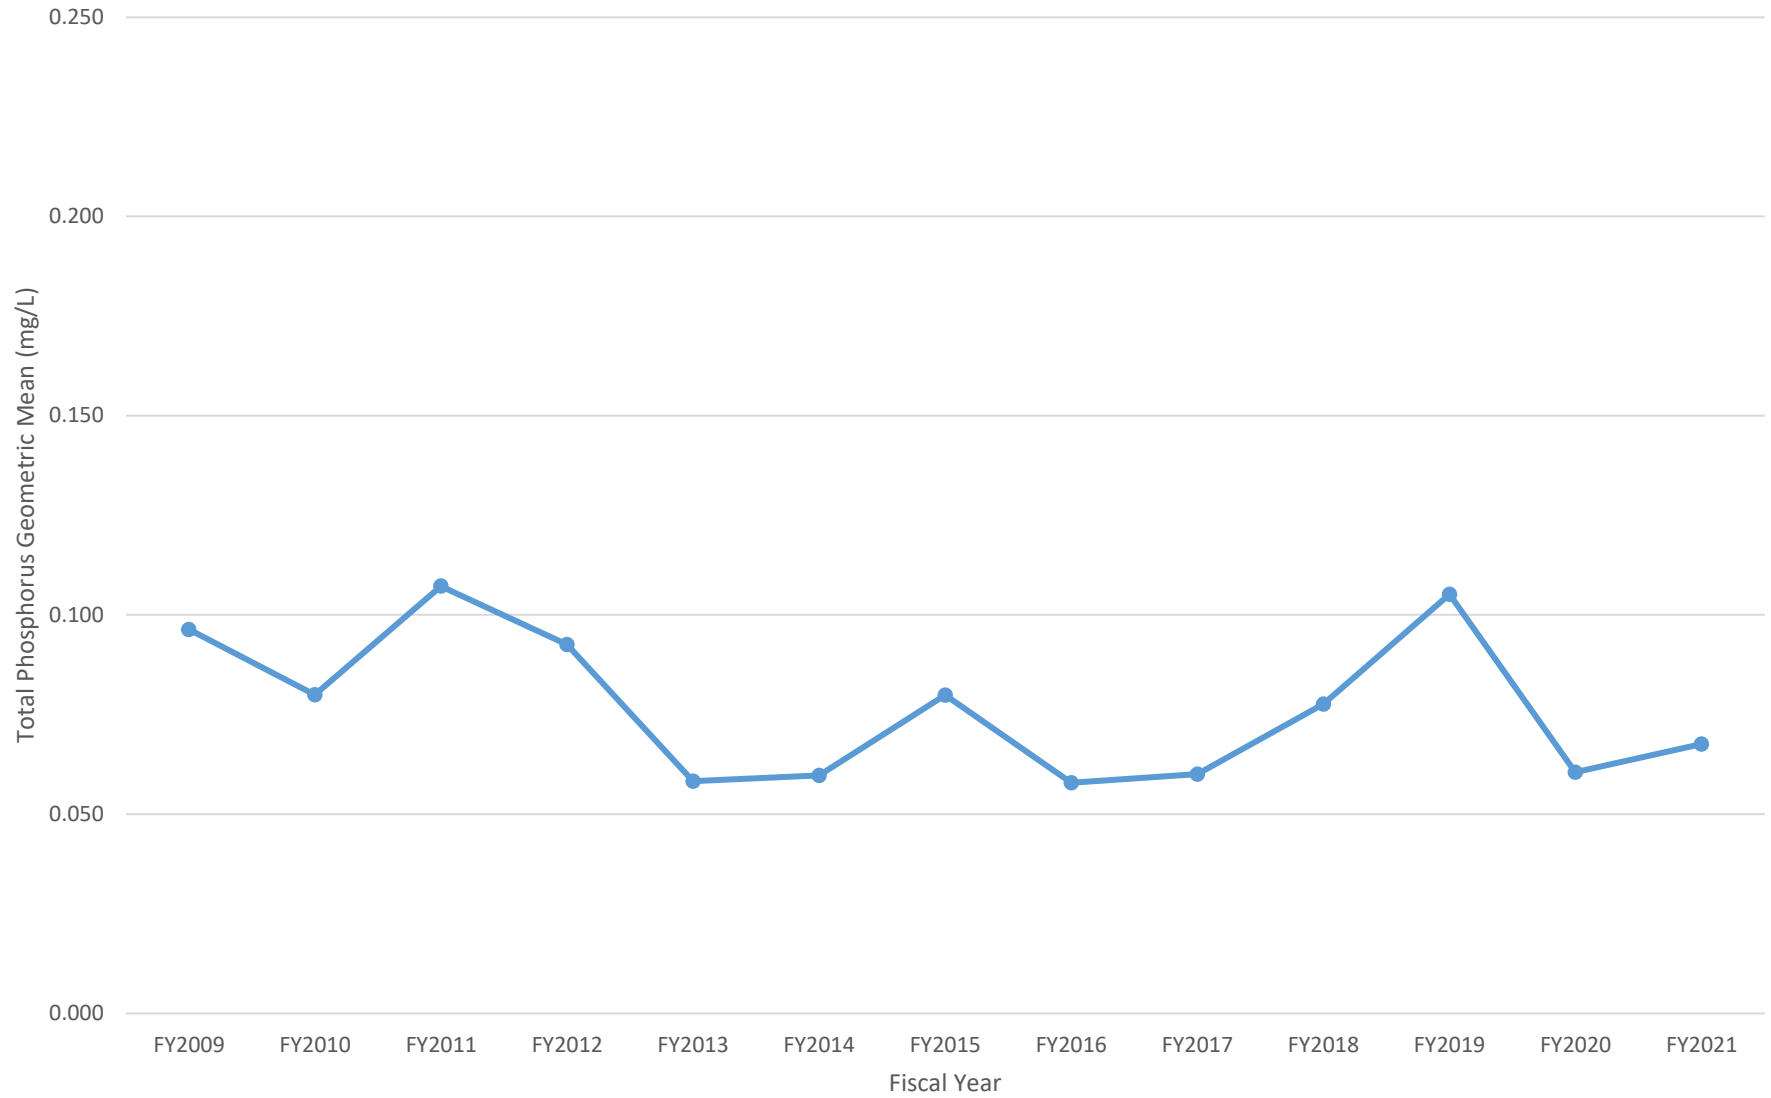
# Total Phosphorus Geometric Means by Fiscal Year Patapsco River Watershed

REEDBIRD AVE.

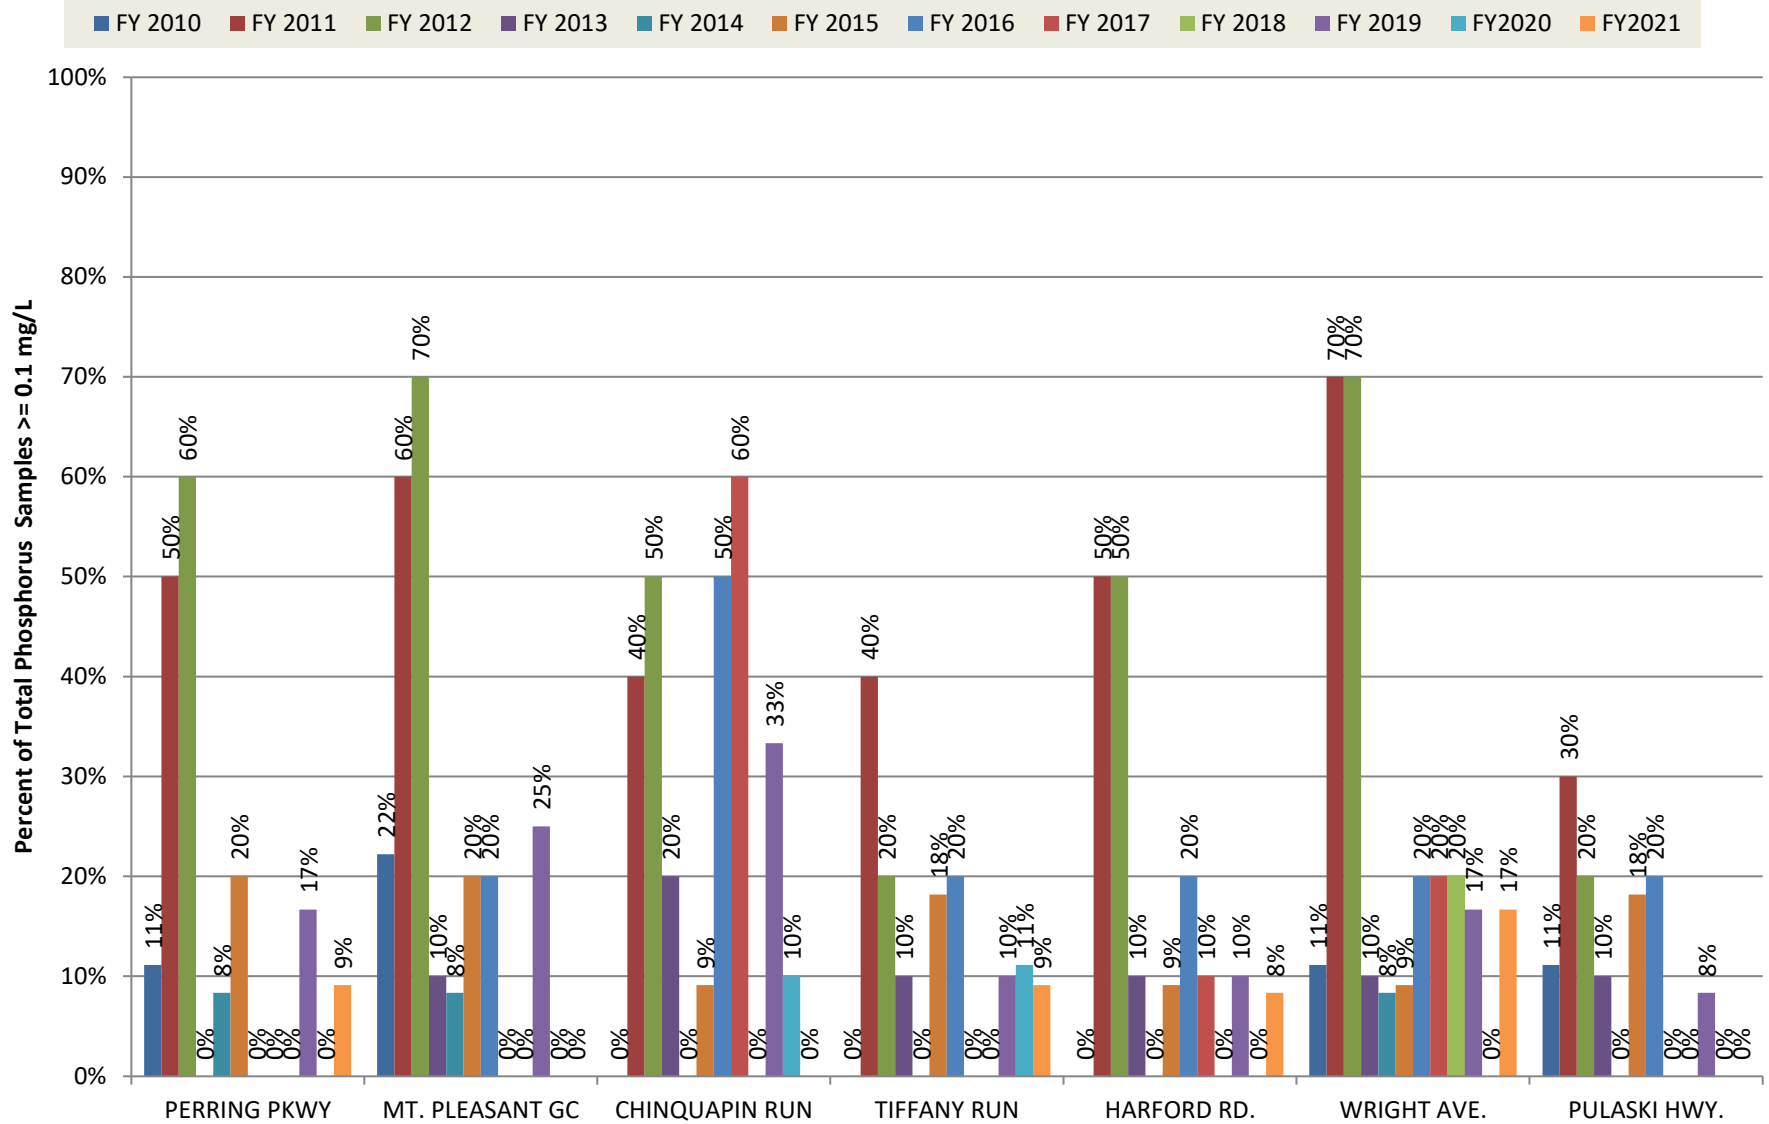
# Herring Run SIS Dry Weather Total Phosphorus Percent of Samples Greater Than or Equal to 0.1 mg/L by Fiscal Year

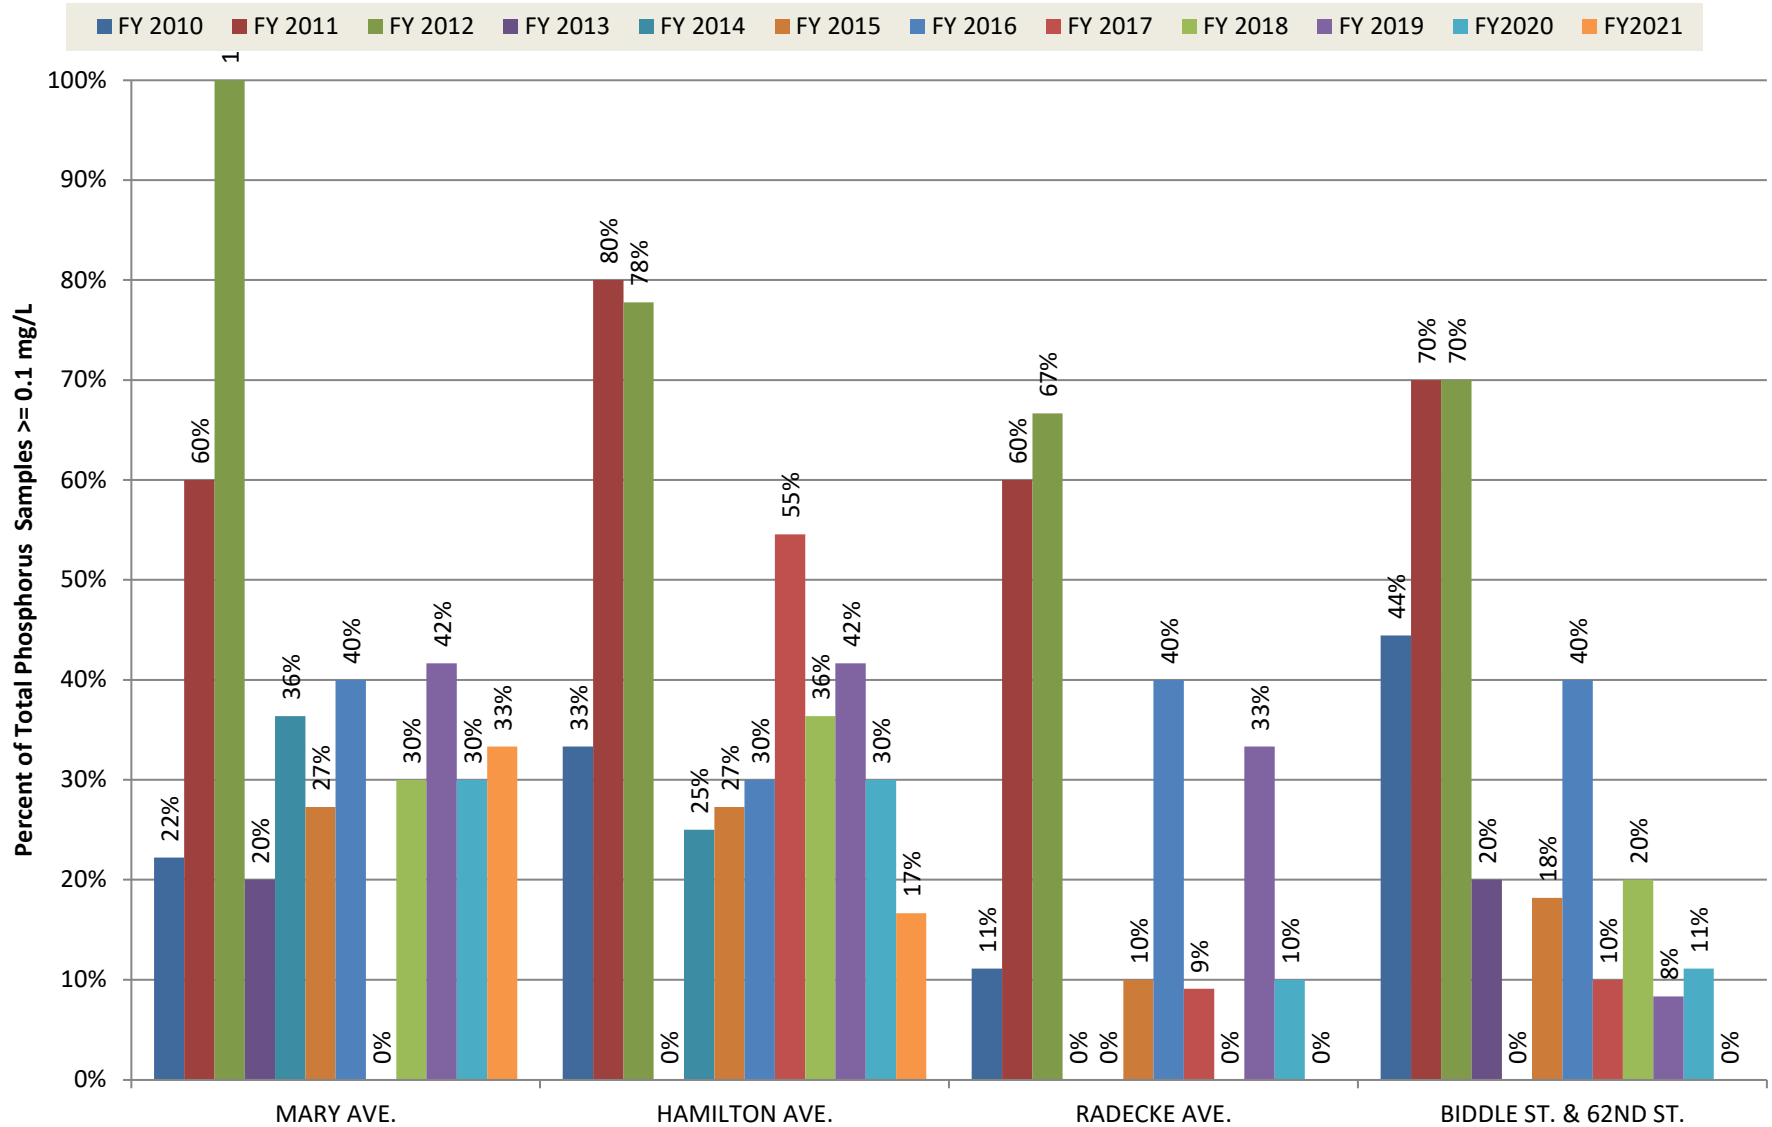
# **Moores Run SIS Dry Weather Total Phosphorus** **Percent of Samples Greater Than or Equal to 0.1 mg/L** **by Fiscal Year**

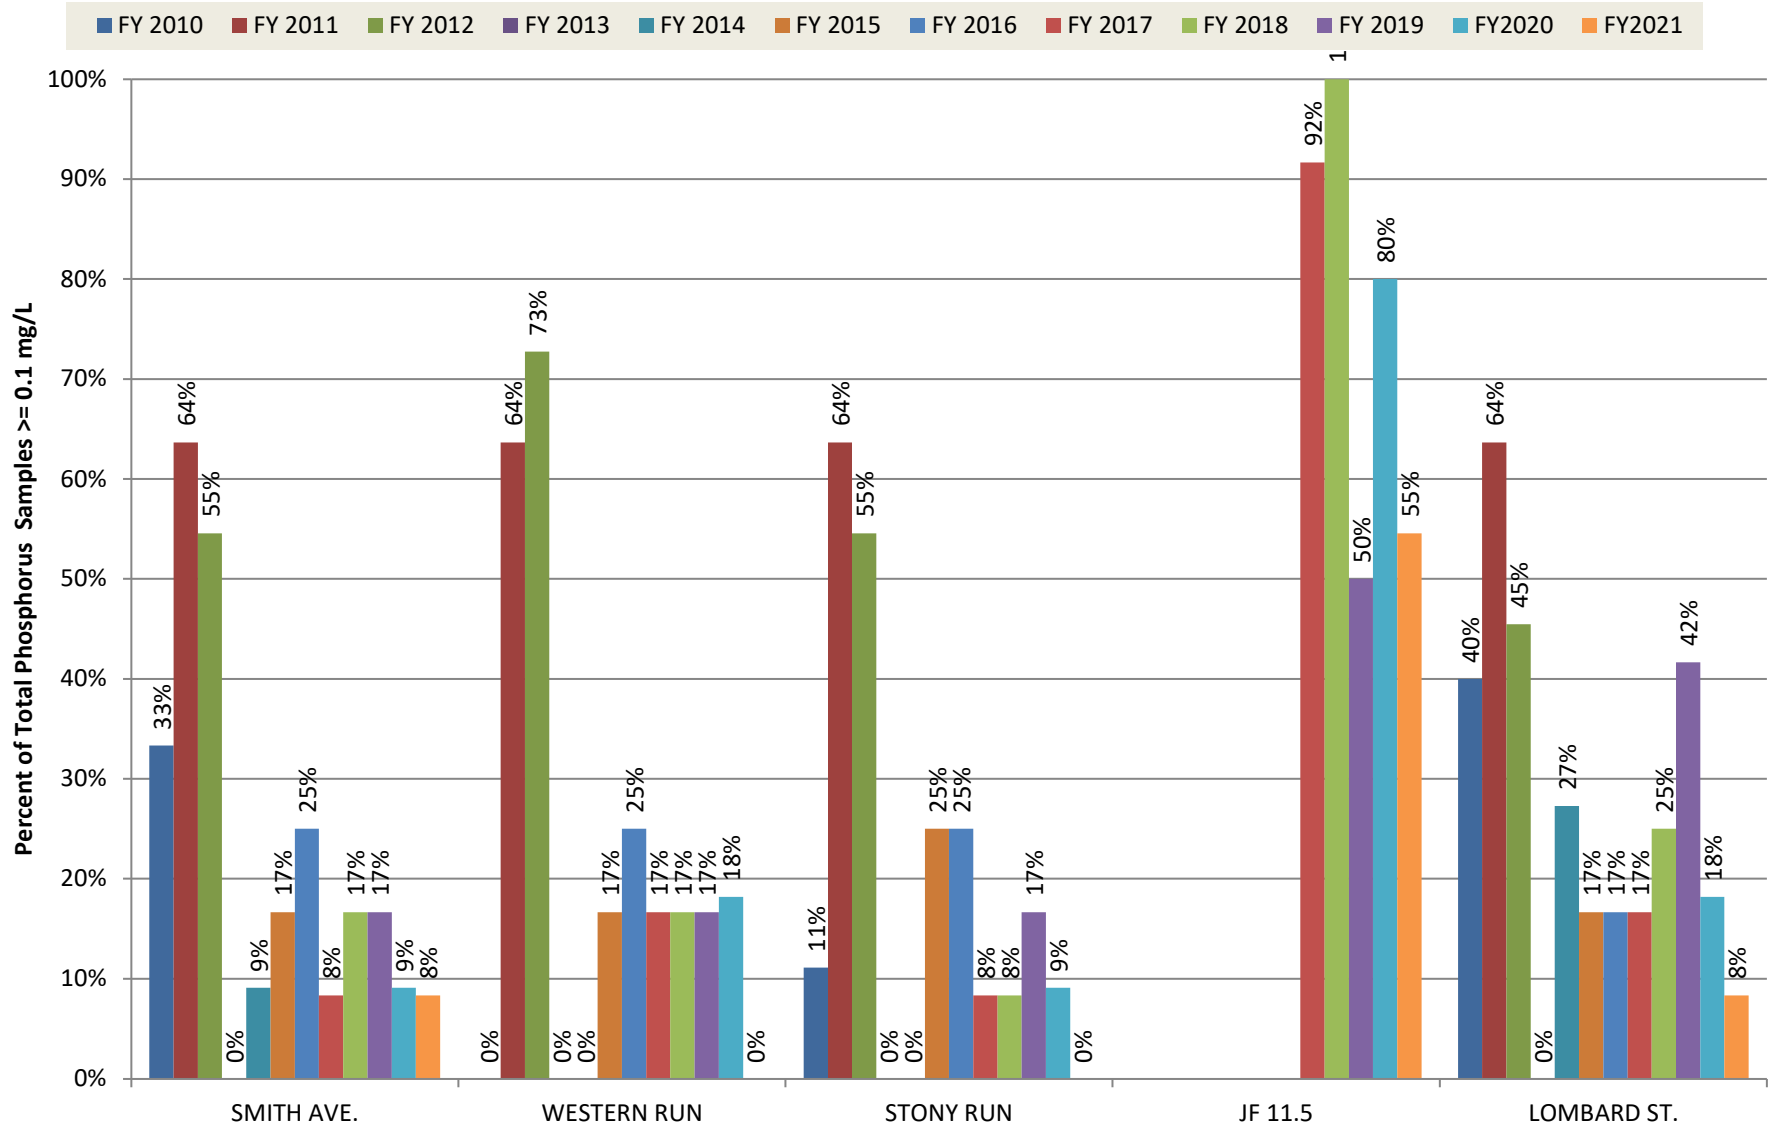
# **Jones Falls SIS Dry Weather Total Phosphorus Percent of Samples Greater Than or Equal to 0.1 mg/L by Fiscal Year**
