# **BALTIMORE CITY MS4 ANNUAL REPORT**

**Reporting Period: July 1, 2020 to June 30, 2021**

This report includes the progress of compliance for the period of Fiscal Year (FY) 2021, in association with Baltimore City's National Pollutant Discharge Elimination System (NPDES) Municipal Separate Storm Sewer System (MS4) Discharge Permit (Permit Number: 11-DP-3315, MD0068292). The permit associated with the time period of this report was issued on December 27, 2013. Although that permit expired on December 27, 2018, it was administratively continued and the City remained responsible for compliance of those permit conditions. Annual report periods follow the City's fiscal calendar: July 1 to June 30. This Annual report has been formatted to match the reporting requirements as listed in Part V of the MS4 permit.

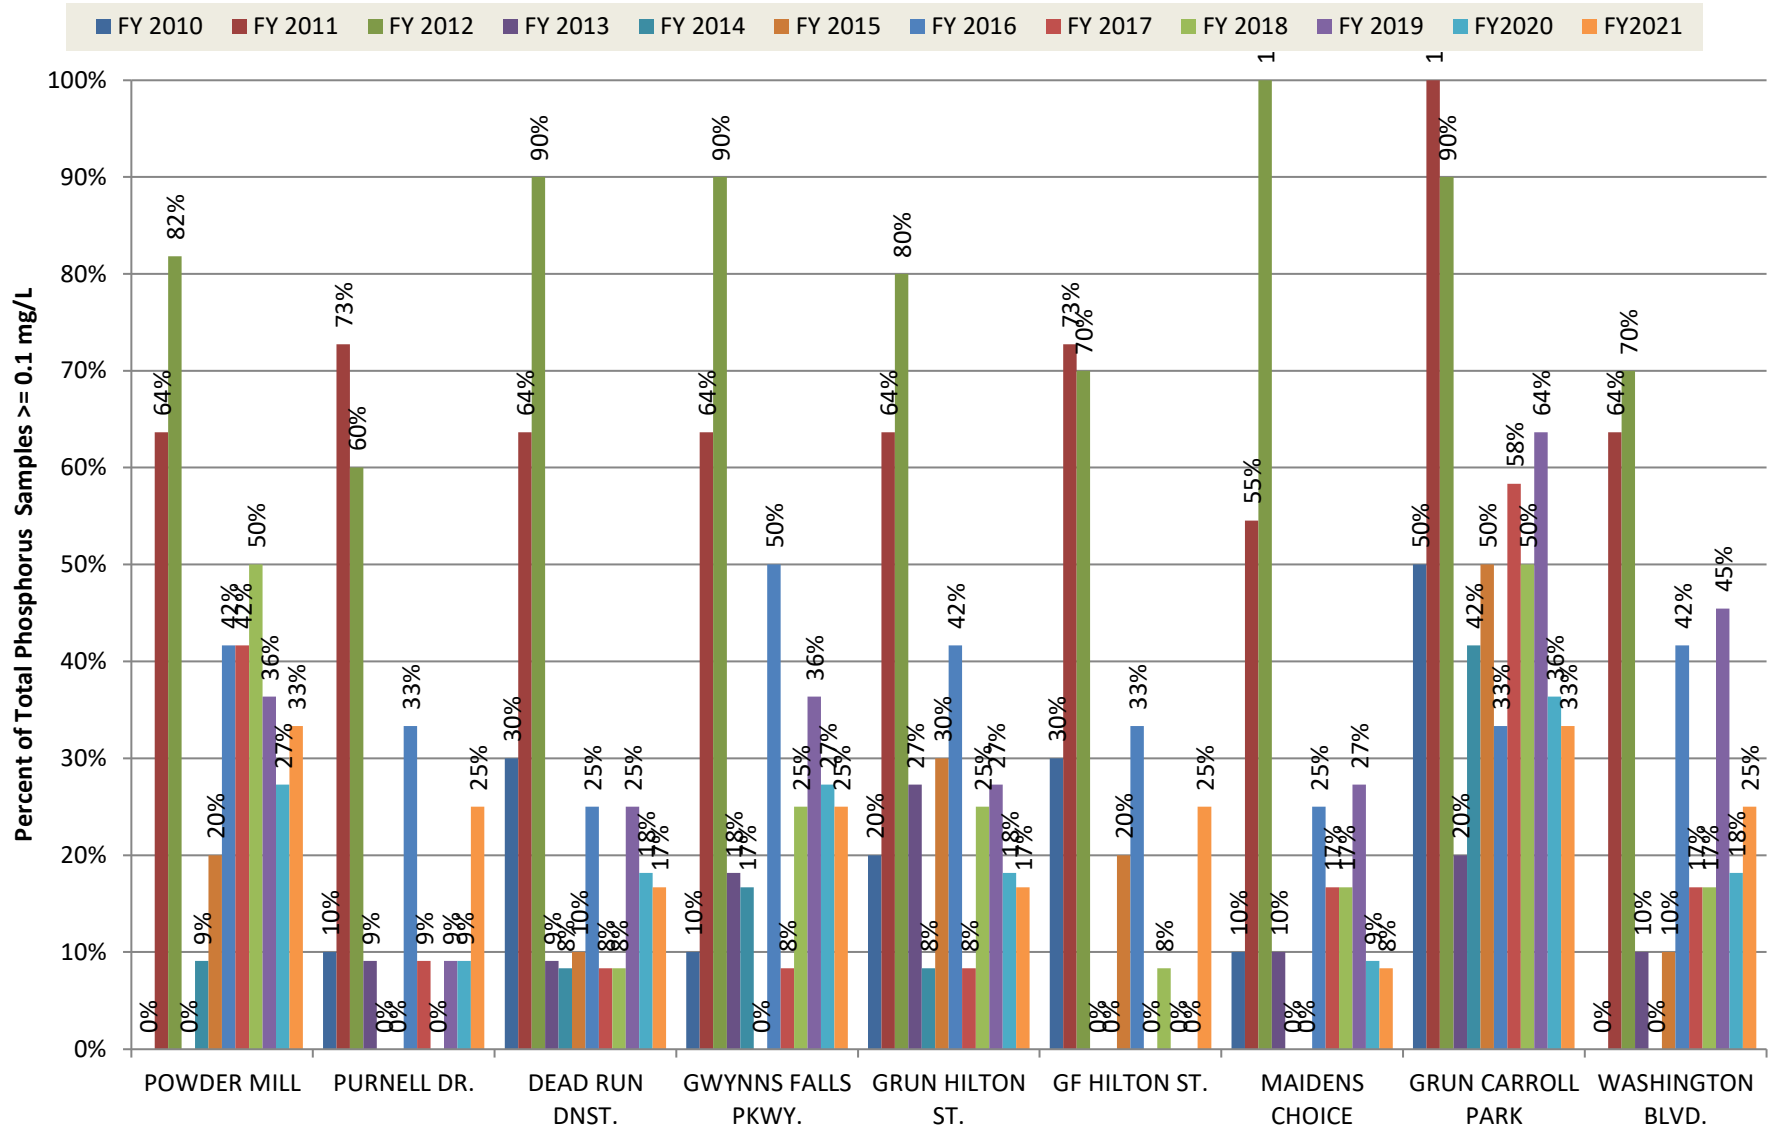
# Gwynns Falls SIS Dry Weather Total Phosphorus Percent of Samples Greater Than or Equal to 0.1 mg/L by Fiscal Year

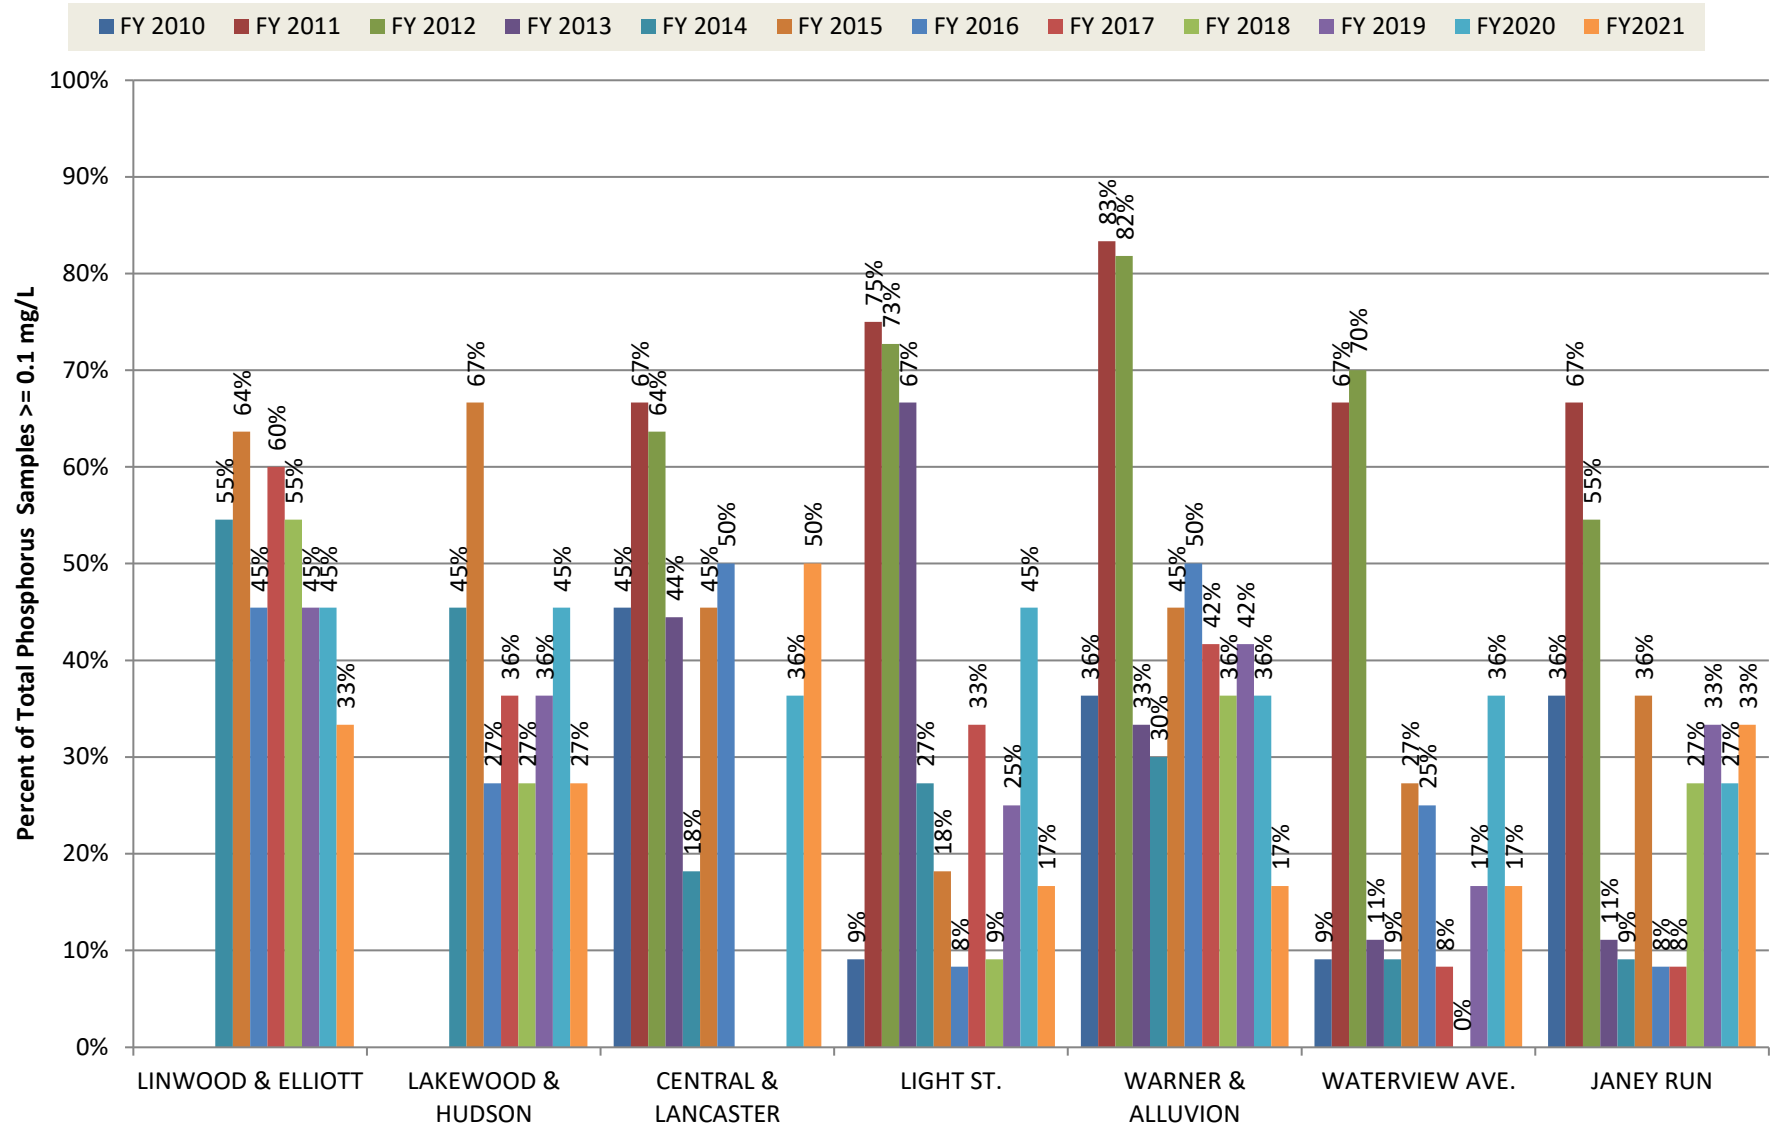
# Harbor SIS Dry Weather Total Phosphorus Percent of Samples Greater Than or Equal to 0.1 mg/L by Fiscal Year

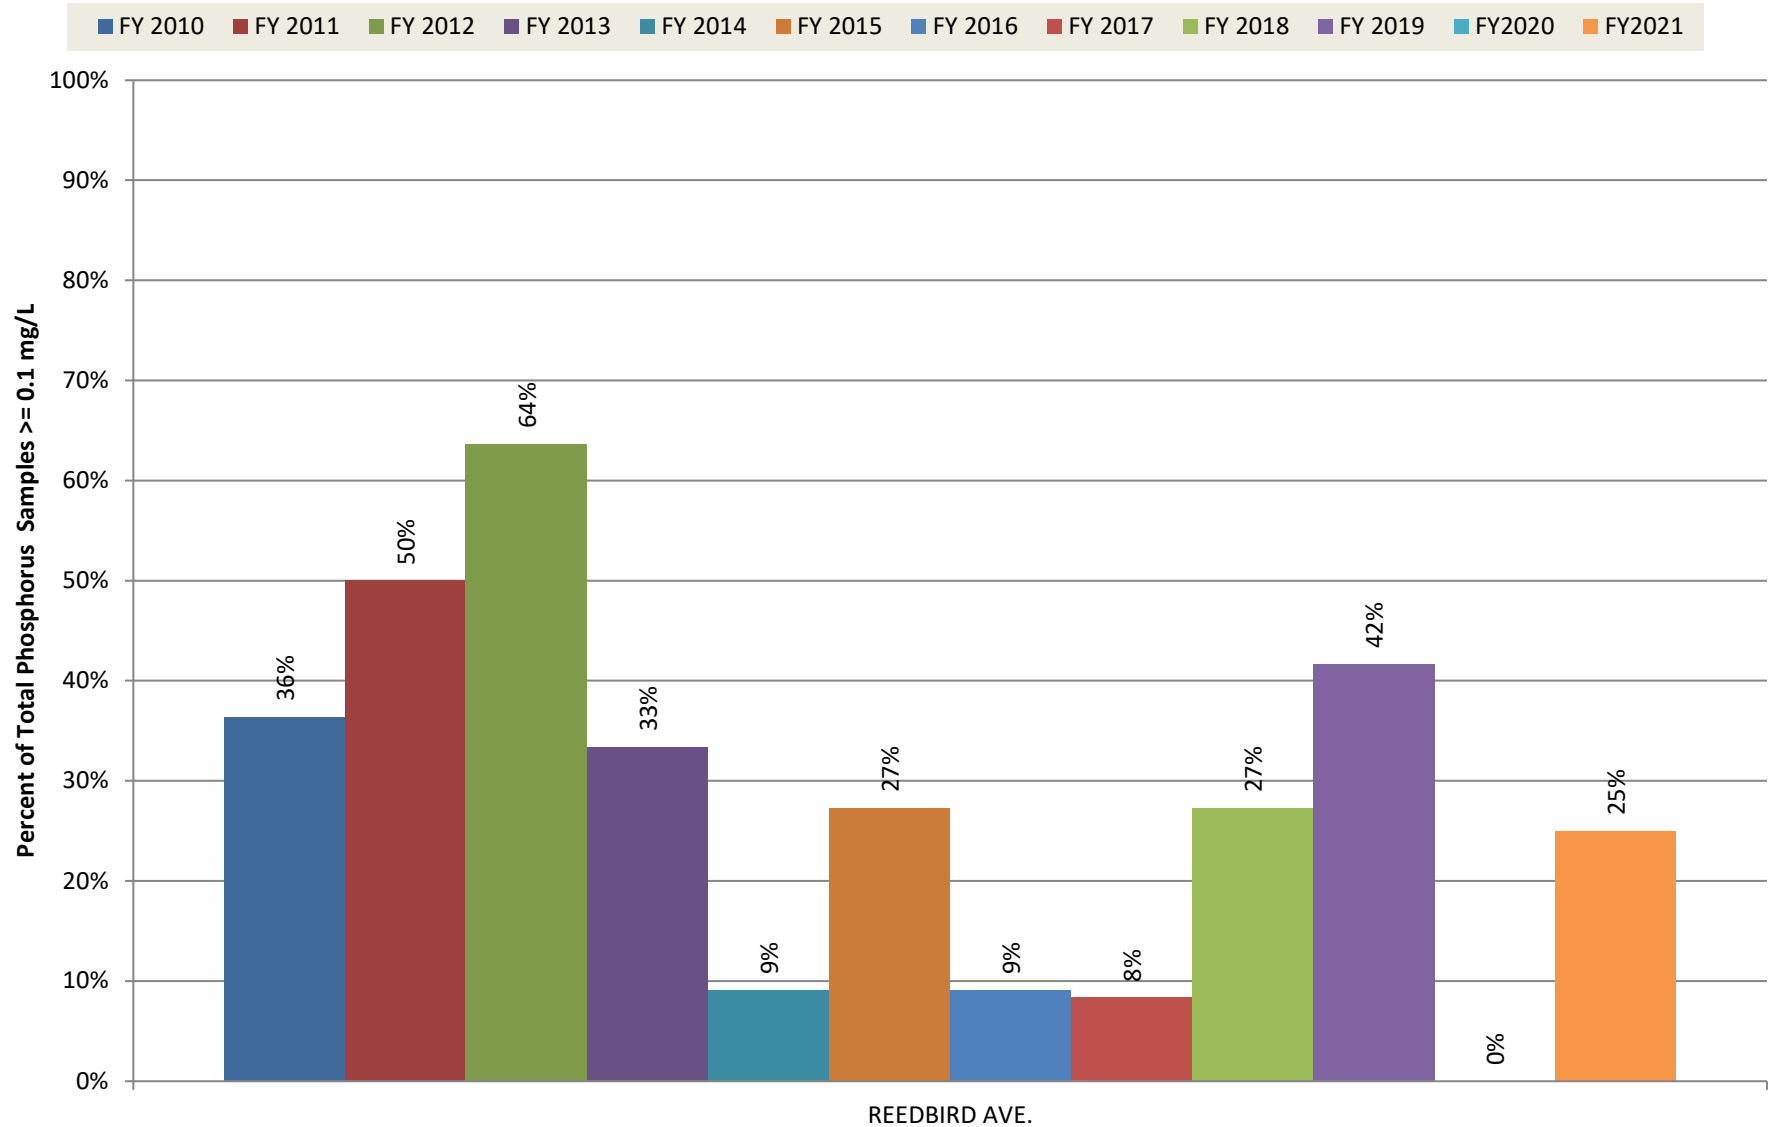
**Patapsco River SIS Dry Weather Total Phosphorus  
Percent of Samples Greater Than or Equal to 0.1 mg/L  
by Fiscal Year**

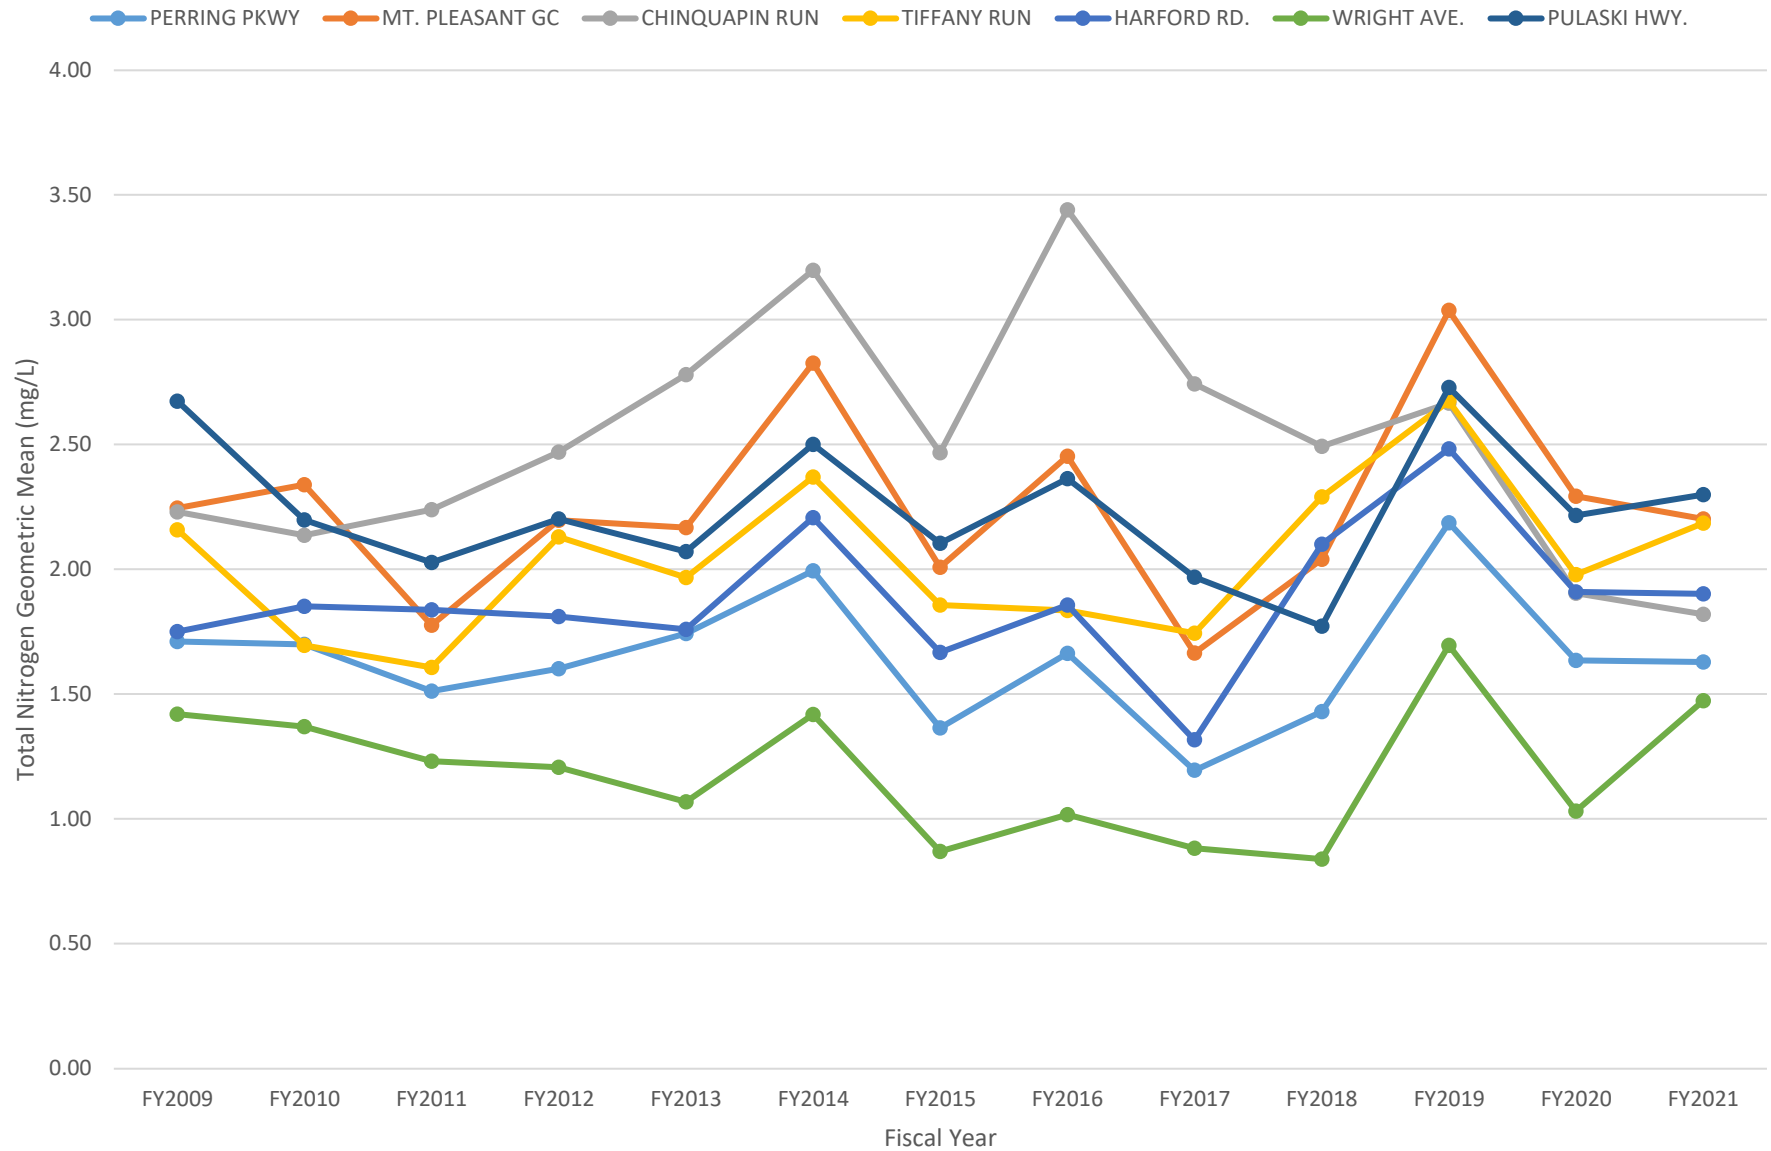
# Total Nitrogen Geometric Means by Fiscal Year Back River Watershed, Herring Run Subwatershed

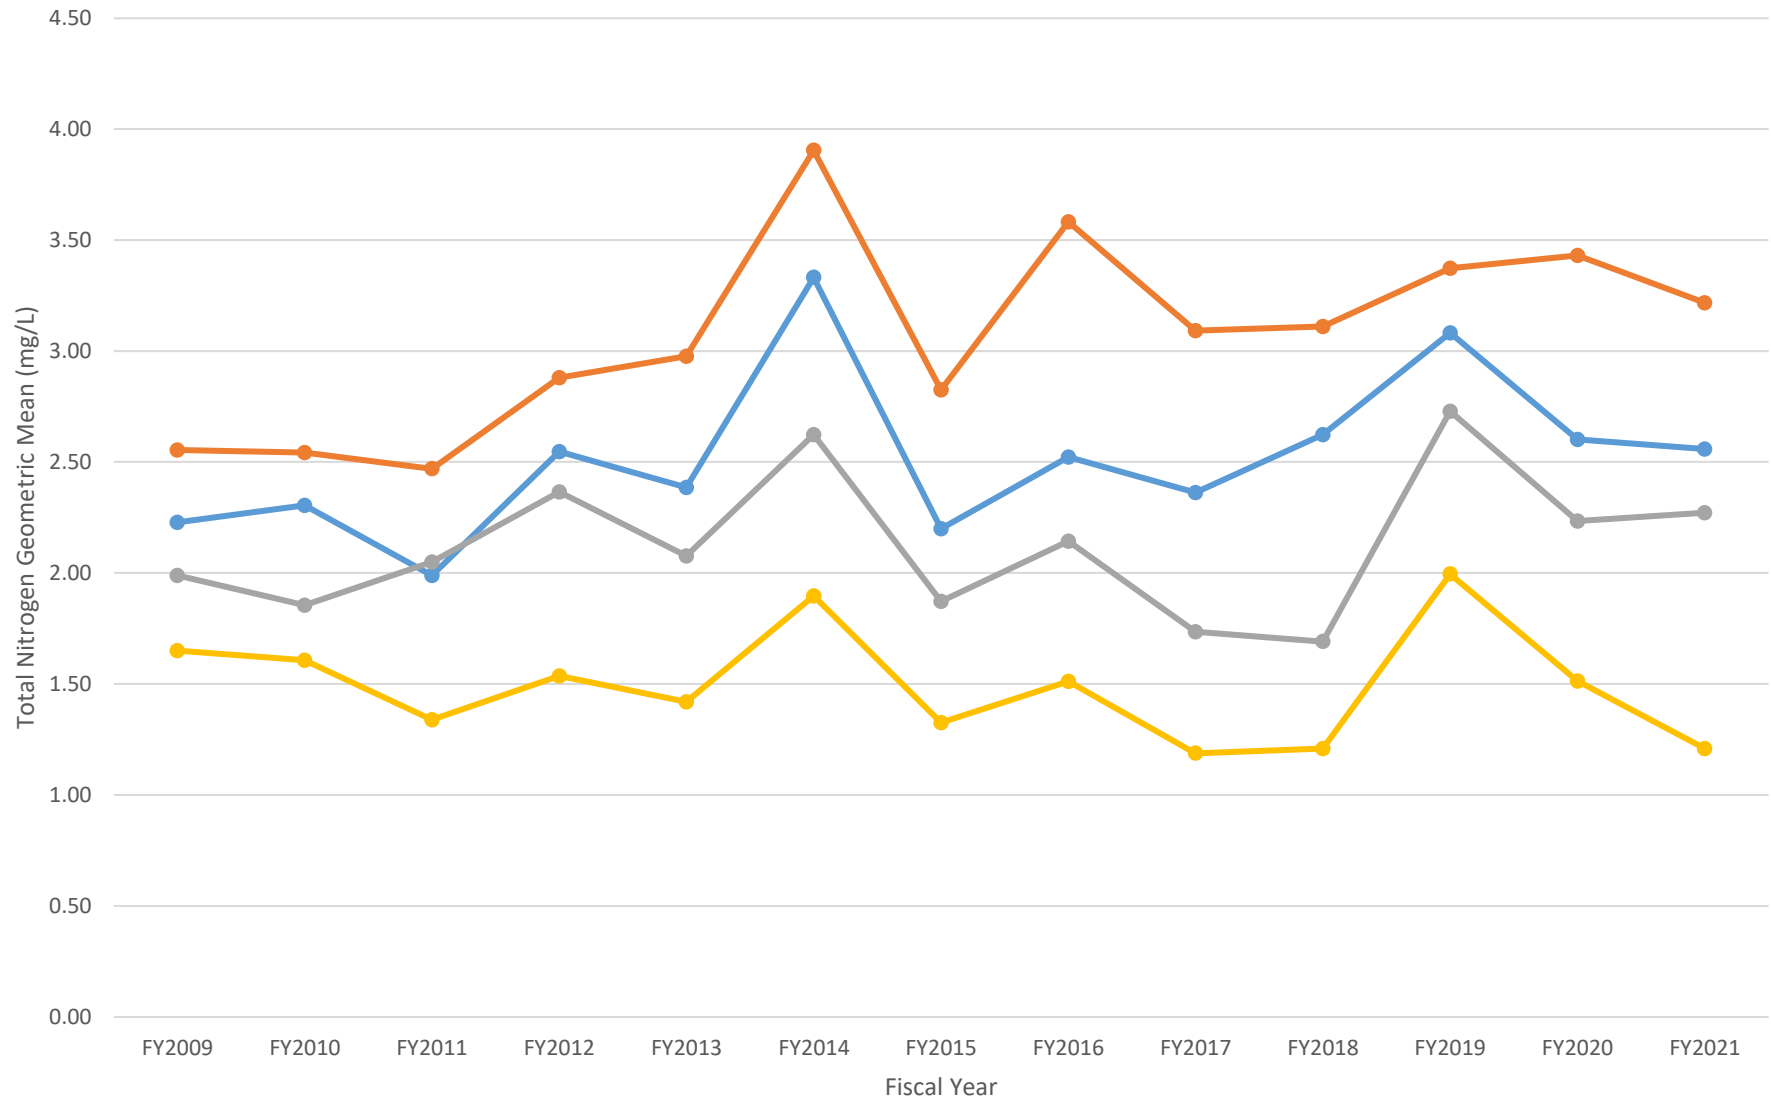
# Total Nitrogen Geometric Means by Fiscal Year Back River Watershed, Moores Run Subwatershed

MARY AVE. HAMILTON AVE. RADECKE AVE. BIDDLE ST. & 62ND ST.

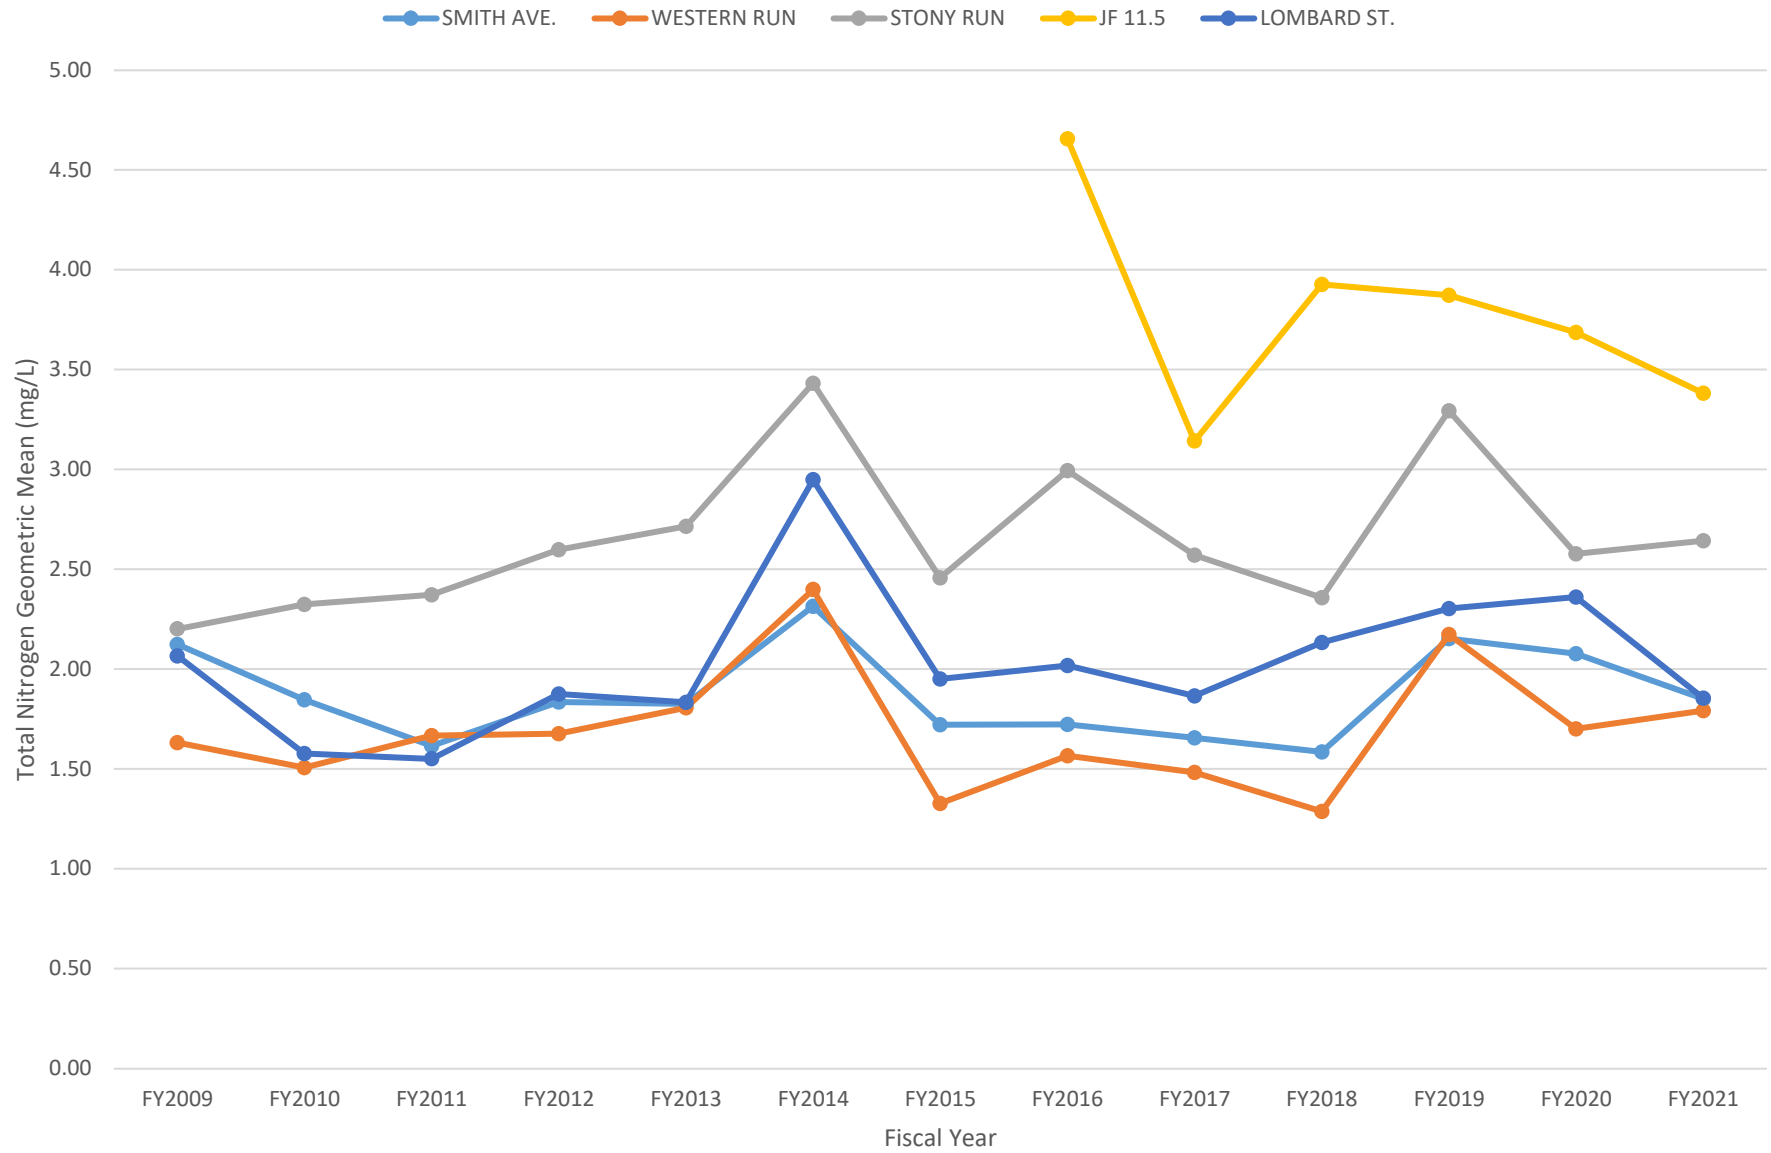
# Total Nitrogen Geometric Means by Fiscal Year Jones Falls Watershed

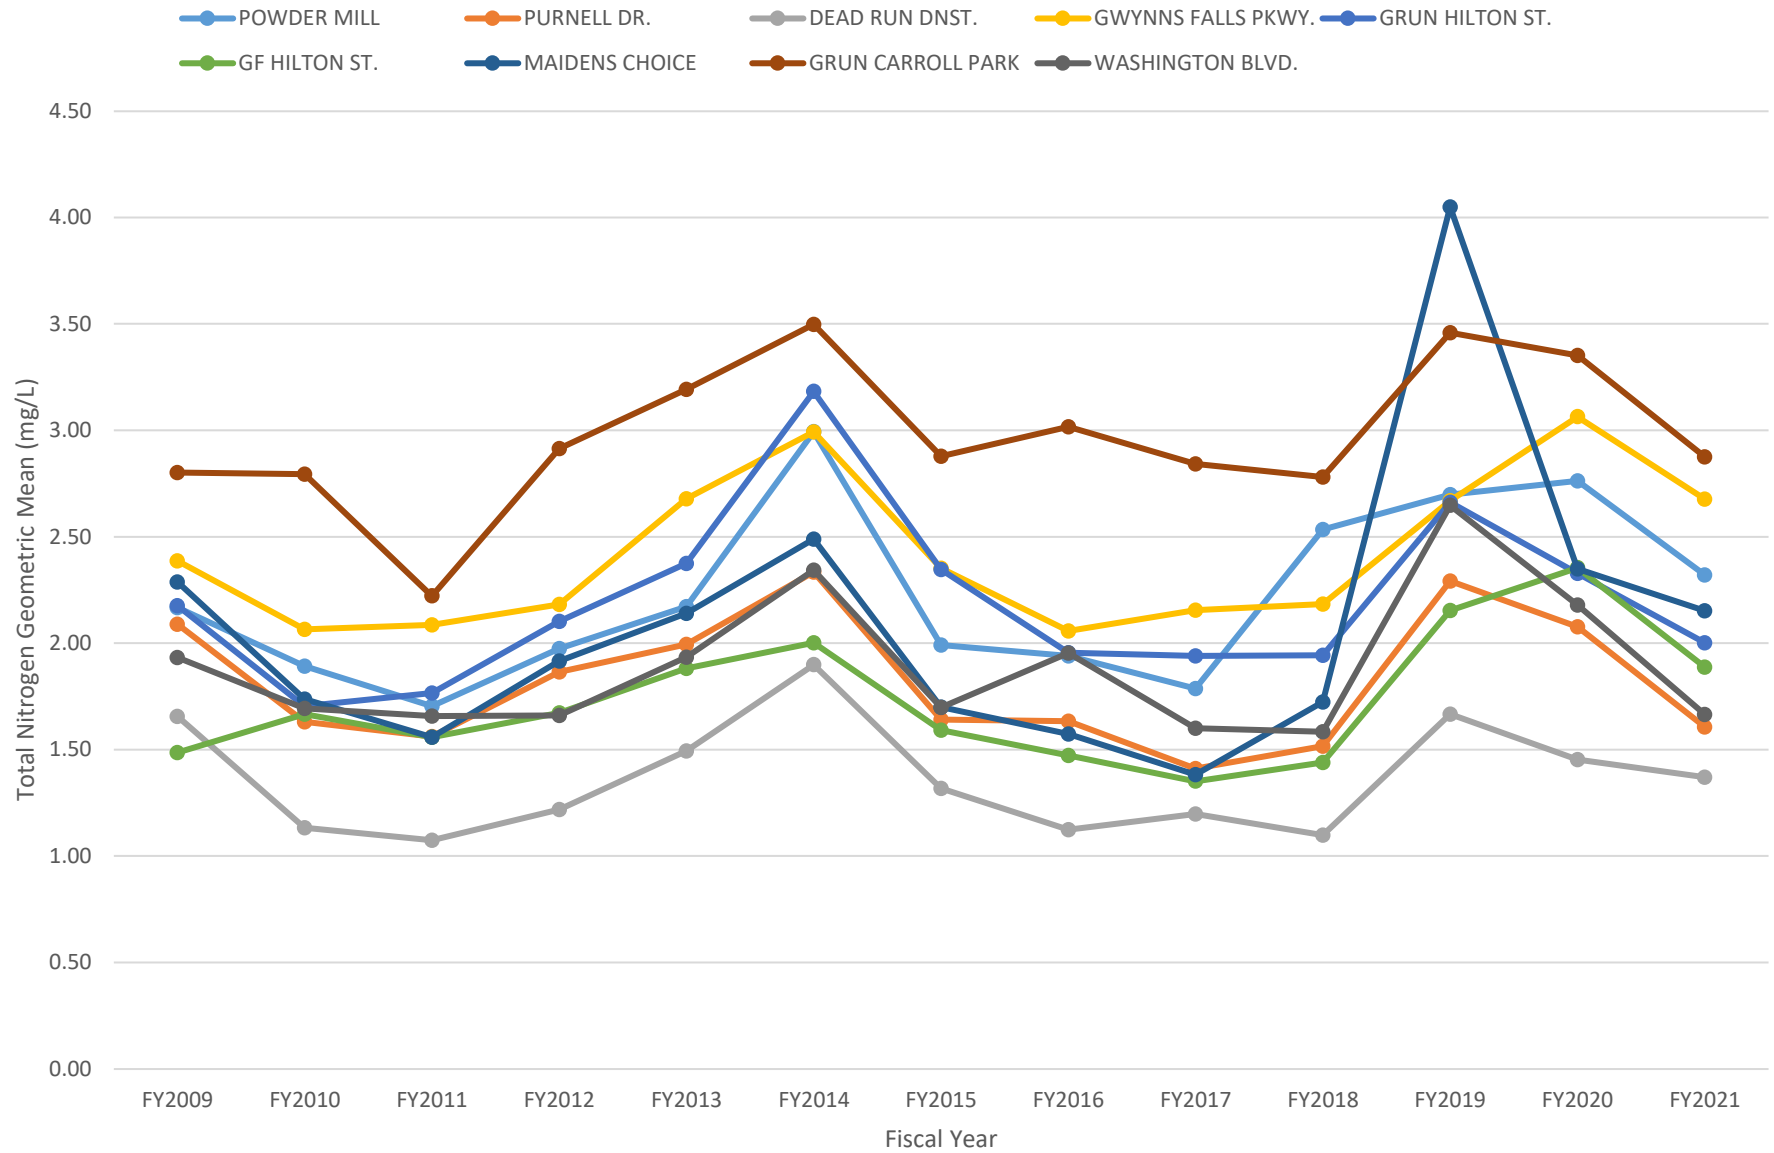
# Total Nitrogen Geometric Means by Fiscal Year Gwynns Falls Watershed

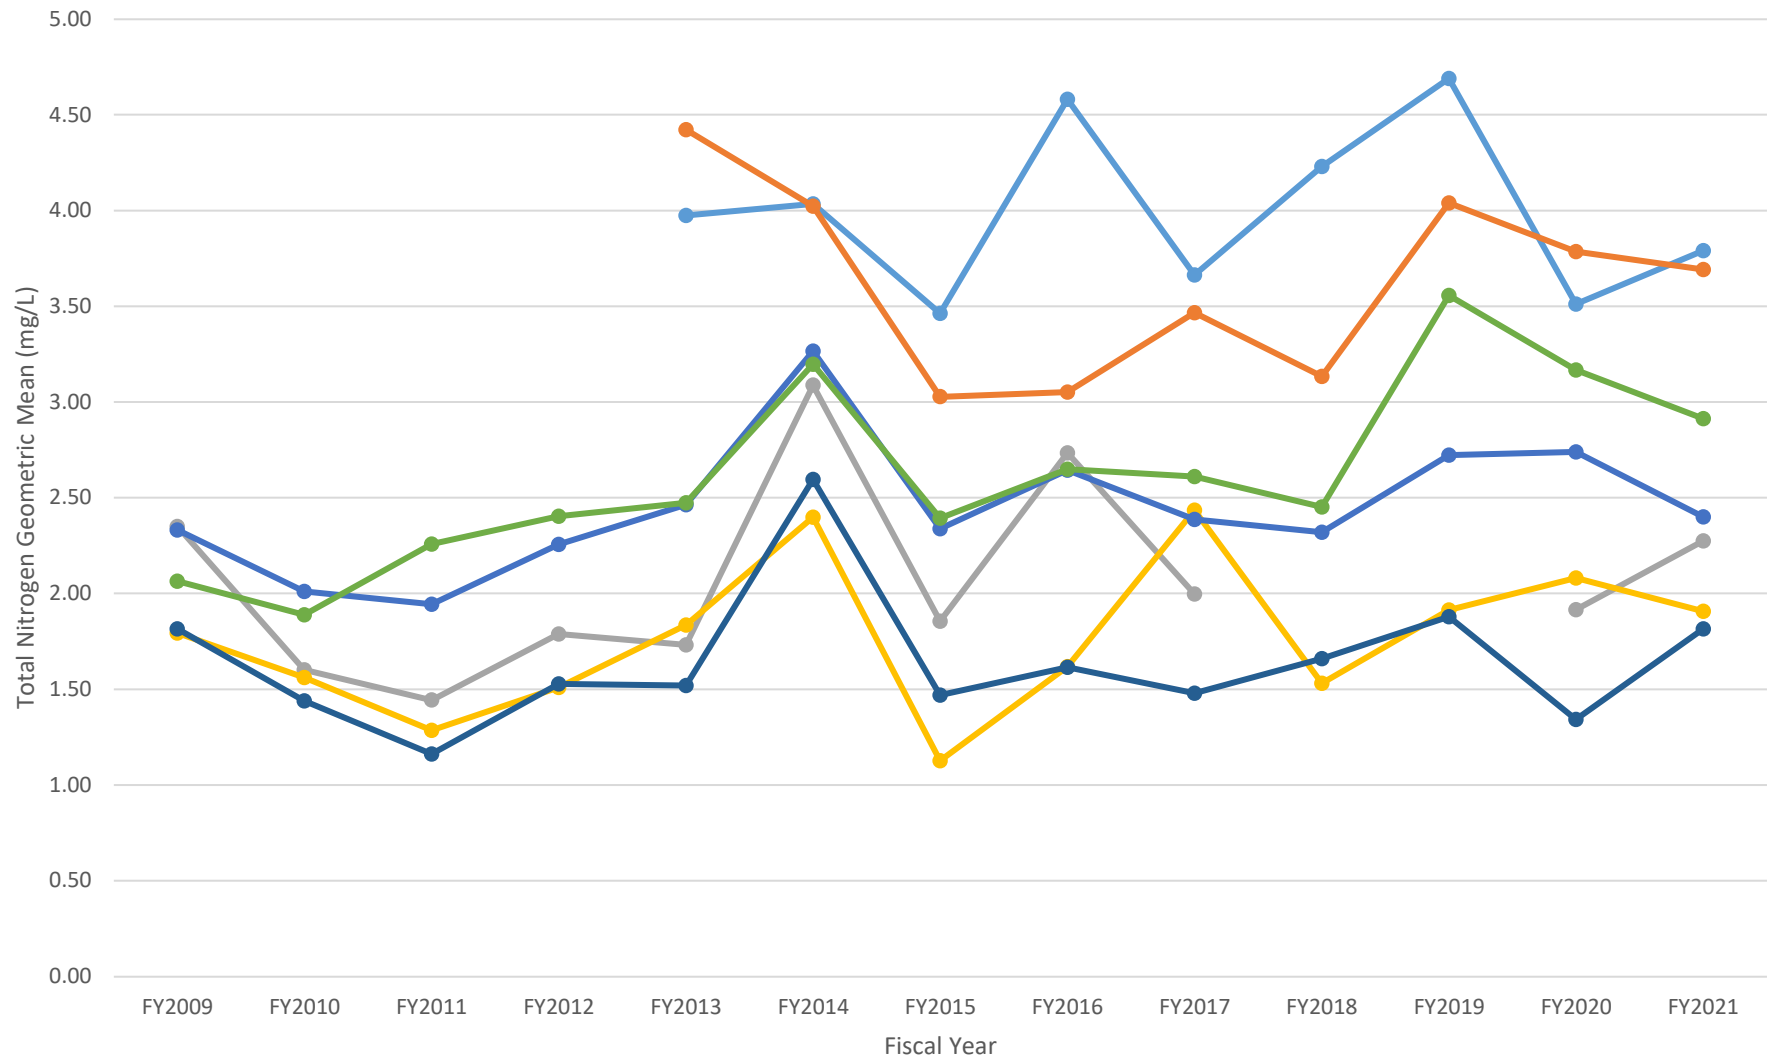
# Total Nitrogen Geometric Means by Fiscal Year

## Direct Harbor Watershed

LINWOOD & ELLIOTT LAKEWOOD & HUDSON CENTRAL & LANCASTER LIGHT ST.  
WARNER & ALLUVION WATERVIEW AVE. JANEY RUN

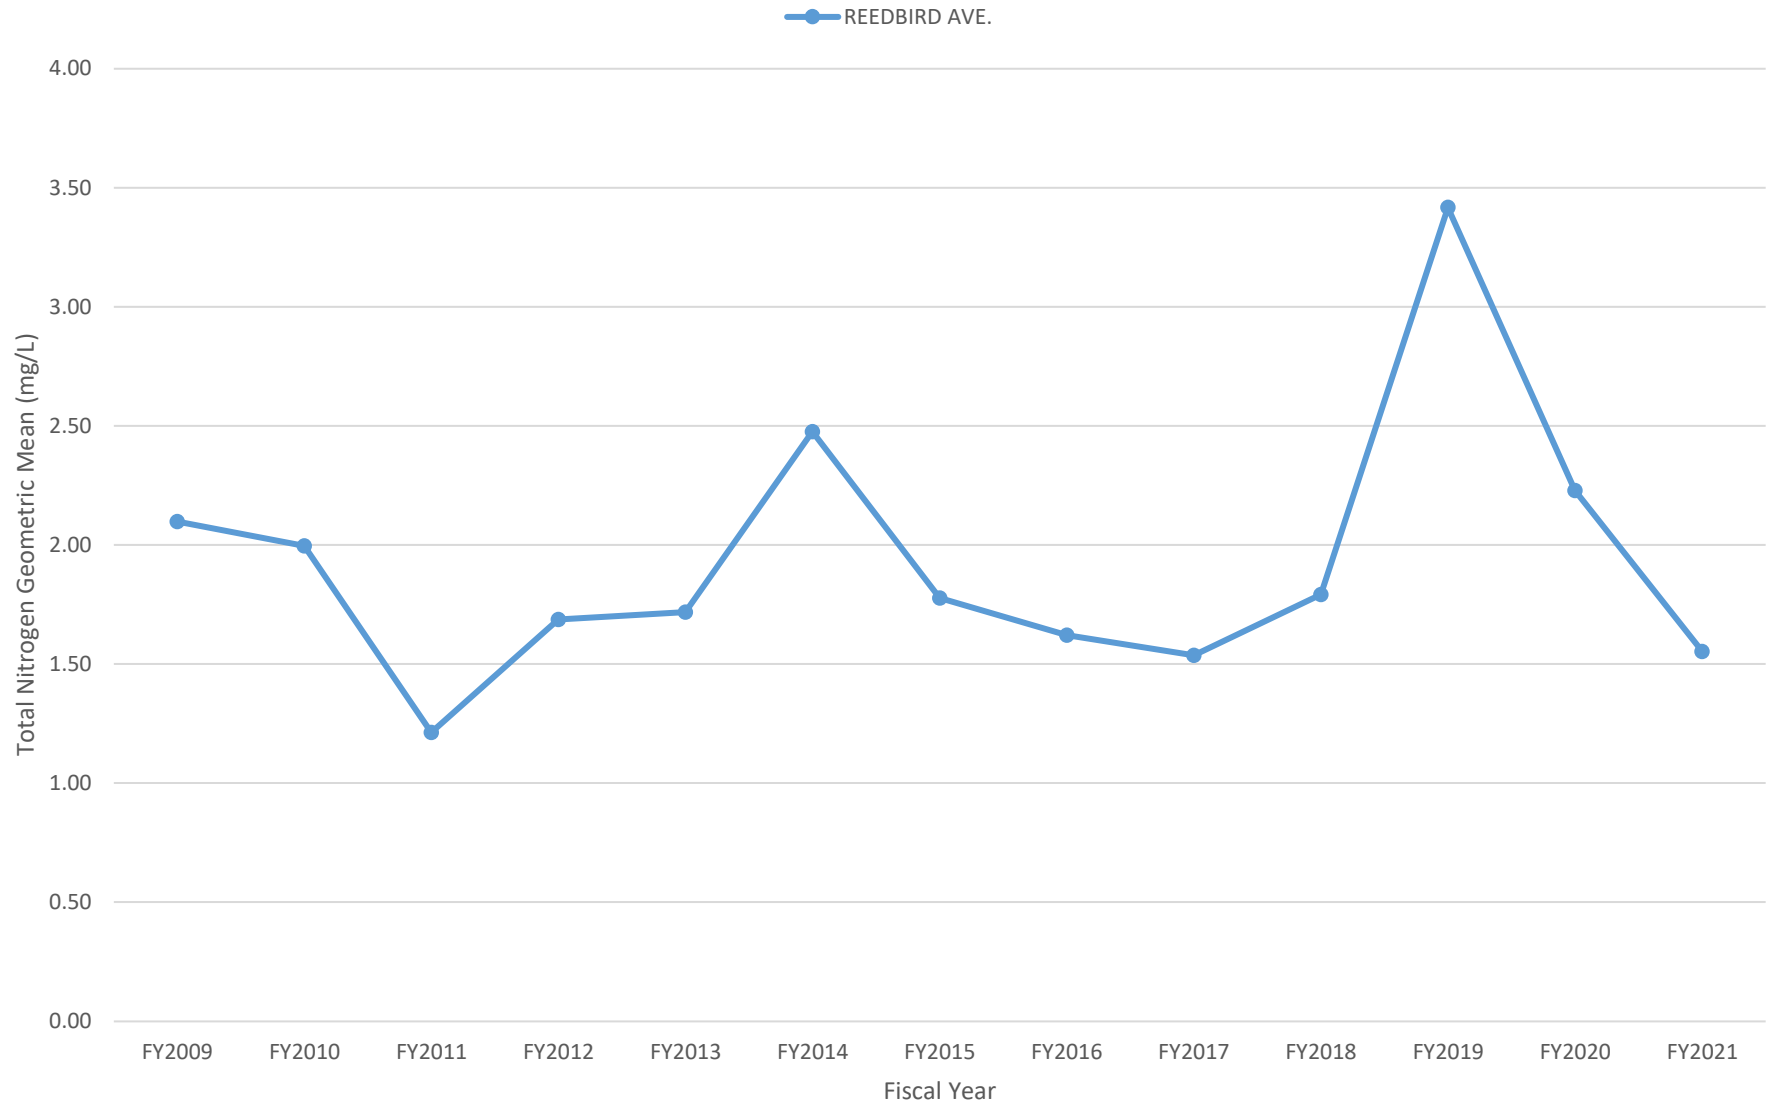
Total Nitrogen Geometric Means by Fiscal Year  
Patapsco River Watershed  
Sampling suspended at REEDBIRD AVE. in October 2020 due to construction at site.

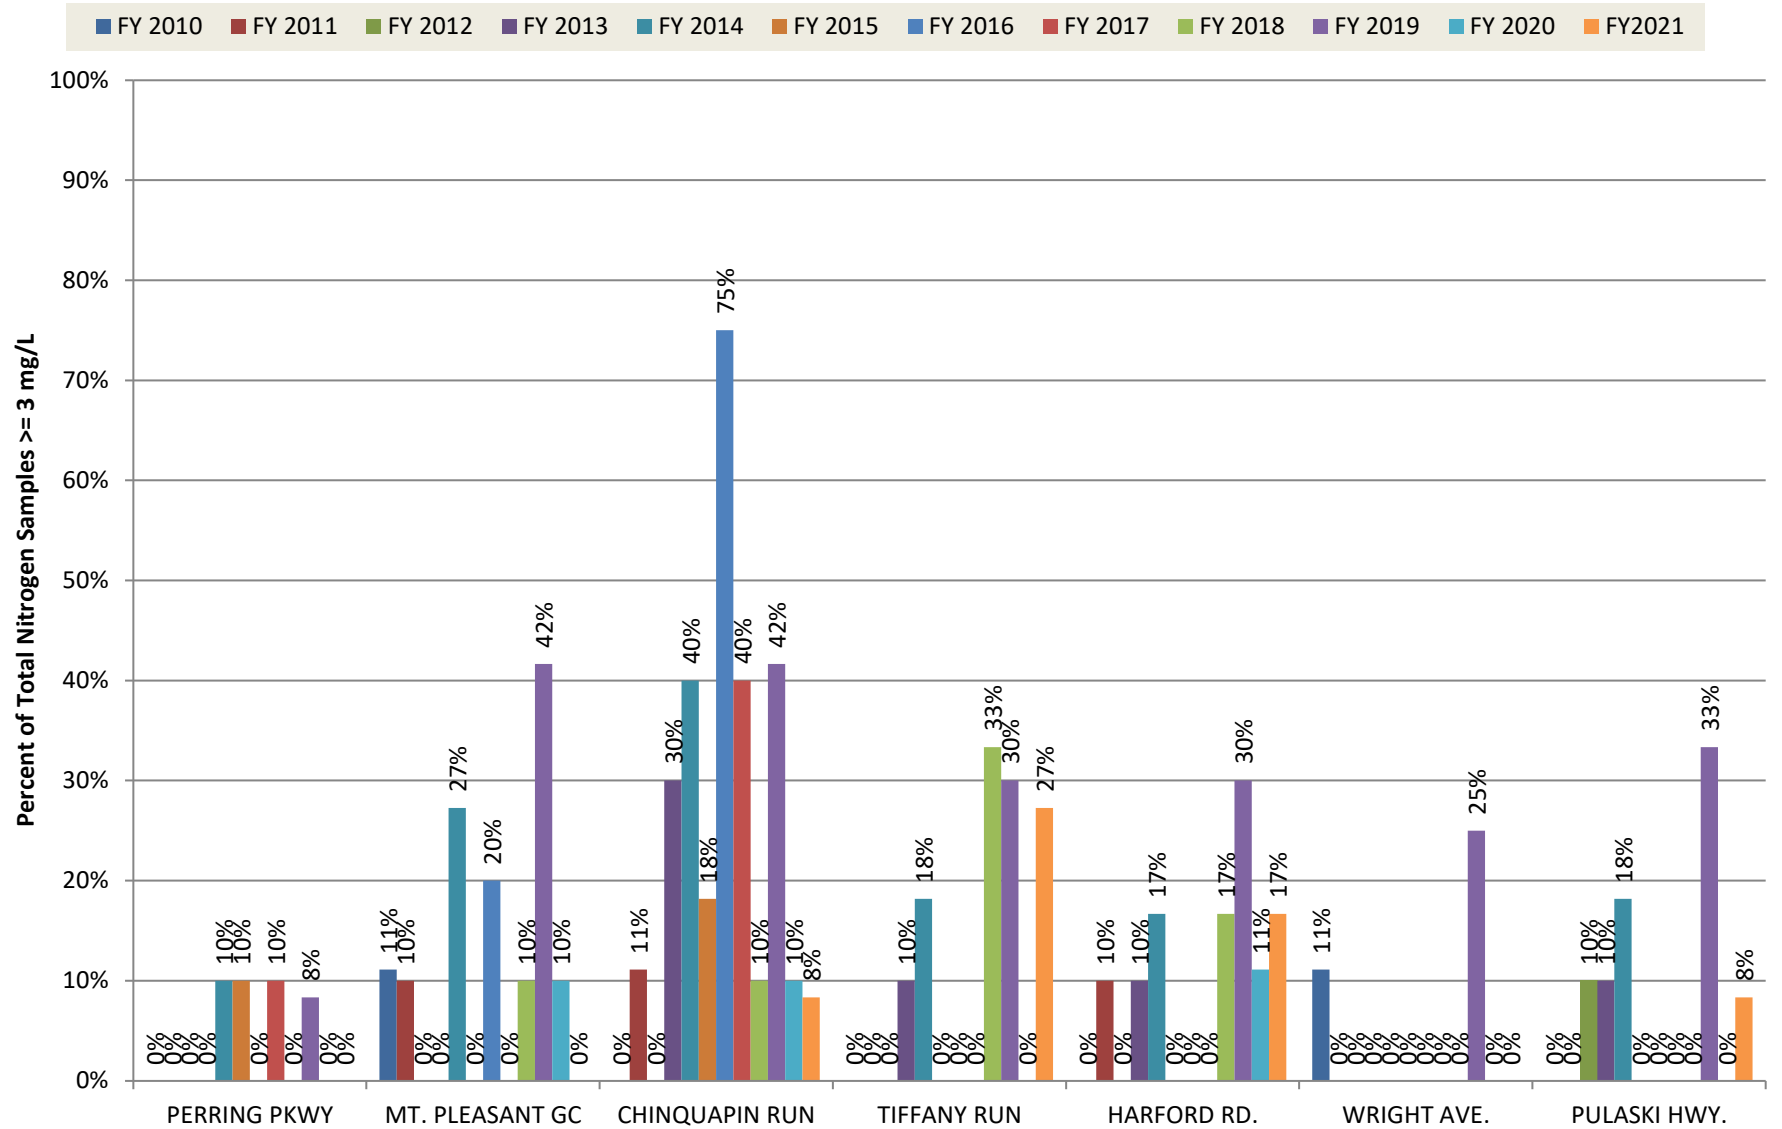
# Herring Run SIS Dry Weather Total Nitrogen Percent of Samples Greater Than or Equal to 3 mg/L by Fiscal Year

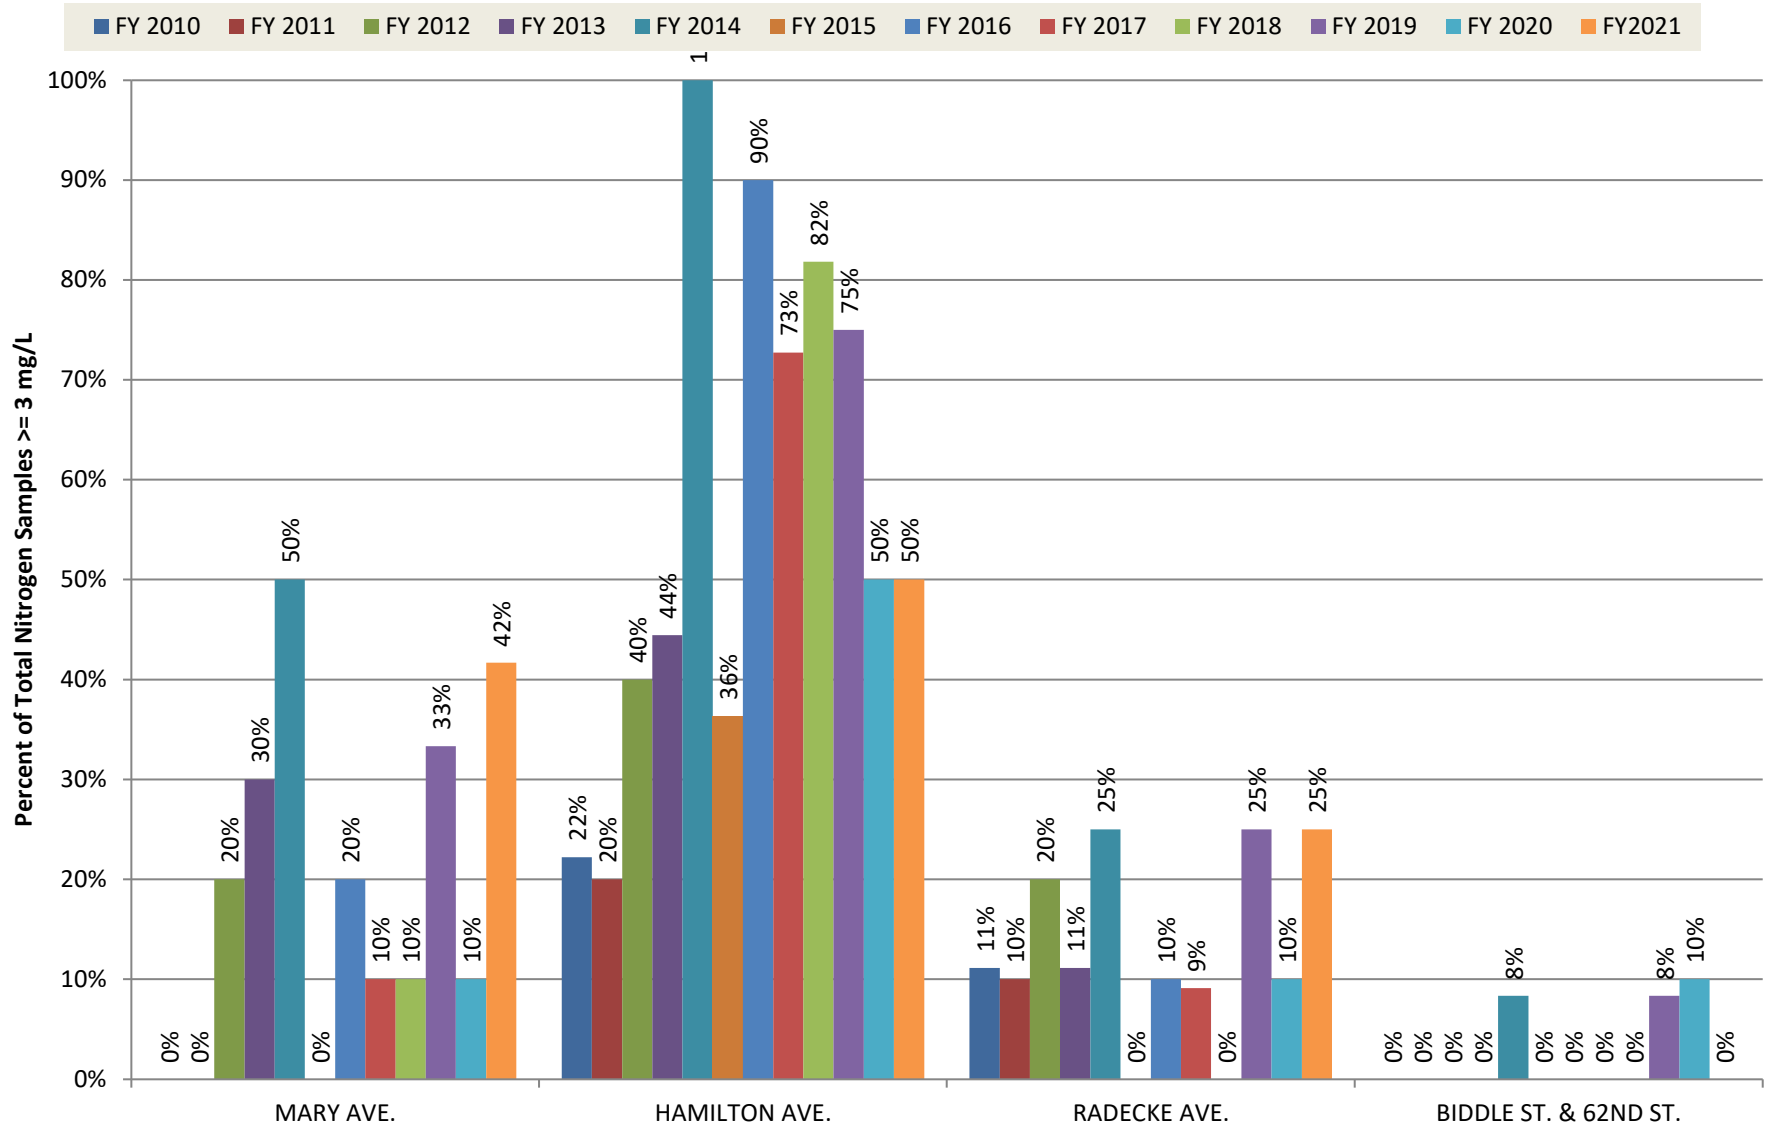
# **Moore's Run SIS Dry Weather Total Nitrogen Percent of Samples Greater Than or Equal to 3 mg/L by Fiscal Year**
