# **BALTIMORE CITY MS4 ANNUAL REPORT**

**Reporting Period: July 1, 2020 to June 30, 2021**

This report includes the progress of compliance for the period of Fiscal Year (FY) 2021, in association with Baltimore City's National Pollutant Discharge Elimination System (NPDES) Municipal Separate Storm Sewer System (MS4) Discharge Permit (Permit Number: 11-DP-3315, MD0068292). The permit associated with the time period of this report was issued on December 27, 2013. Although that permit expired on December 27, 2018, it was administratively continued and the City remained responsible for compliance of those permit conditions. Annual report periods follow the City's fiscal calendar: July 1 to June 30. This Annual report has been formatted to match the reporting requirements as listed in Part V of the MS4 permit.

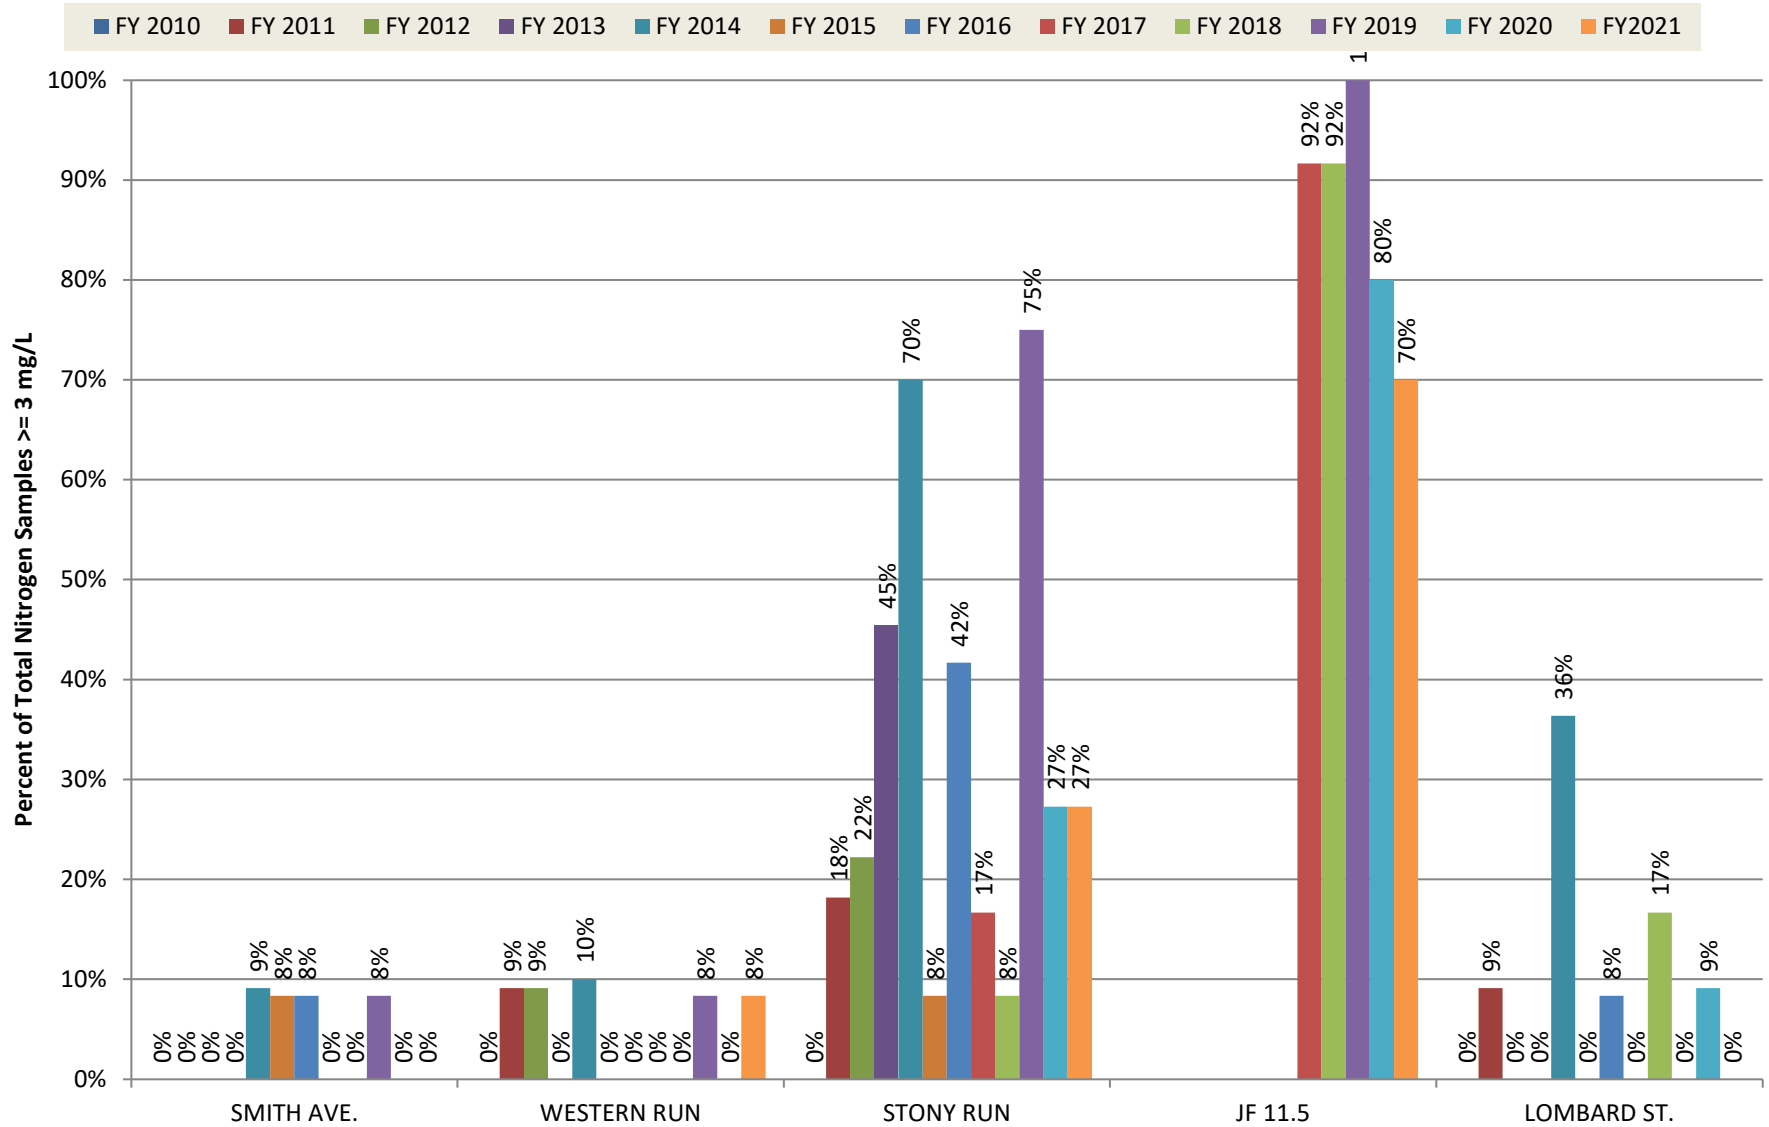
# Jones Falls SIS Dry Weather Total Nitrogen Percent of Samples Greater Than or Equal to 3 mg/L by Fiscal Year

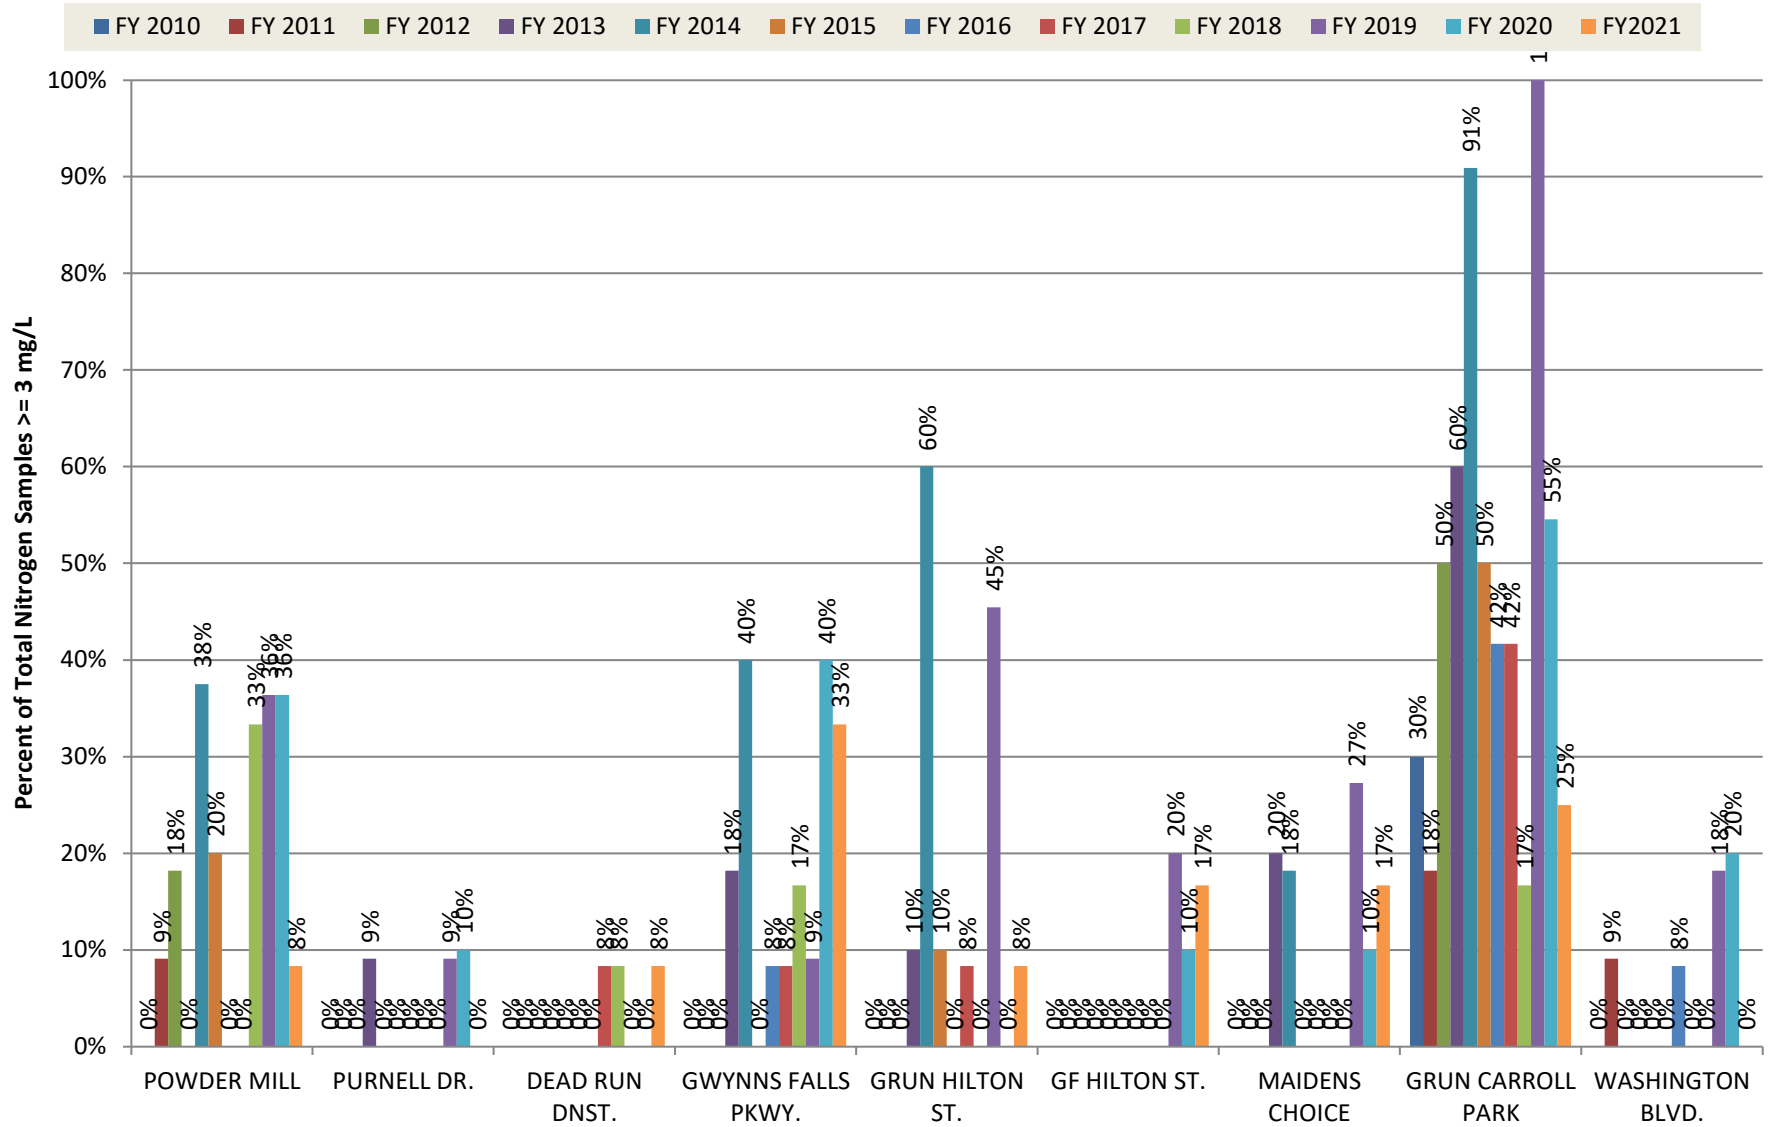
# Gwynns Falls SIS Dry Weather Total Nitrogen Percent of Samples Greater Than or Equal to 3 mg/L by Fiscal Year

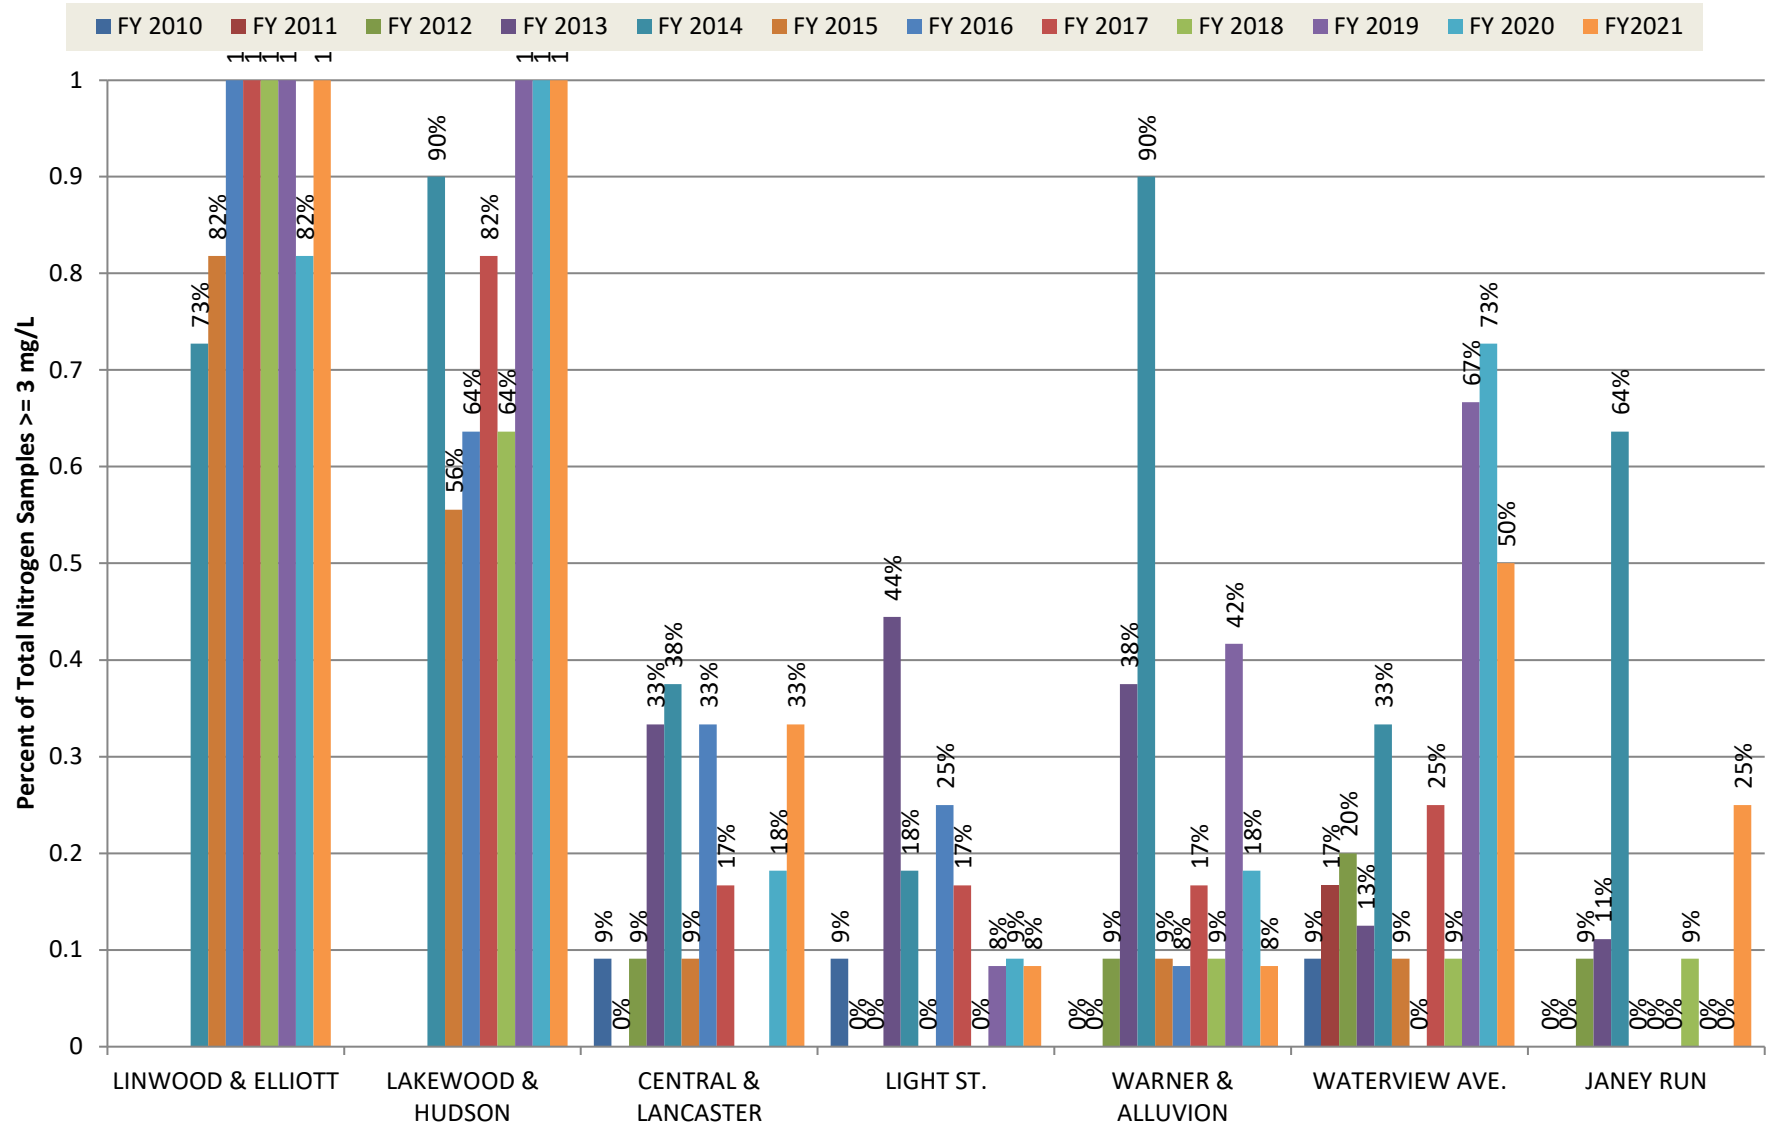
**Harbor SIS Dry Weather Total Nitrogen**  
**Percent of Samples Greater Than or Equal to 3 mg/L**  
**by Fiscal Year**

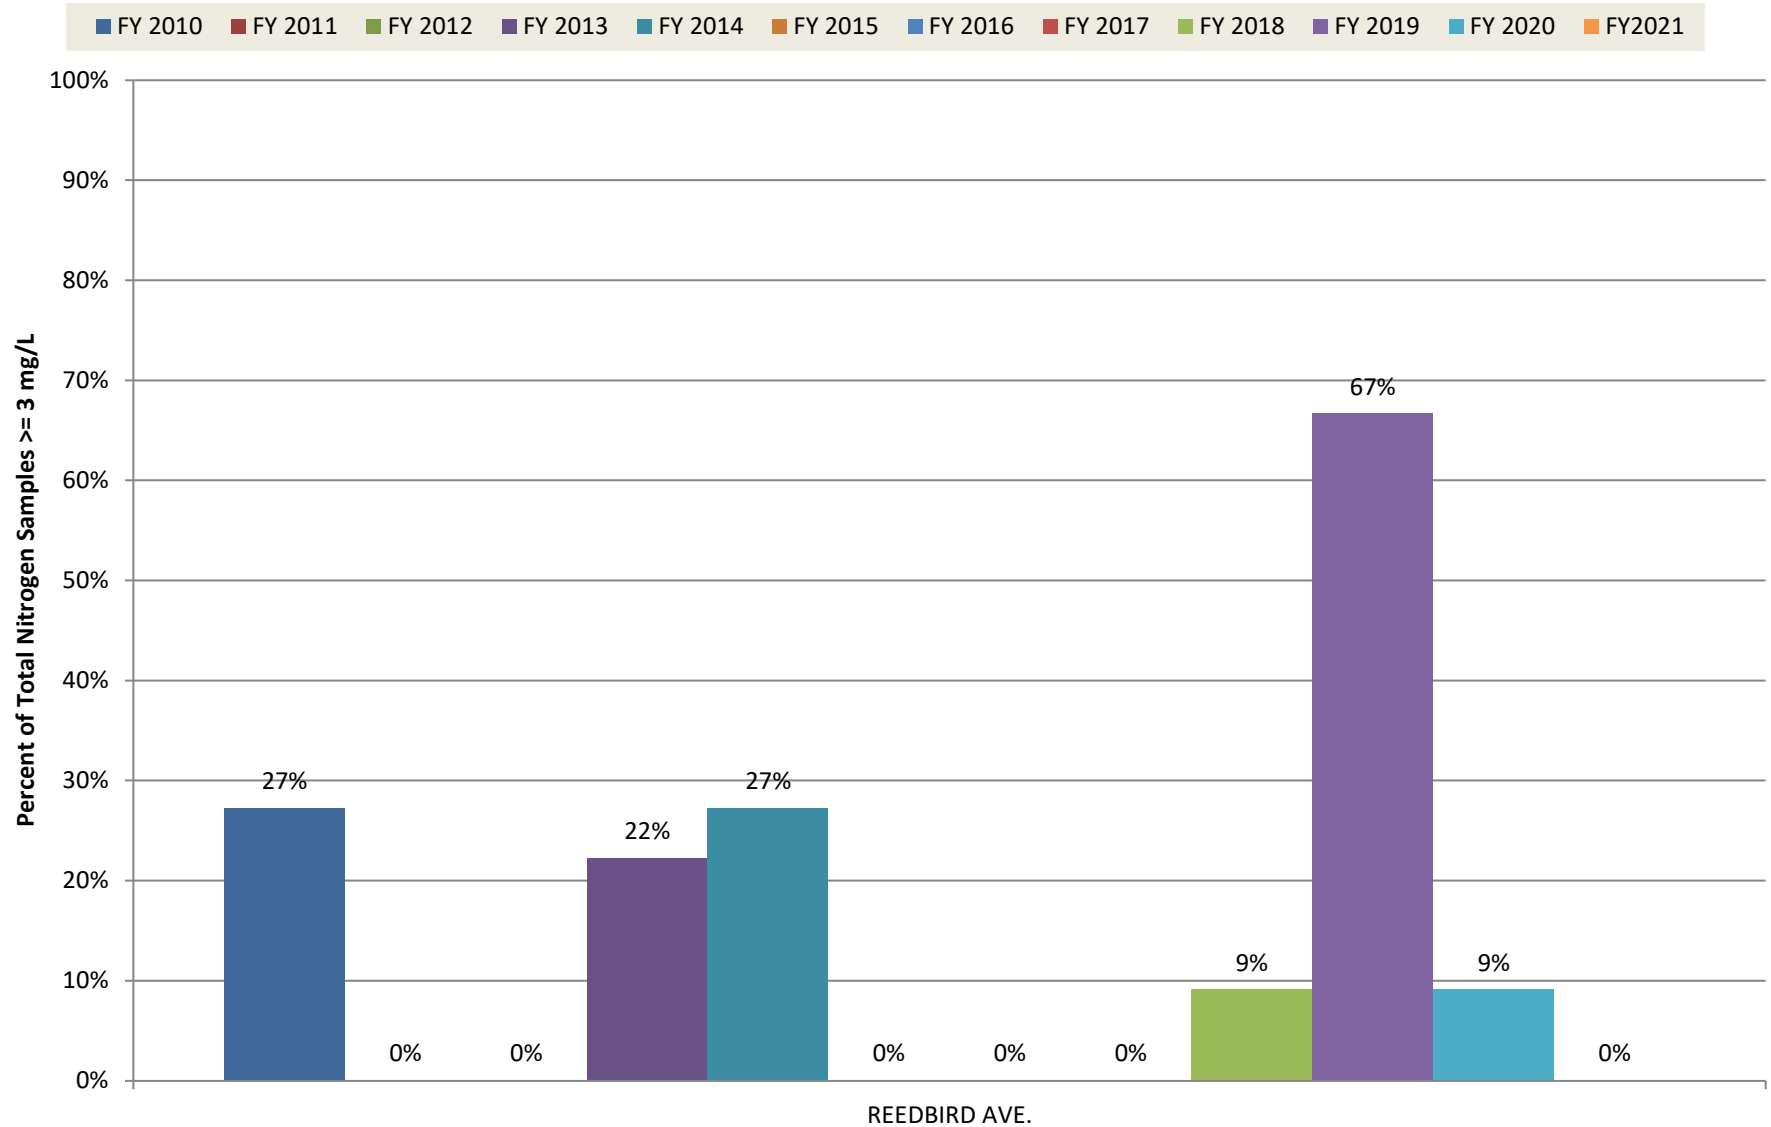
**Patapsco River SIS Dry Weather Total Nitrogen  
Percent of Samples Greater Than or Equal to 3 mg/L  
by Fiscal Year**

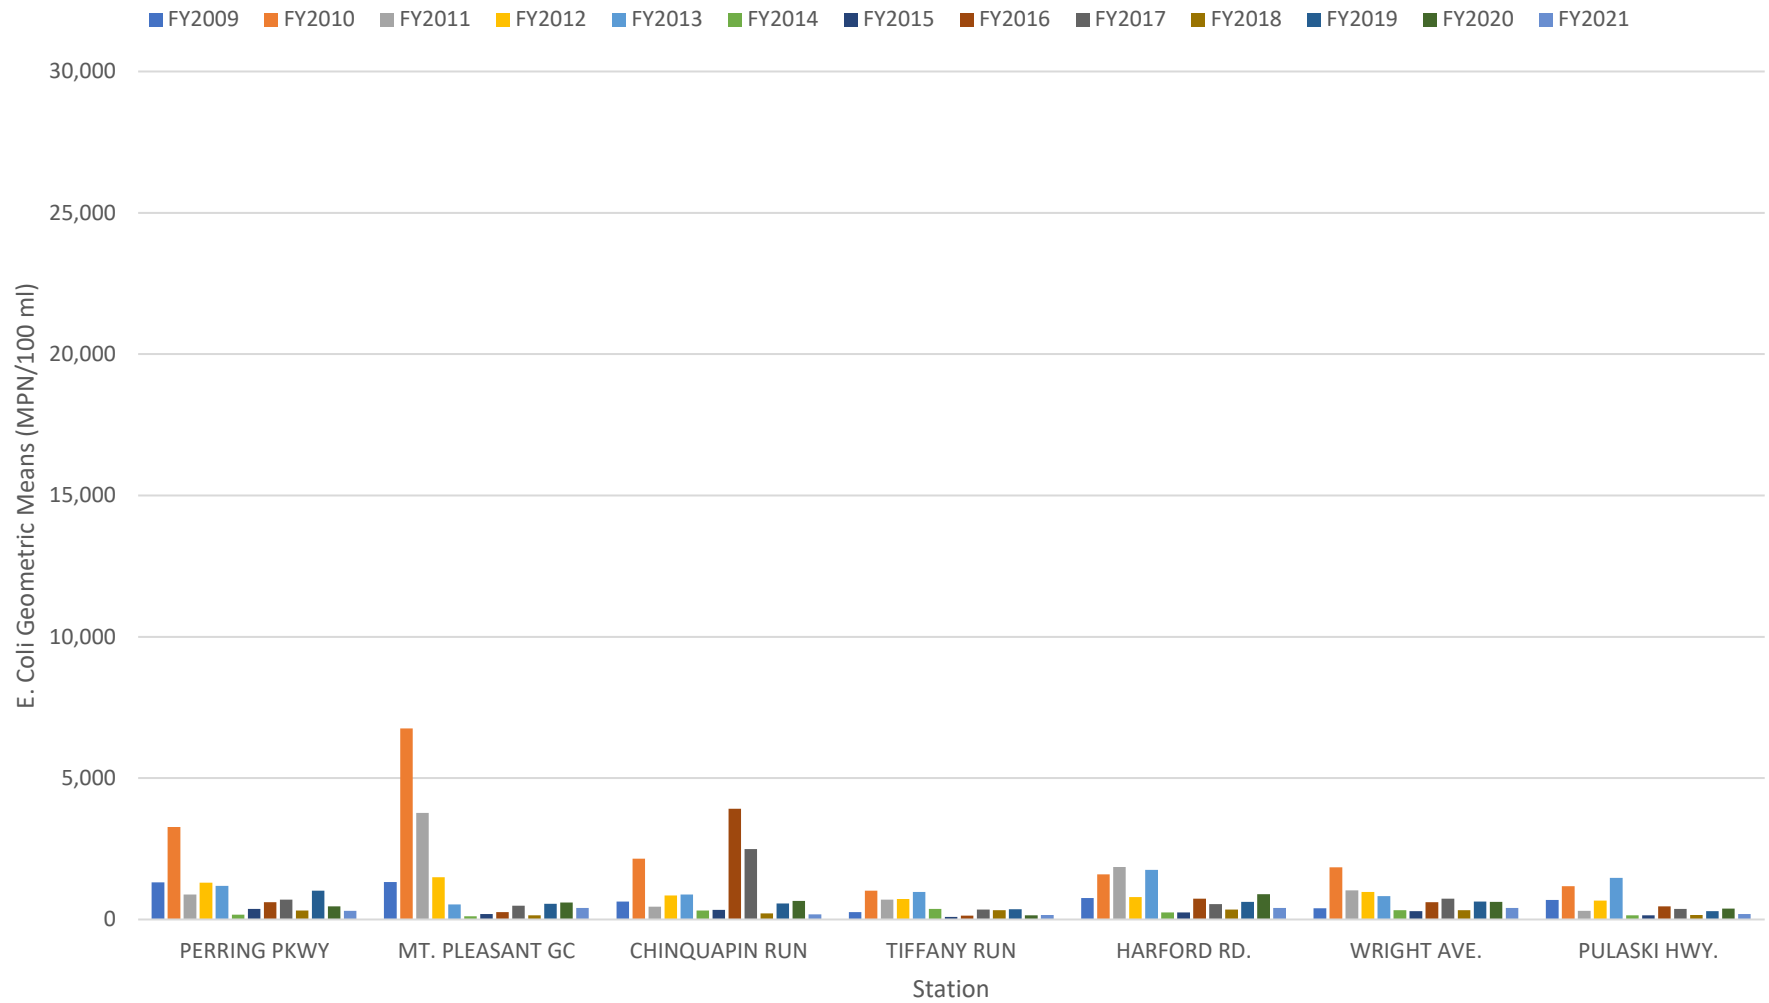
Please note: from COMAR 26.08.02.03-3 the criteria is that the Steady State Geometric Mean Indicator Density be less than or equal to 126 MPN/100 ml for freshwaters.

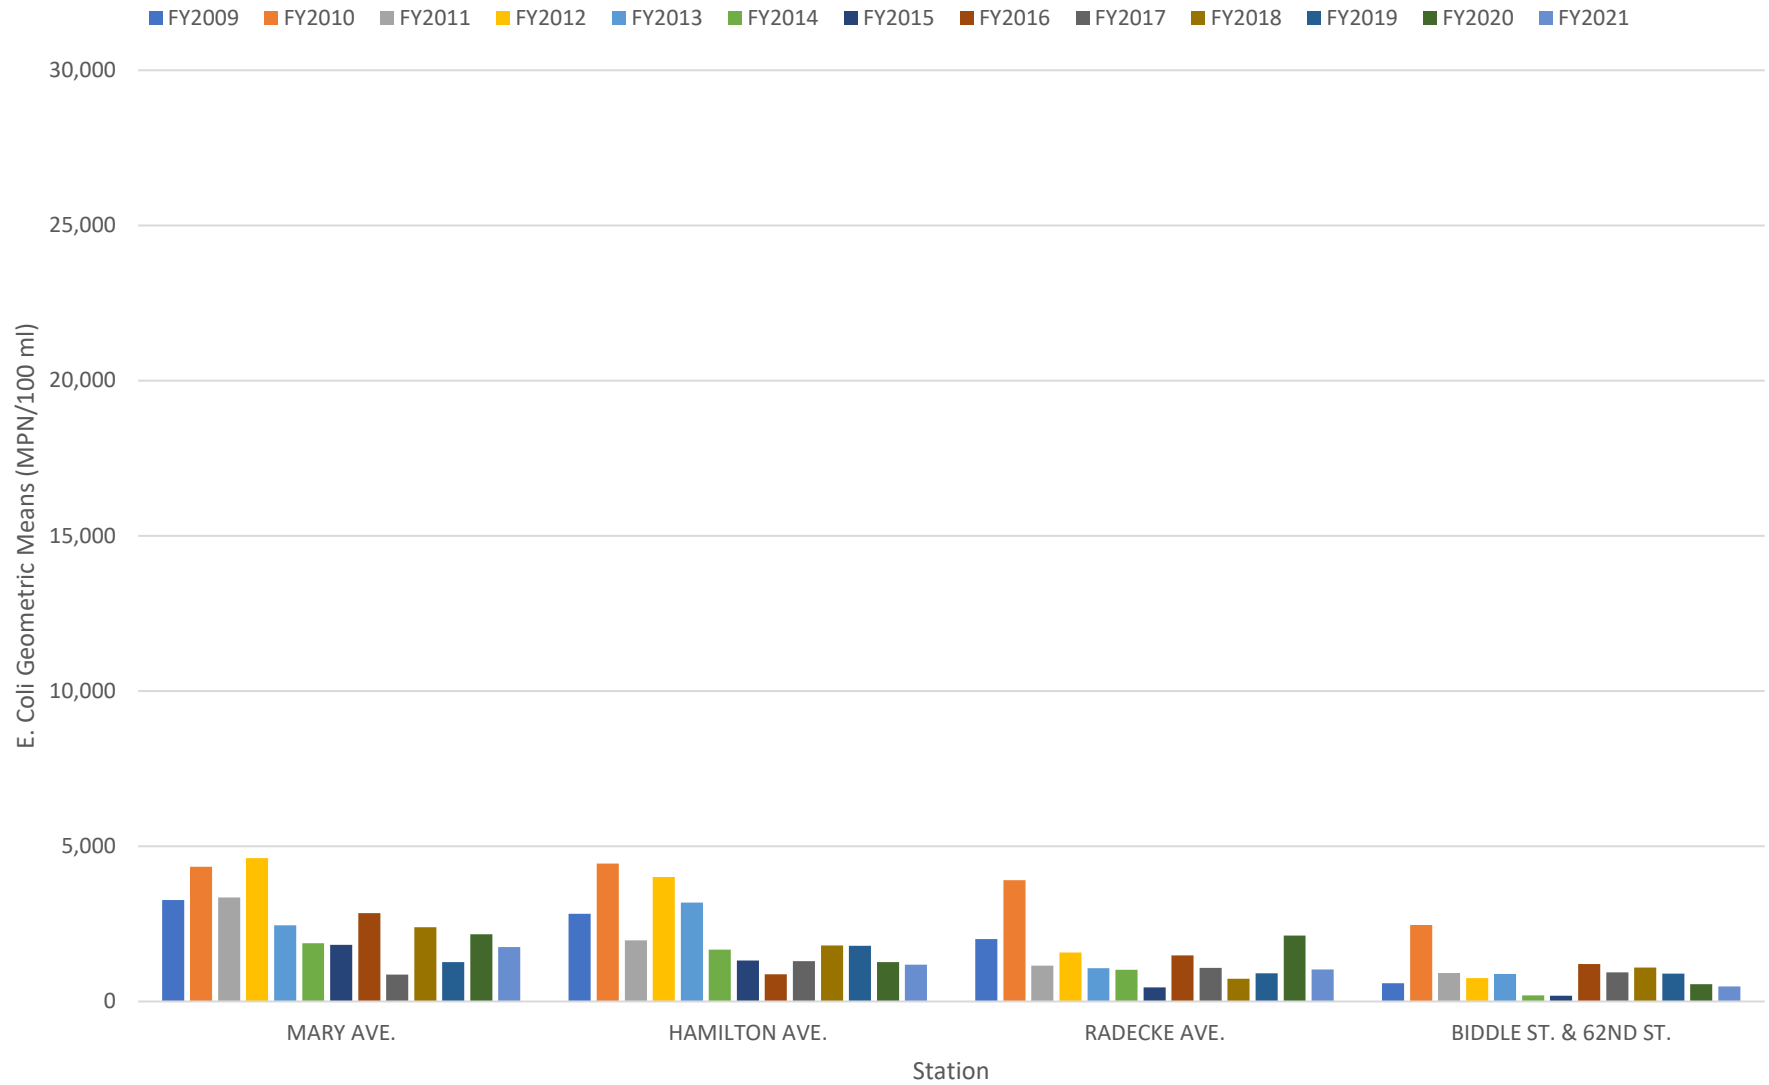
## Back River-Moores Run Watershed SIS E. Coli Counts

### Geometric Means by Fiscal Year

*Please note: from COMAR 26.08.02.03-3 the criteria is that the Steady State Geometric Mean Indicator Density be less than or equal to 126 MPN/100 ml for freshwaters.*

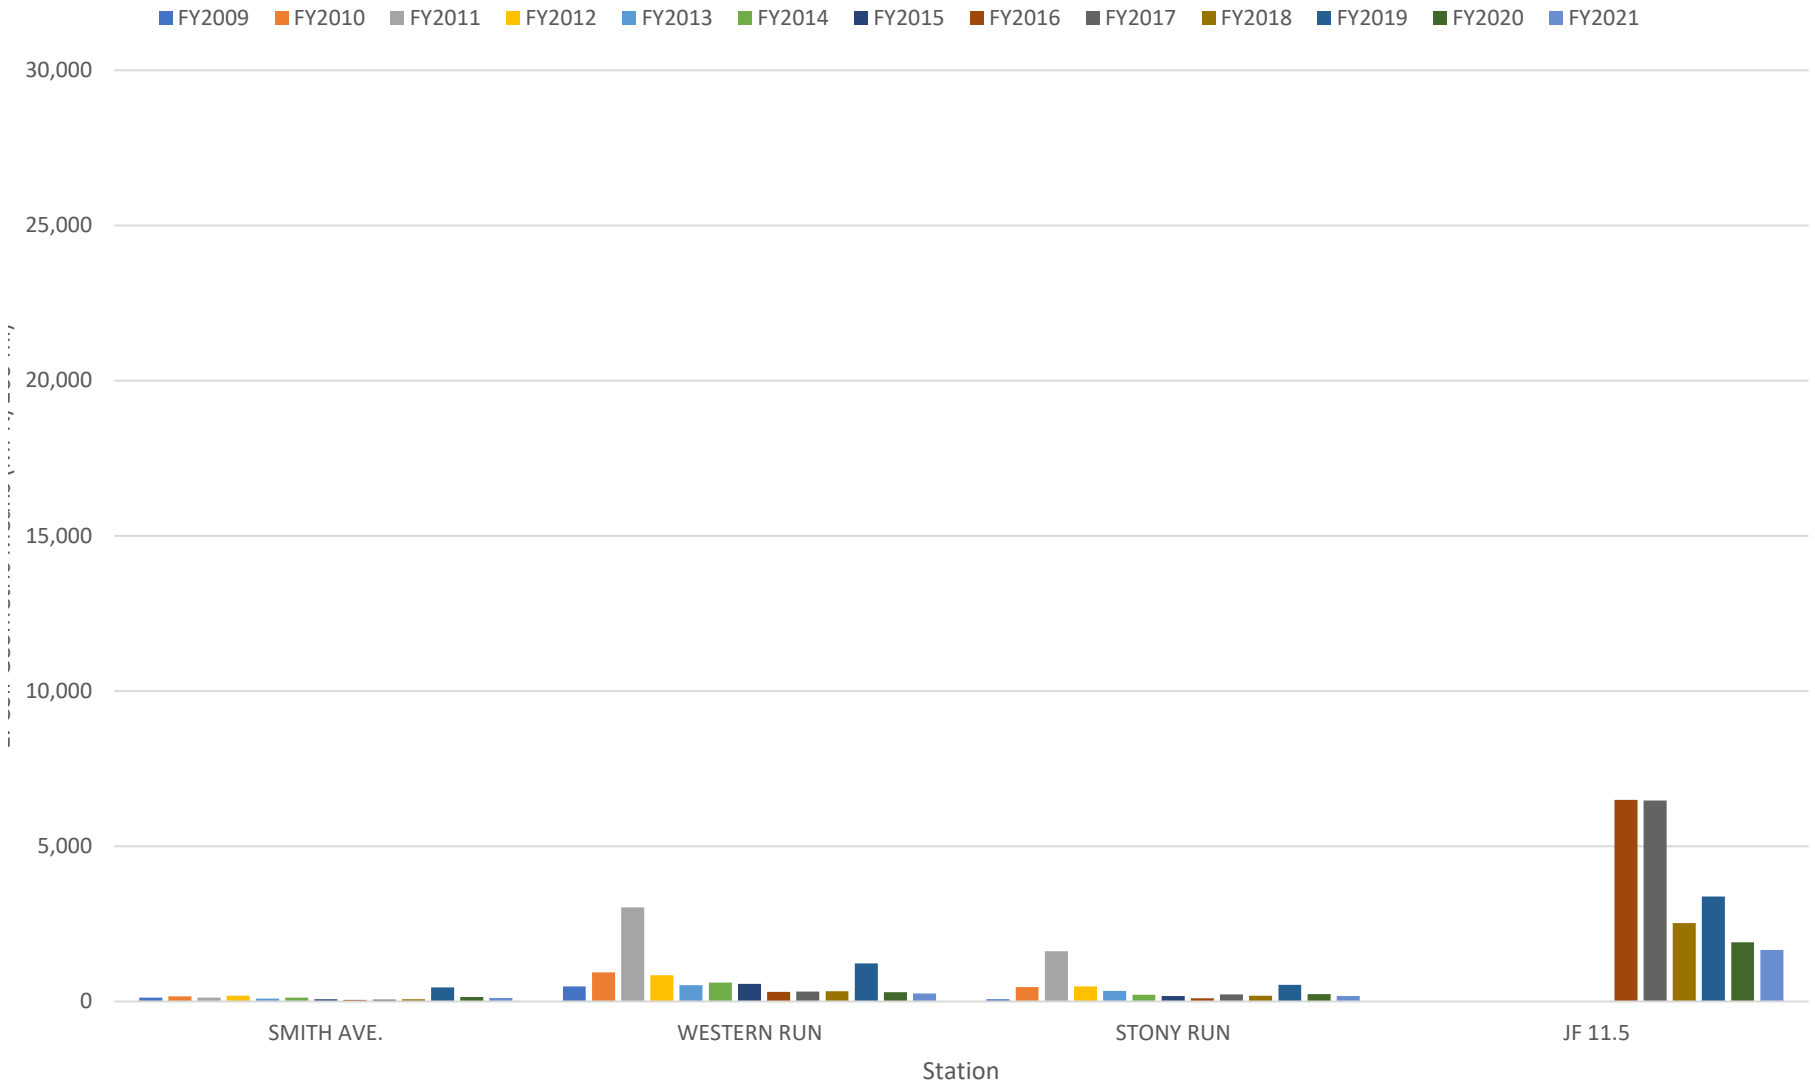
## Jones Falls Watershed SIS E. Coli Counts Geometric Means by Fiscal Year

*Please note: from COMAR 26.08.02.03-3 the criteria is that the Steady State Geometric Mean Indicator Density be less than or equal to 126 MPN/100 ml for freshwaters.*

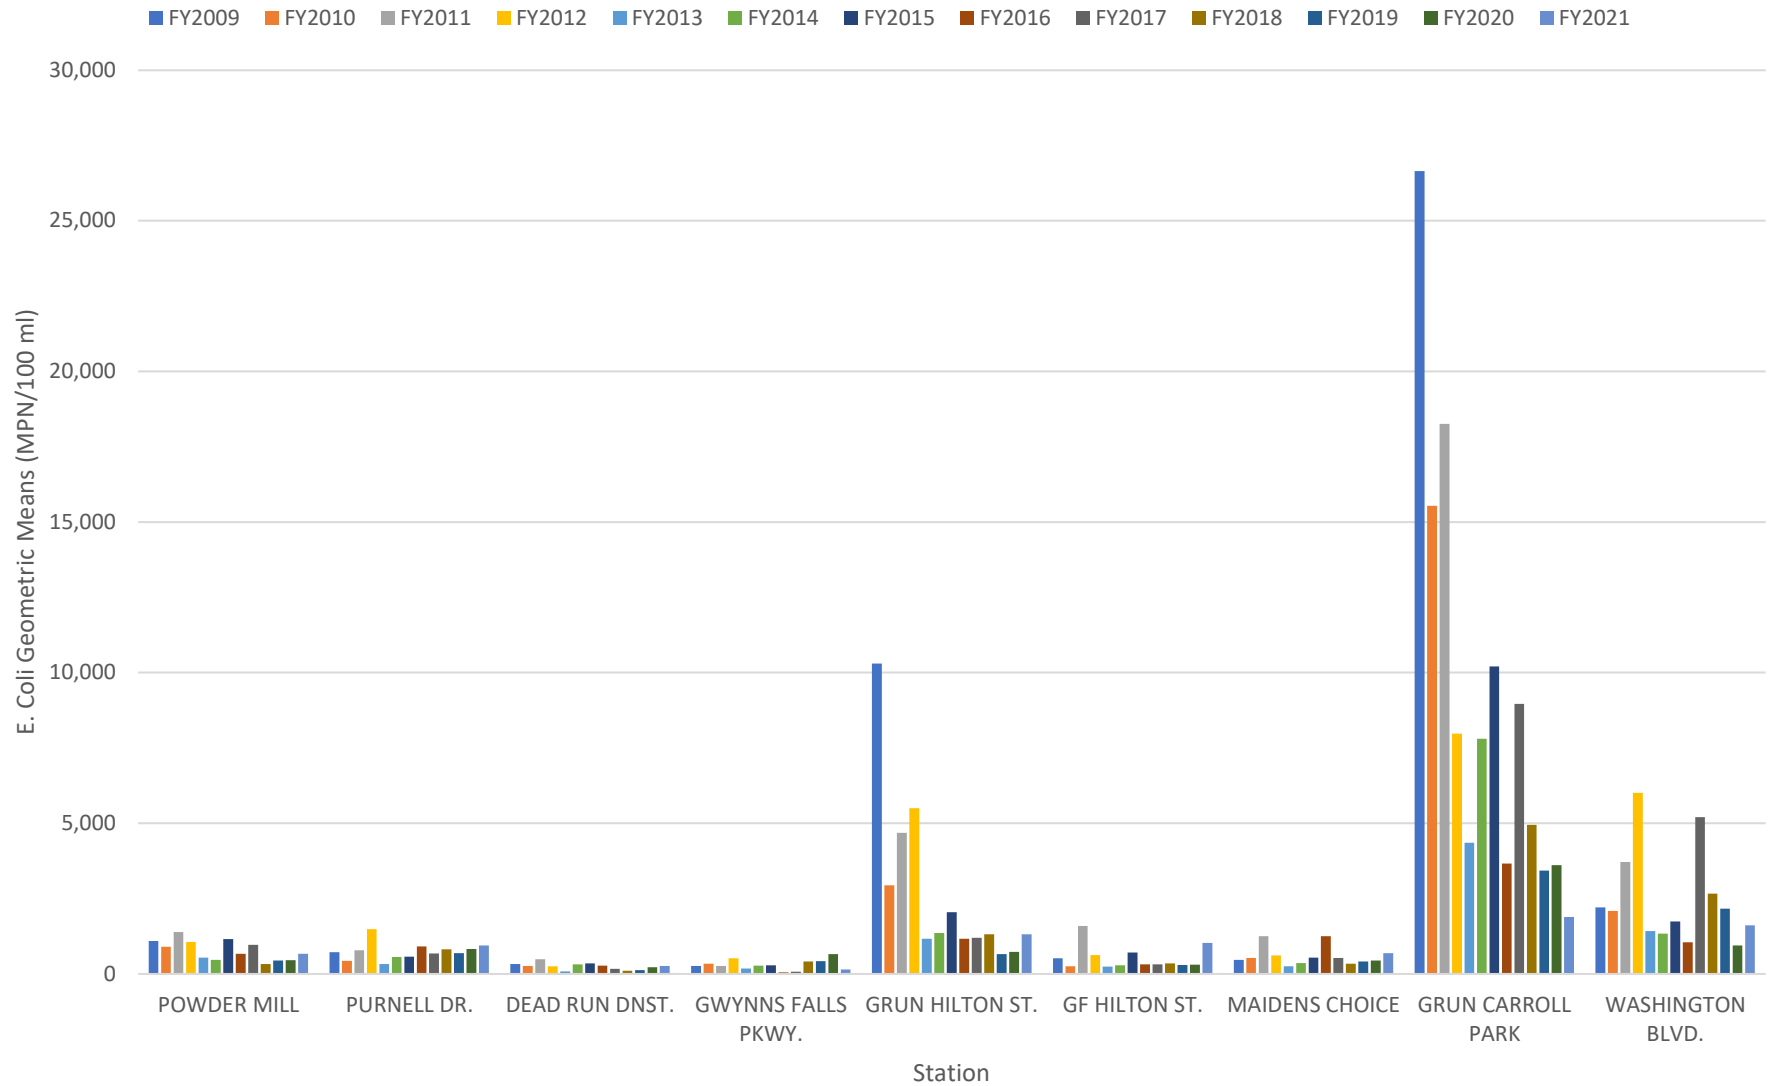
## Gwynns Falls Watershed SIS E. Coli Counts

### Geometric Means by Fiscal Year

*Please note: from COMAR 26.08.02.03-3 the criteria is that the Steady State Geometric Mean Indicator Density be less than or equal to 126 MPN/100 ml for freshwaters.*

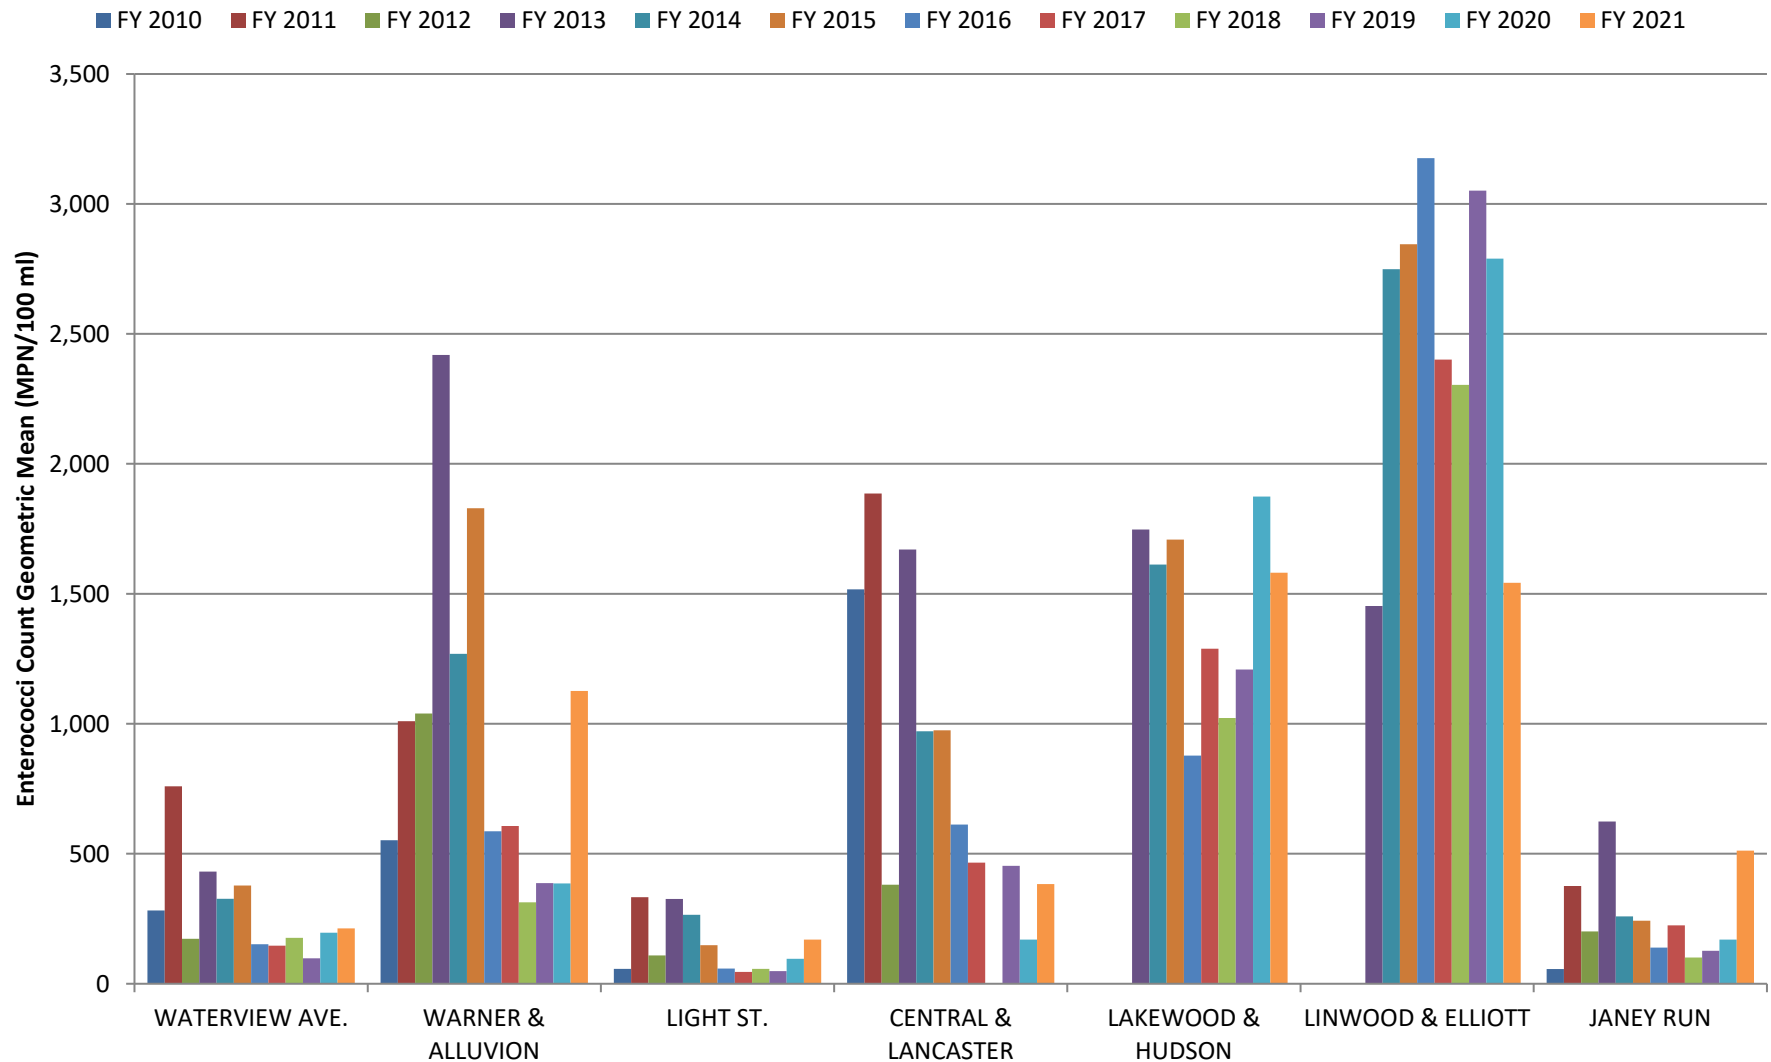
# Harbor SIS Dry Weather Enterococci MPN Count

## Geometric Means by Fiscal Year

*Please note: from COMAR 26.08.02.03-3 the criteria is that the Steady State Geometric Mean Indicator Density be less than or equal to 35 MPN/100 ml for marine waters.*

None of the stations met all of the water quality criteria for FY 2021. No stations had a GM for enterococci counts close to the criterion of 35 MPN/100 ml. Four (4) stations failed by falling below the dissolved oxygen minimum threshold of 5 mg/L: Warner & Alluvion, Light Street, Central & Lancaster and Janey Run. The temperature criterion was met at all of the stations. Three (3) stations failed by exceeding the maximum pH threshold of 8.5: Waterview Avenue, Light Street and Janey Run.

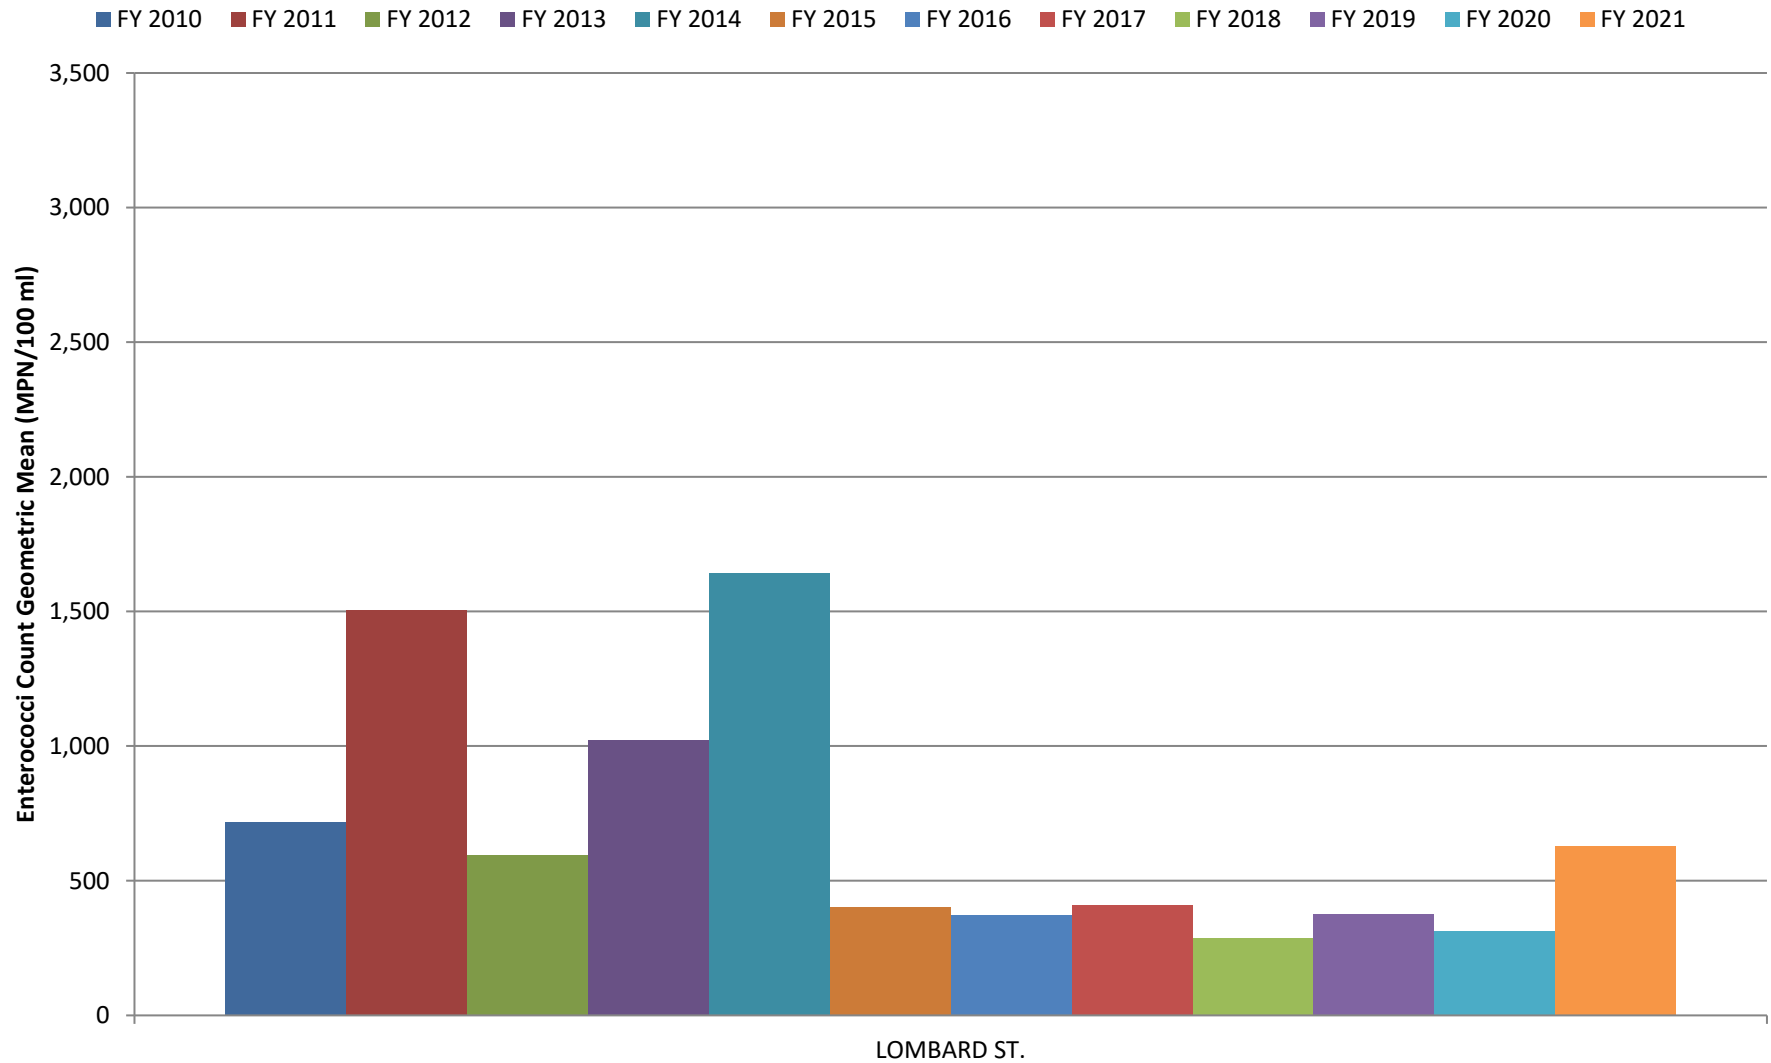
# Jones Falls SIS Dry Weather Enterococci MPN Count Geometric Means by Fiscal Year

*Please note: from COMAR 26.08.02.03-3 the criteria is that the Steady State Geometric Mean Indicator Density be less than or equal to 35 MPN/100 ml for marine waters.*

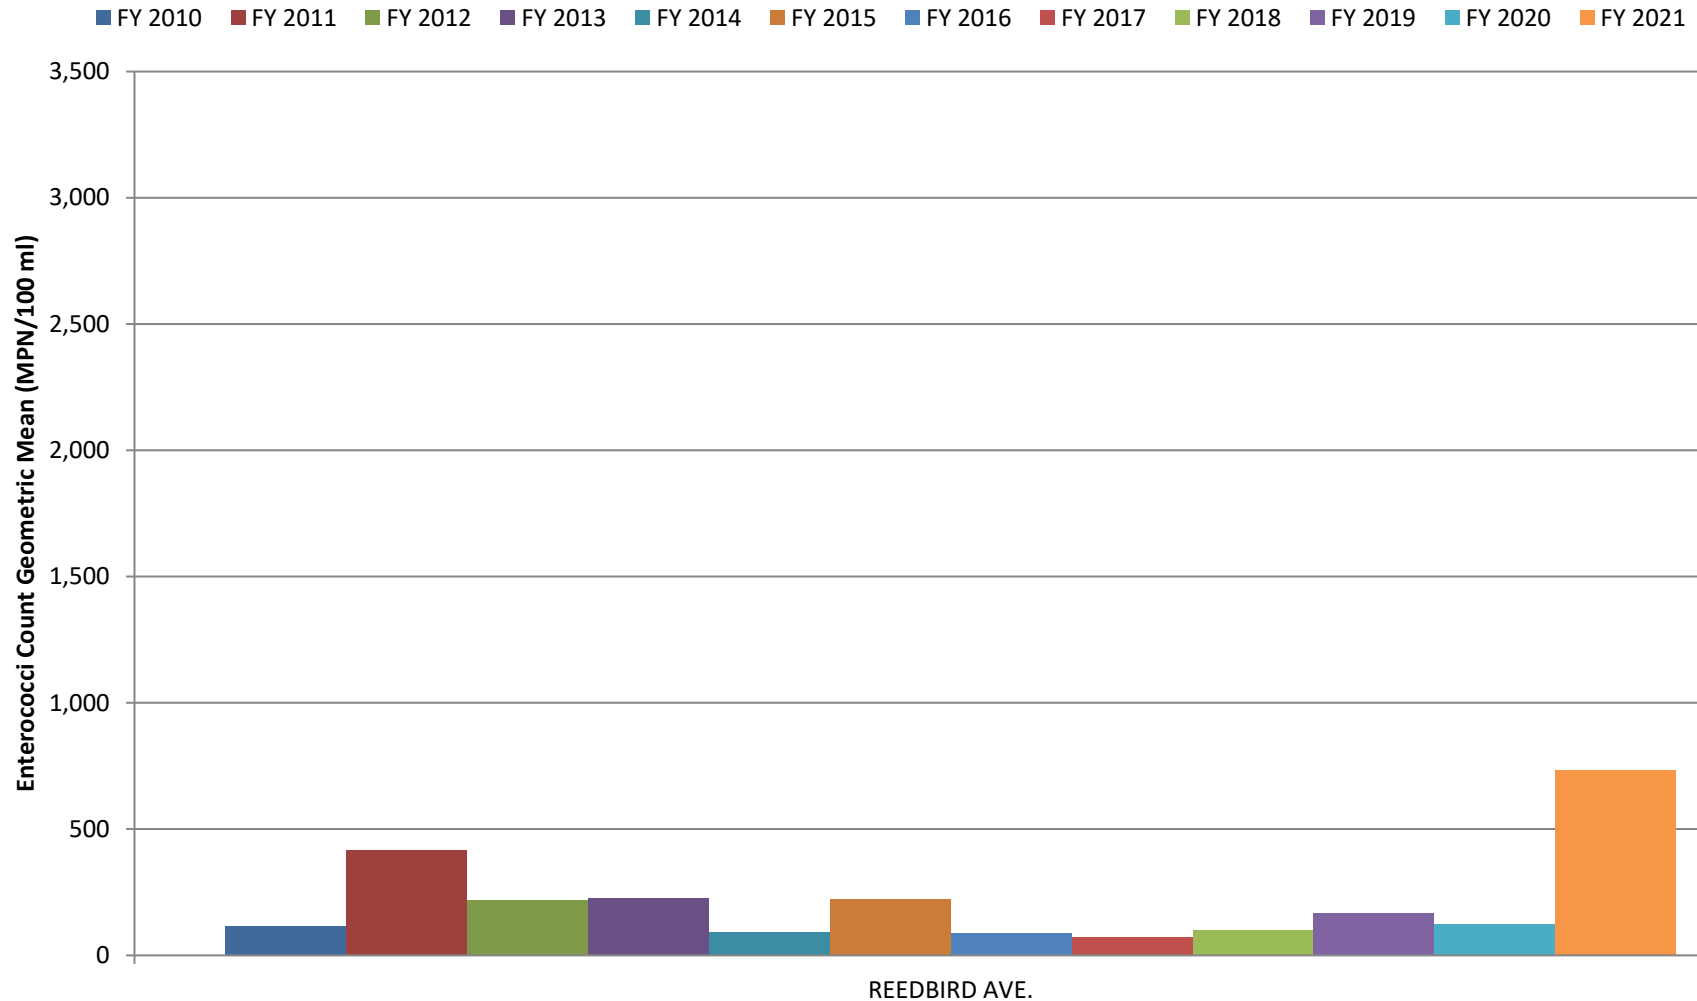
# Patapsco River SIS Dry Weather Enterococci MPN Count

## Geometric Means by Fiscal Year

*Please note: from COMAR 26.08.02.03-3 the criteria is that the Steady State Geometric Mean Indicator Density be less than or equal to 35 MPN/100 ml for marine waters.*
